Locations of the Public Calls in 2014

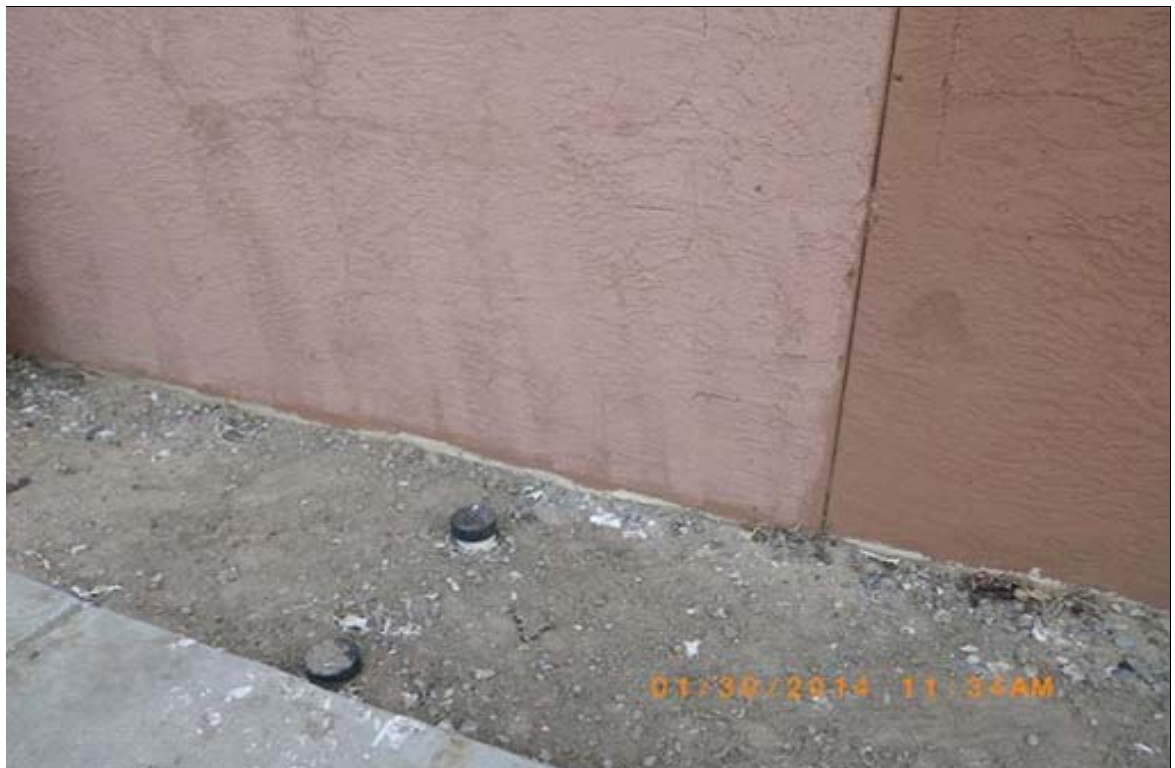
Address	1830 BUENA VISTA SE				
Event ID	388	REPORTING SOURCE	WEB	Complaint Date	1/15/2014
CUSTOMER	ERIC BEACH	311CASE ID	WEB	e-mail	beacheric@comcast.net
CUSTOMER Ph#	270-9165	SharePointLink: http://sharepoint.cabq.gov/dmd/storm/STORMWATER%20POLLUTION			
Description:	RAW SEWAGE OVERFLOWING FROM 4 PLEX INTO PARKING LOT AND STREET				
Suspected Facility	APARTMENTS	Type of Complaint	SEWAGE		
Inspection Date	1/30/2014	Number of Field Visits	1	Inspector	SK
Facility Contact	NA	Facility Ph. #	na		
FIELD OBSERVATION	THERE WAS DRY RESIDUE NEAR THE SANITARY LINE CLEAN UP VALVE INDICATING SEWAGE OVERFLOW.				
INITIAL ACTION	IT HAS BEEN FIXED, NO ACTION REQUIRED

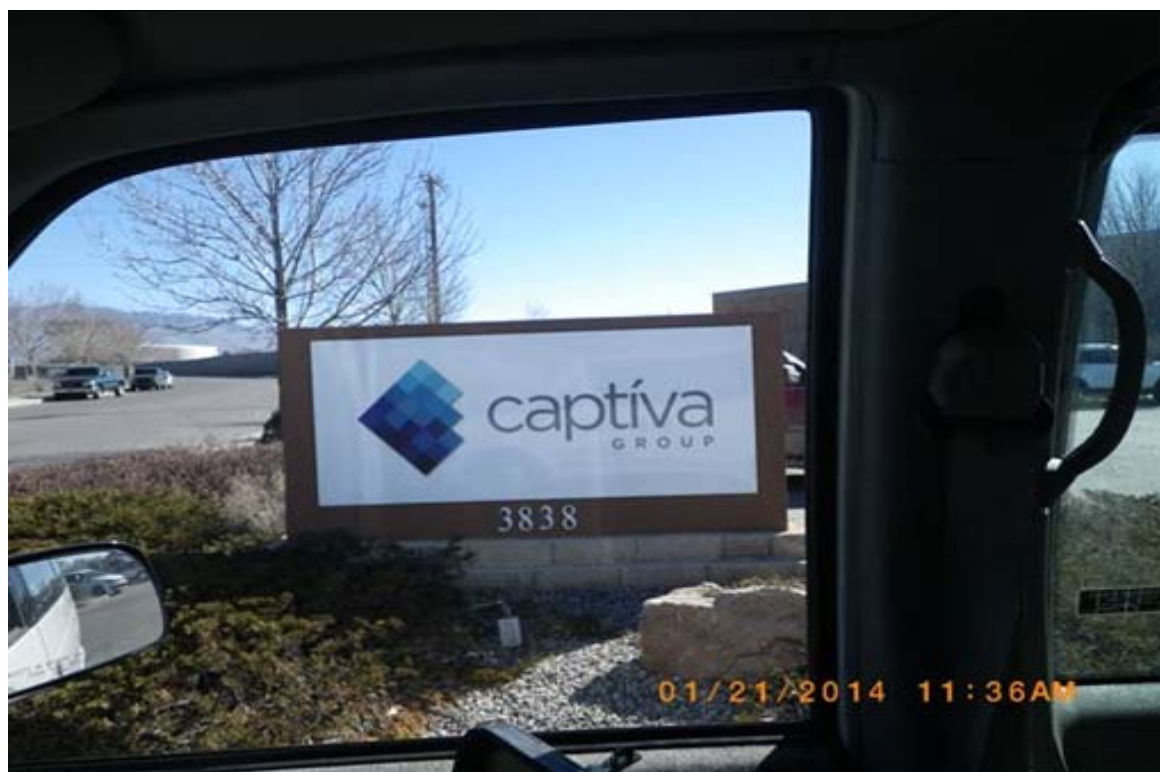
Address	3838 BOGAN NE				
Event ID	386	REPORTING SOURCE	WEB	Complaint Date	1/16/2014
CUSTOMER	ANONYMOUS	311CASE ID	WEB	e-mail	
CUSTOMER Ph#		SharePointLink: http://sharepoint.cabq.gov/dmd/storm/STORMWATER%20POLLUTION			
Description:	CHEMICAL WASTE SOLVENT COATING				
Suspected Facility	CAPTIVA GROUP	Type of Complaint	HAZARDOUS MATERIAL		
Inspection Date	1/21/2014	Number of Field Visits	1	Inspector	SK
Facility Contact	NA	Facility Ph. #			
FIELD OBSERVATION	I DID NOT SEE ANY EVIDENC OF DUMPING				
INITIAL ACTION	NO ACTION TAKEN

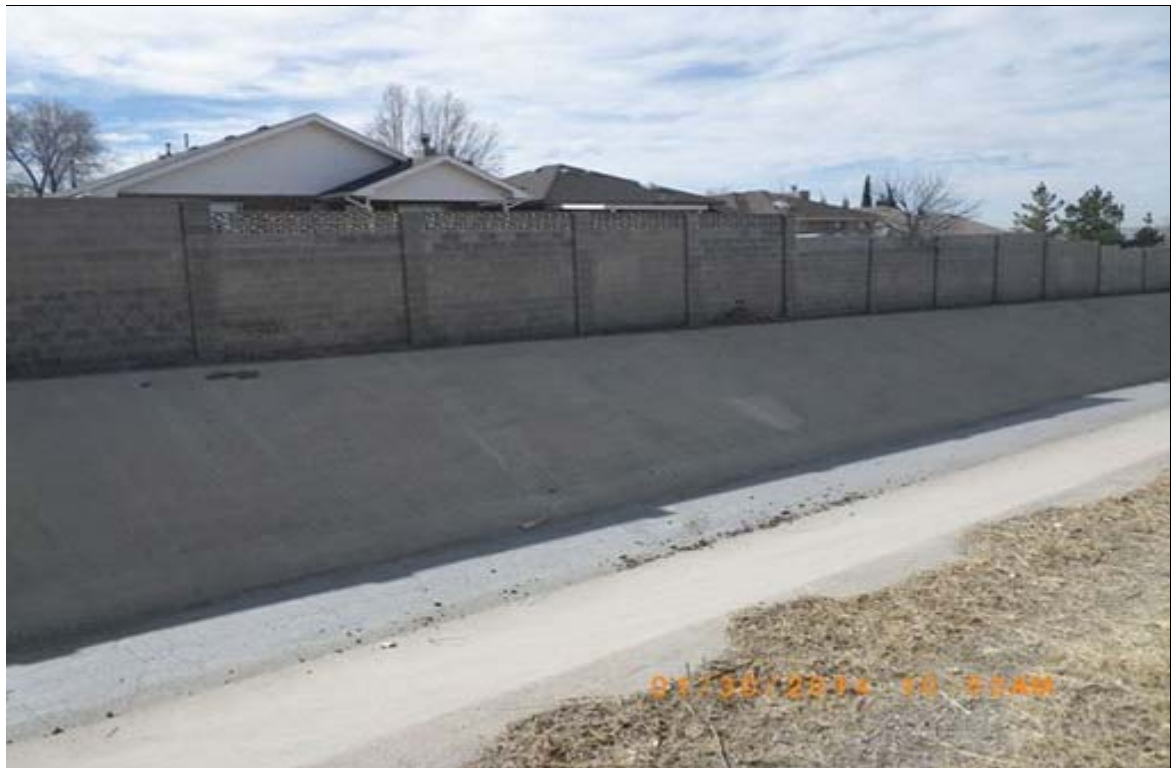
PER CITIZEN HE SAID THAT PERSON LIVING AT THIS ADDRESS IS THROWING DROG DROPPINGS OVER WALL INTO ARROYO

I WENT TO THIS ADDRESS BUT NOBODY WAS HOME, I LEFT A NOTE FOR THE RESIDENT TO CLEAN UP THE STUFF THAT THEY THROW AND TO STOP THROWING ANY MORE DOG POOPS OVER THE FENCE TO THE ARROYO.I DISTRIBUTED SOME POLLUTION PREVENTION BROCHURES AT THIS NEIGHBORHOOD.

I WENT TO THIS ADDRESS BUT NOBODY WAS HOME, I LEFT A NOTE FOR THE RESIDENT TO CLEAN UP THE STUFF THAT THEY THROW AND TO STOP THROWING ANY MORE DOG POOPS OVER THE FENCE TO THE ARROYO.I DISTRIBUTED SOME POLLUTION PREVENTION BROCHURES AT THIS NEIGHBORHOOD.

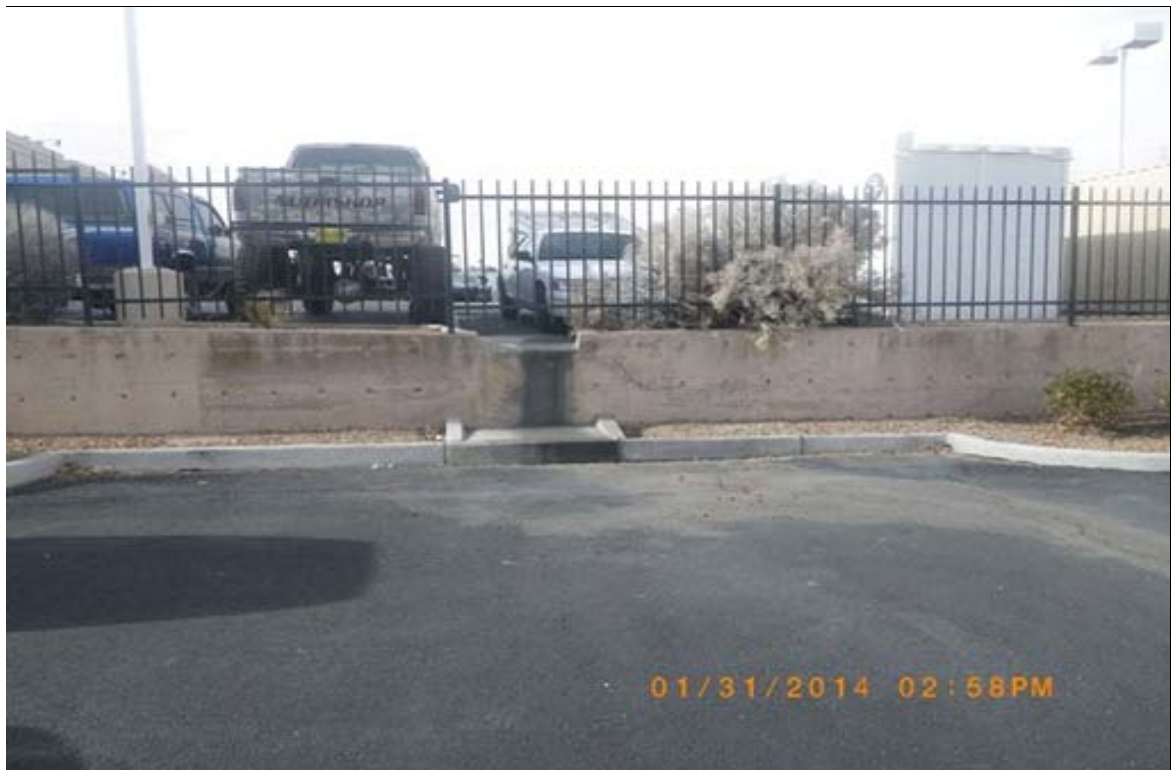
CITIZEN HAS PICTURES OF OIL DUMPING IT IS FROM AN AUTO BODY WORK SHOP LOCATED IN FRONT OF ADDRESS AT BUILDING B. CITIZEN WOULD LIKE A CALL REGARDING THIS REQUEST. CITIZEN WOULD LIKE SOMEONE TO GO OUT ASAP TO LOOK AT ILLEGAL DUMPING.

I SAW DRY RESIDUE SPOT ON THE PARKING LOT OF THE NEXT DOOR BUSINESS PROPERTY.

I SPOKE TO THE MANAGER TODAY 1/31/2014 REGARDING THIS ISSUE, HE SAID THAT THERE WAS NO OIL IN THE WATER, THEY JUST WASHED A CAR. I TOLD HIM THAT THEY MUST MAKE SURE NO OIL SHOULD BE DUMPED. HE AGREED TO DO SO.

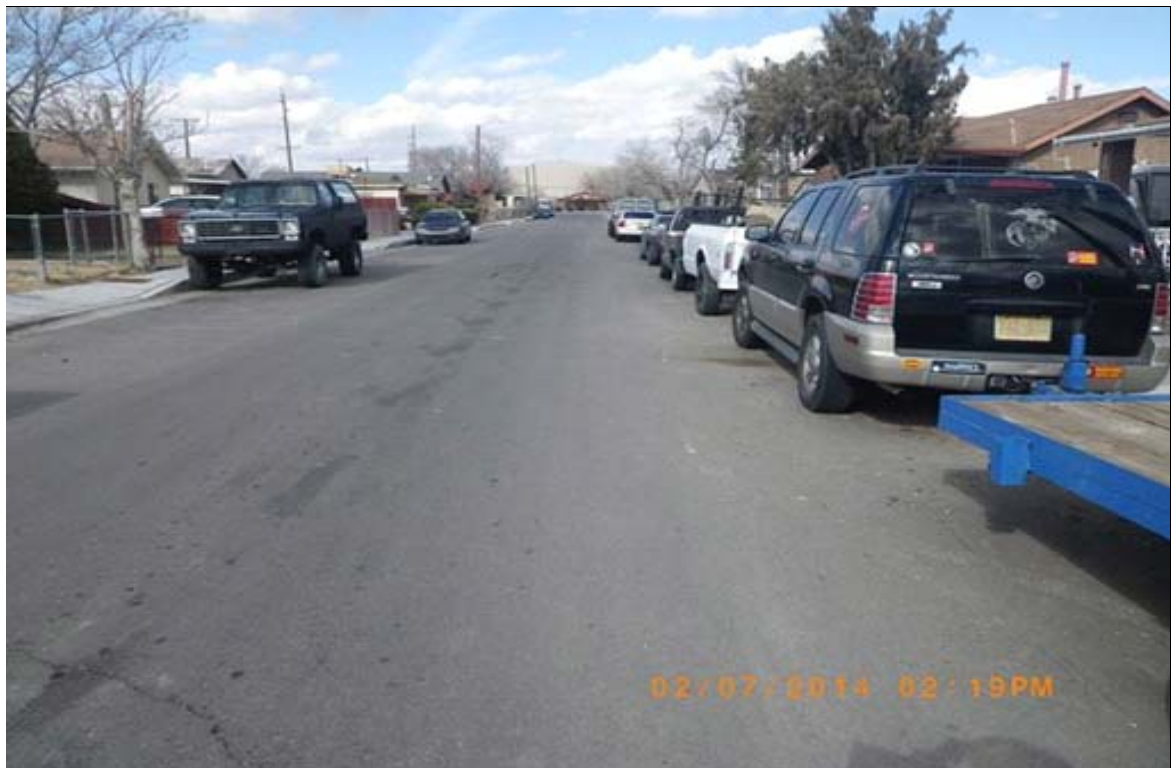
CHANGING OIL AND LETTING THE WASTE OIL DRAIN INTO THE STORM DRAIN.

I SAW AN OIL SPOT COVERED WITH DIRT

I SPOKE TO THE RESIDENT TODAY 2/7/2014 REGARDING THIS ISSUE, HE TOLD ME THAT THE OIL SPILL WAS AN ACCIDENT AND HE ALREADY CLEANED THE AREA AND TOOK THE DRAINED OIL TO RECYCLING PLACE. I ALSO DISTRIBUTED POLLUTION PREVENTION BROCHURES AT THIS NEIGHBORHOOD.

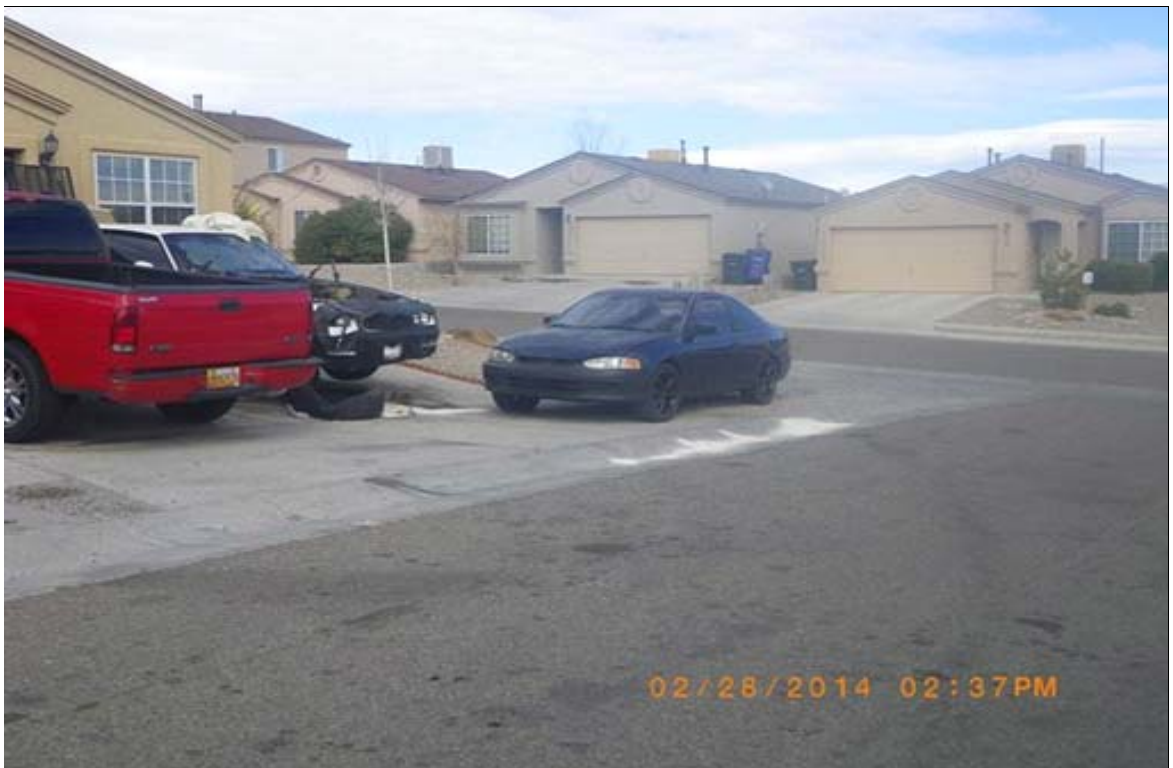
Description: MOTOR OIL IN DRIVE WAY AND FLOWING DOWN THE STREET.

I SAW A BIG OIL SPOT UNDER A CAR PARKED ON THE DRIVEWAY, SOME OF THE OIL WAS FLOWING TO THE SIDEWALK. ALSO I SAW A FEW OIL SPOTS ON THE STREET AT THIS LOCATION.

I SPOKE TO THE RESIDENT ON 2/28/2014 REGARDING THE OIL SPILL ON THE SIDEWALK, SHE TOLD ME THAT THE OIL SPILL WAS AN ACCIDENT AND THEY ARE GOING TO GET RID OF BROKEN CAR VERY SOON AND THEY WILL CLEAN UP THE AREA. I COVERED THE OIL SPOTS WITH OIL ABSORBENT

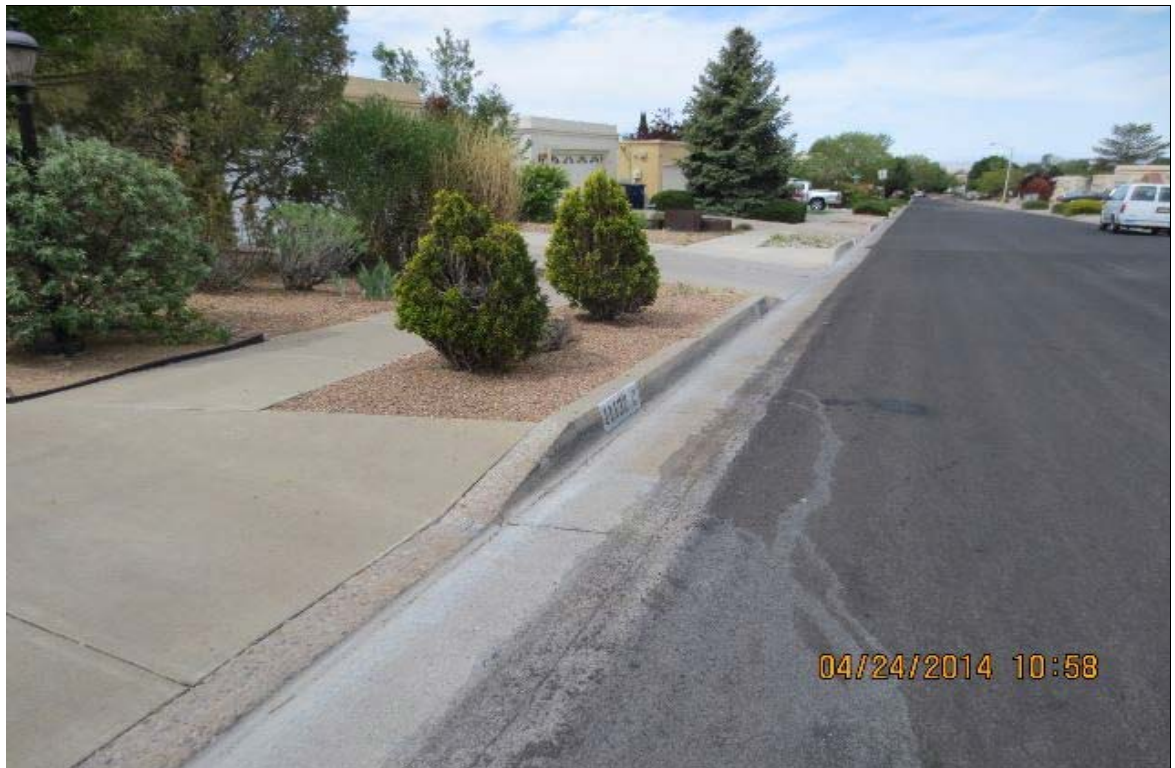
I HAVE A CONTRACTOR IN MY NEIGHBORHOOD WHO CLEANS HIS PAINT CANS INTO THE GUTTER. YOU CAN FOLLOW THE STAINS UP TO 11136 MALAGUENA NE. CAN THIS BE REPORTED TO SOMEONE IN YOUR GROUP?

THE WHIT DRY PAINT RESIDUE WAS VISIBLE COMING FROM THIS ADDRESS.

NOBODY WAS HOME AT THE TIME OF MY VISIT. I LEFT POLLUTION PREVENTION BROCHURES AT THIS ADDRESS AND THE REST OF THIS NEIGHBORHOOD.

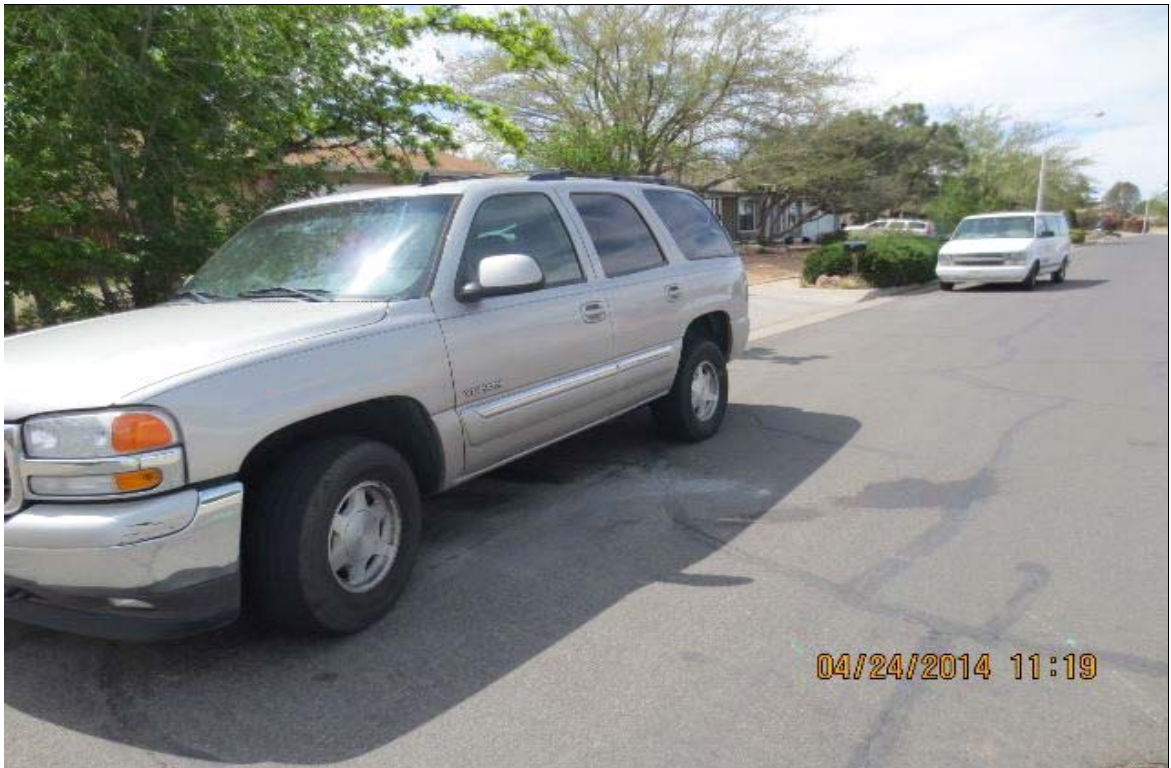
SUV PARKED IN FRONT OF HOUSE FOR SEVERAL WEEKS NOW WITH MAJOR OIL SPILL UNDERNEATH VEHICLE. SEVERAL GALLONS OF OIL OR TRANSMISSION FLUID WITH STRONG GASOLINE SMELL LAYING ON STREET. CAR IS POSSIBLY DISABLED OR ABANDONED AND NEEDS TO BE MOVED.

THE RESIDENT AT THIS ADDRESS WAS NOT HOME AT THE TIME OF MY VISIT TODAY 4/24/2014. THE PAVEMENT UNDER THE VEHICLE WAS CLEAN AND THERE WAS NO OIL DRIPPING, ALSO THE VEHICLE HAD LEGAL VALID LICENCE PLATE AND IN GOOD SHAPE.

NO ACTION IS NECESSARY. I LEFT A POLLUTION PREVENTION BROCHURE ON THE VEHICLE AND ALSO DISTRIBUTED POLLUTION PREVENTION BROCHURES AT THIS NEIGHBORHOOD.
