March 12, 2015

Kathy Verhage  
City of Albuquerque  
Department of Municipal Development; Storm Drainage Design  
P.O. Box 1293  
Room 301  
Albuquerque, NM 87103

Re: DRAFT Report, PCB Sediment Sampling Investigation in the Tijeras Arroyo

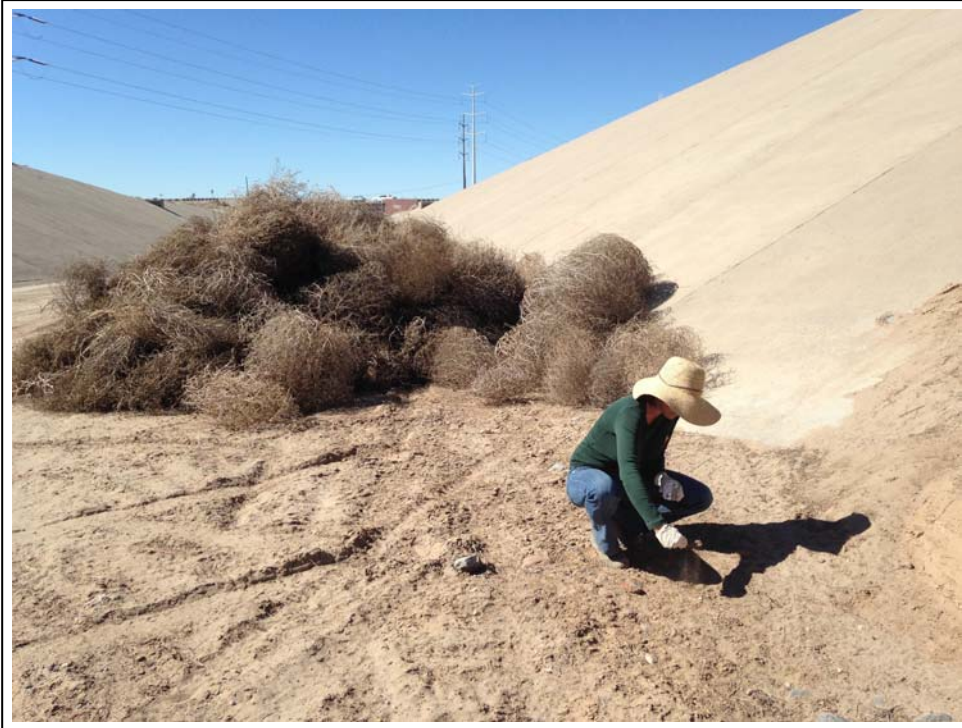
1. Tijeras Arroyo-1 sampling location; looking west at beginning of concrete-lined portion of the arroyo.

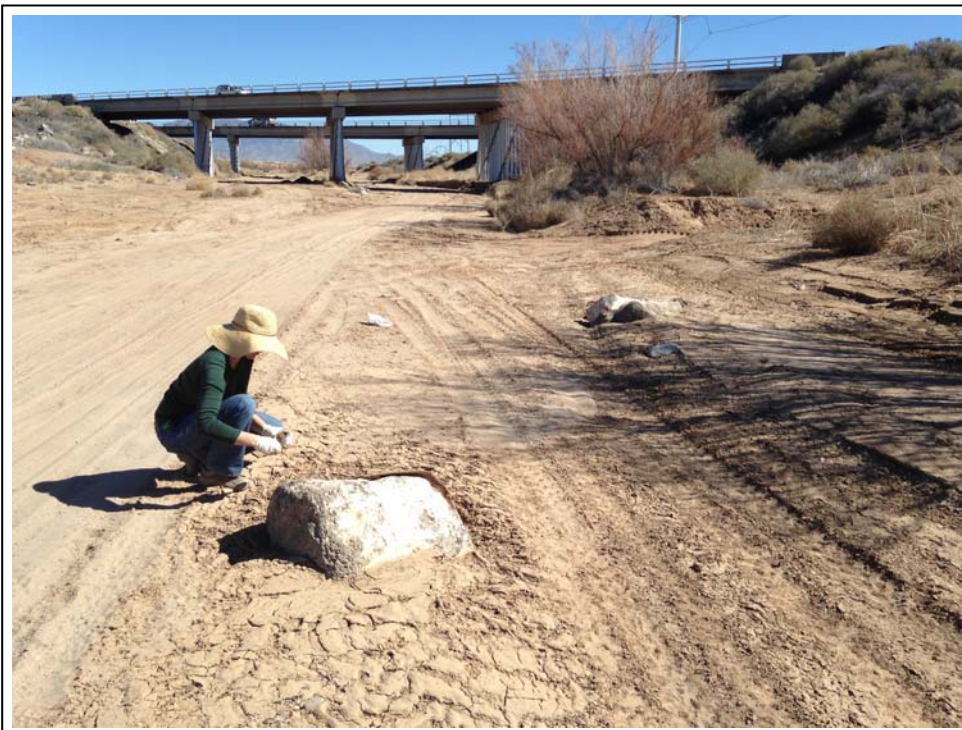
2. Tijeras Arroyo-2 sampling location; looking east at the Interstate 25 overpass.

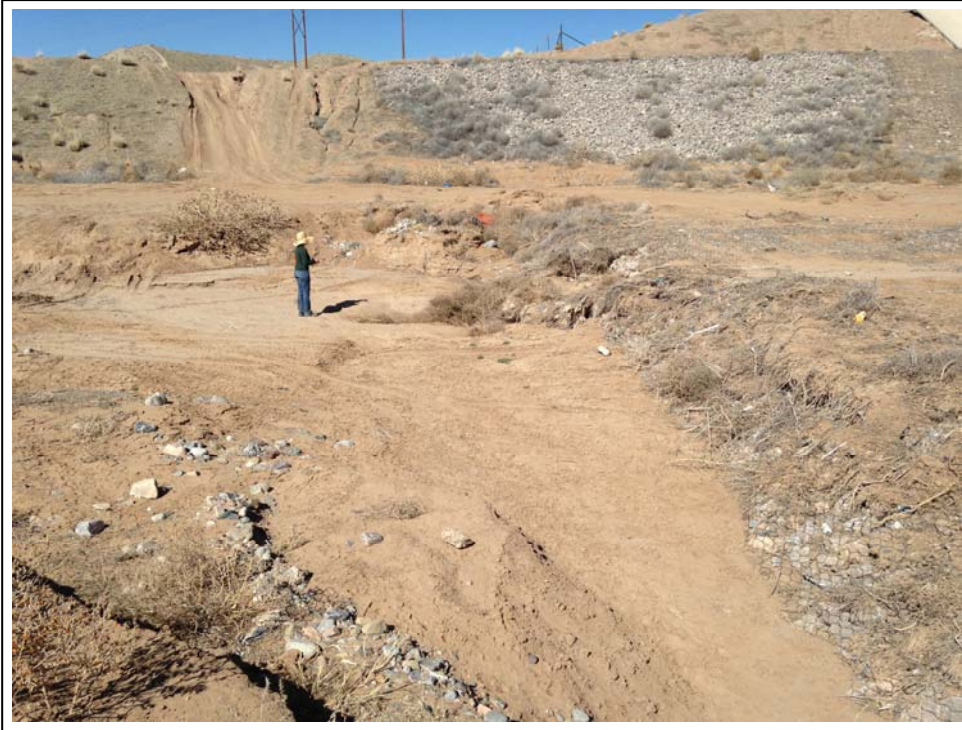
3. Tijeras Arroyo-3 sampling location near University Blvd.

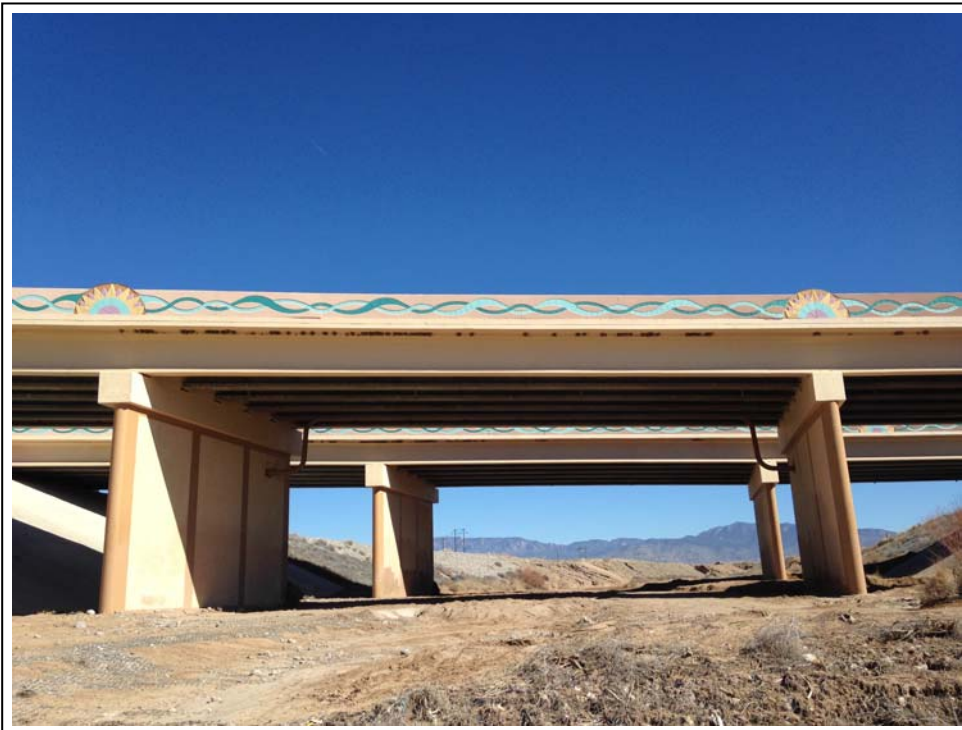
4. Tijeras Arroyo-3 sampling location; looking east at University Blvd overpass.

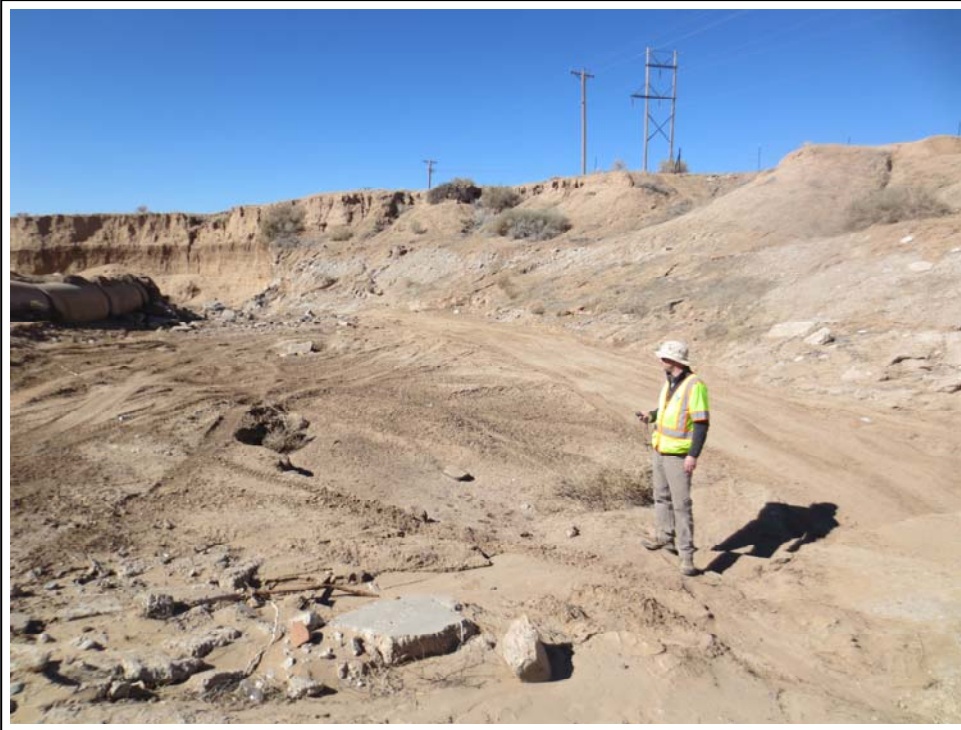
5. Tijeras Arroyo-4 sampling location near Ira Spector Road.

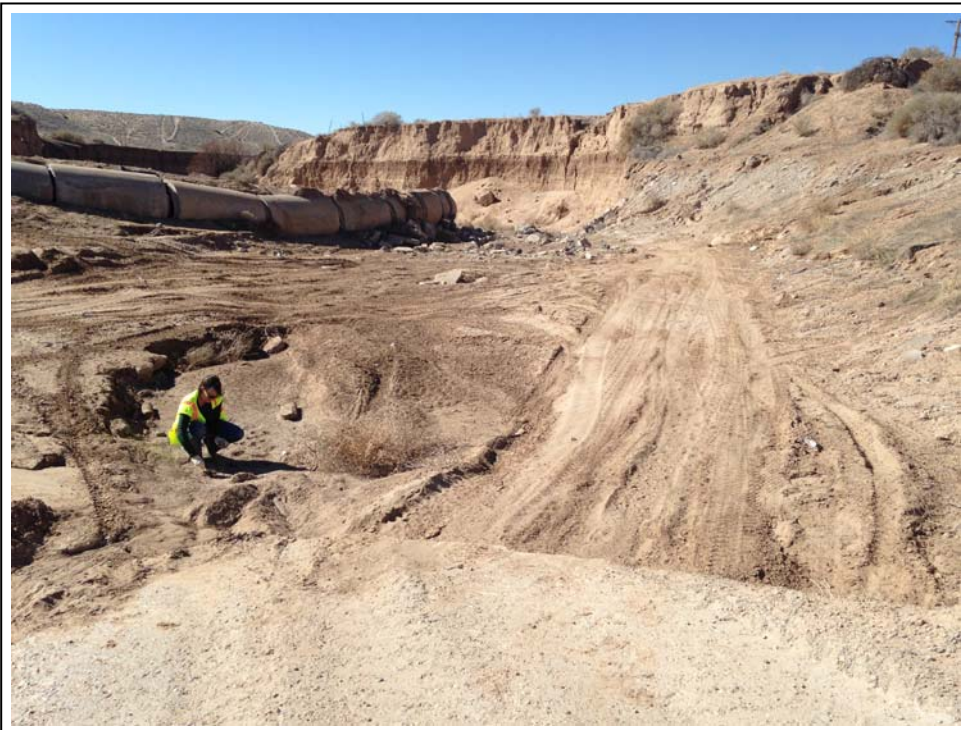
6. Tijeras Arroyo-4 sampling location; looking at a water control feature.

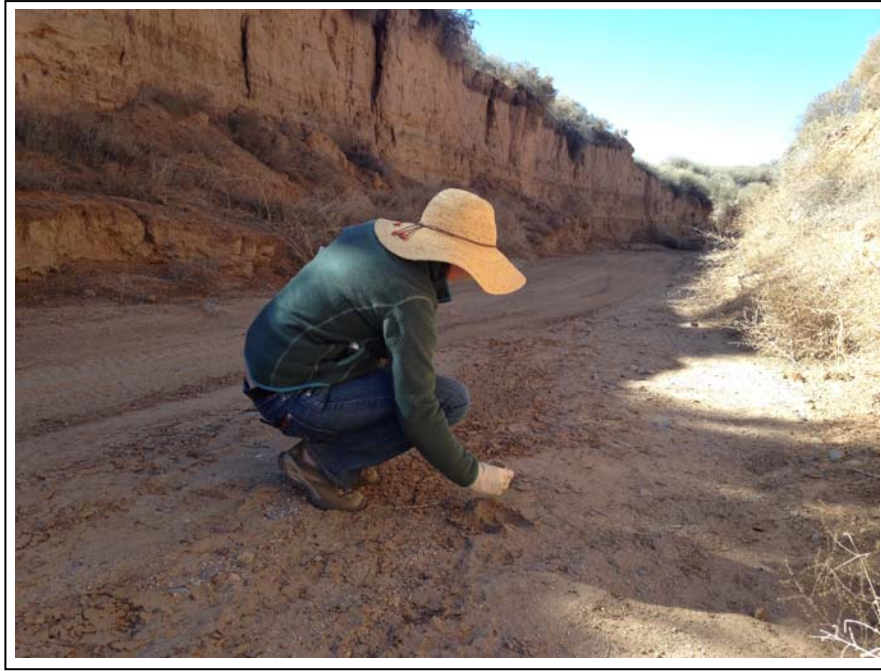
7. Tijeras Arroyo-5 sampling location, downstream of confluence with the Albuquerque International Tributary Arroyo.

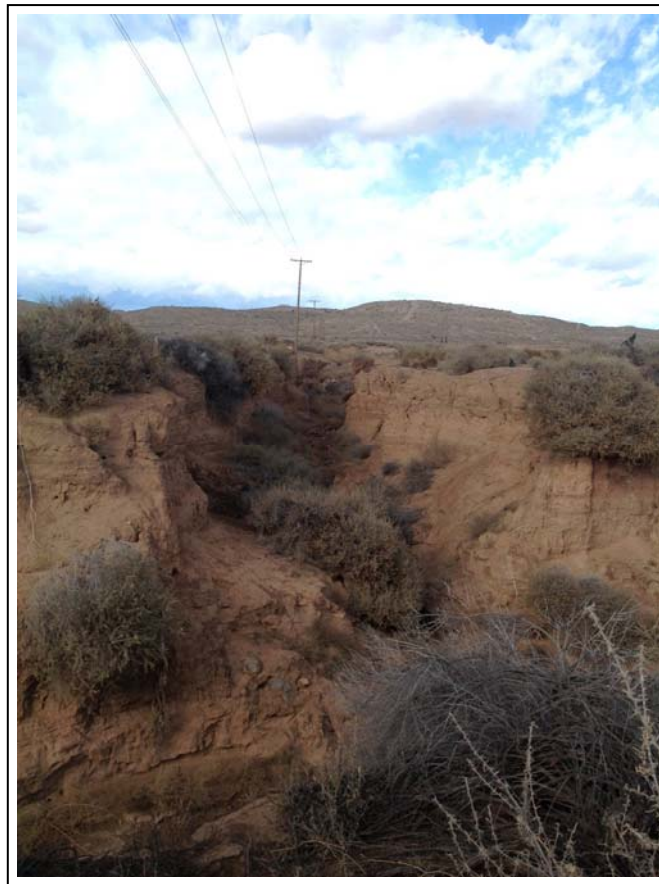
8. Tijeras Arroyo-5/Tijeras Arroyo-6: looking north into Albuquerque International Tributary Arroyo.

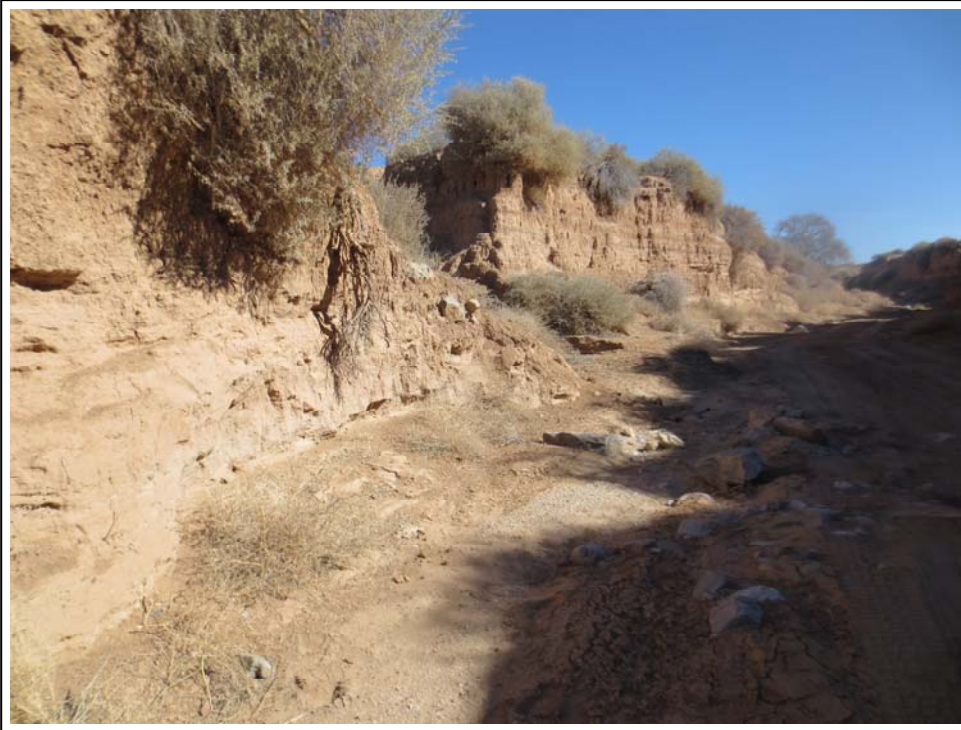
9. Tijeras Arroyo-5/Tijeras Arroyo-6 sampling locations; looking east at confluence with the Albuquerque International Tributary Arroyo.

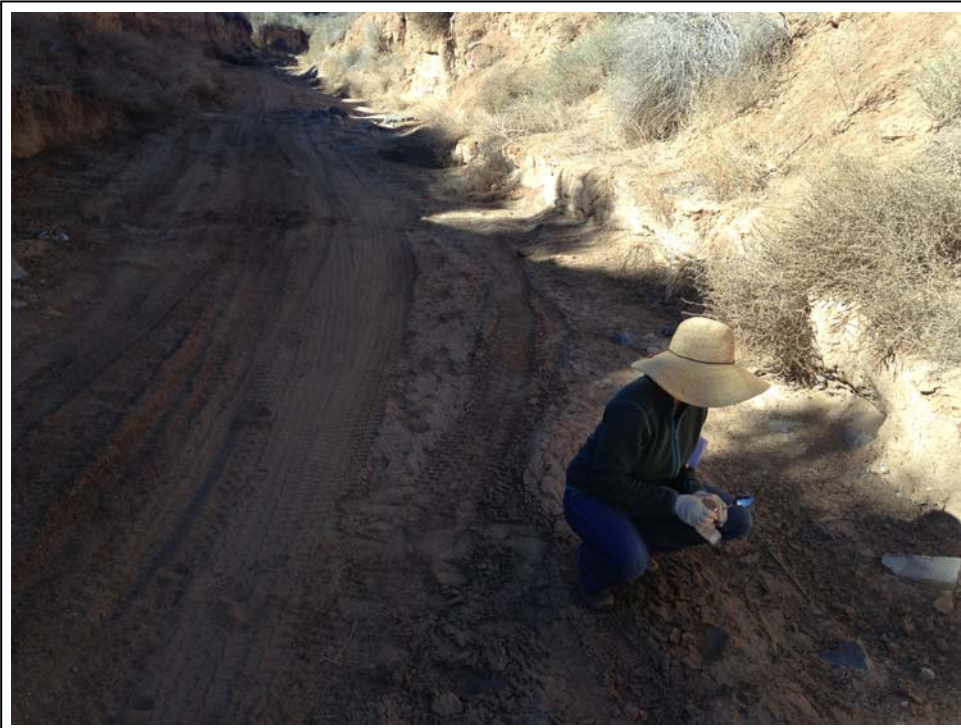
10. Tijeras Arroyo-6 sampling location located upstream of the confluence with the Albuquerque International Tributary Arroyo.

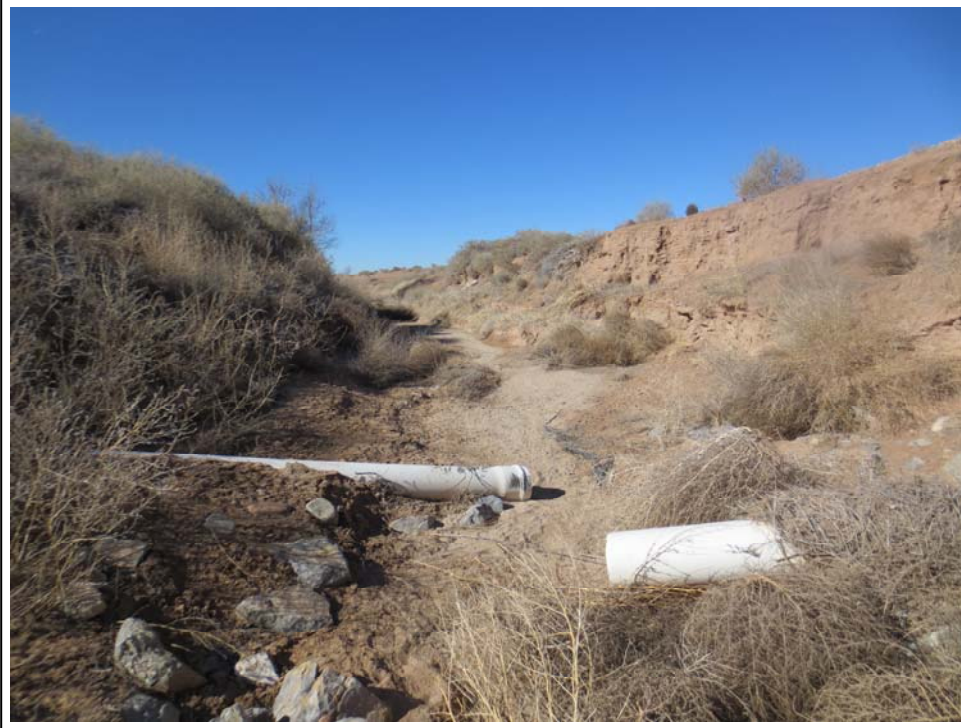
The Tijeras Arroyo-7 sampling location is downstream of an area used by the Albuquerque Police Department to explode munitions. On the south side of the arroyo is a former holding pond that was once used to hold irrigation water for a tree farm that was managed by the U.S. Forest Service (USFS), according to an email from Matthew Schmader of the COA Open Space Division (December 23, 2014). This irrigation holding pond has reportedly not been in use for many years.

11. Tijeras Arroyo-7 sampling location; PVC pipe likely part of former USFS irrigation holding ponds.

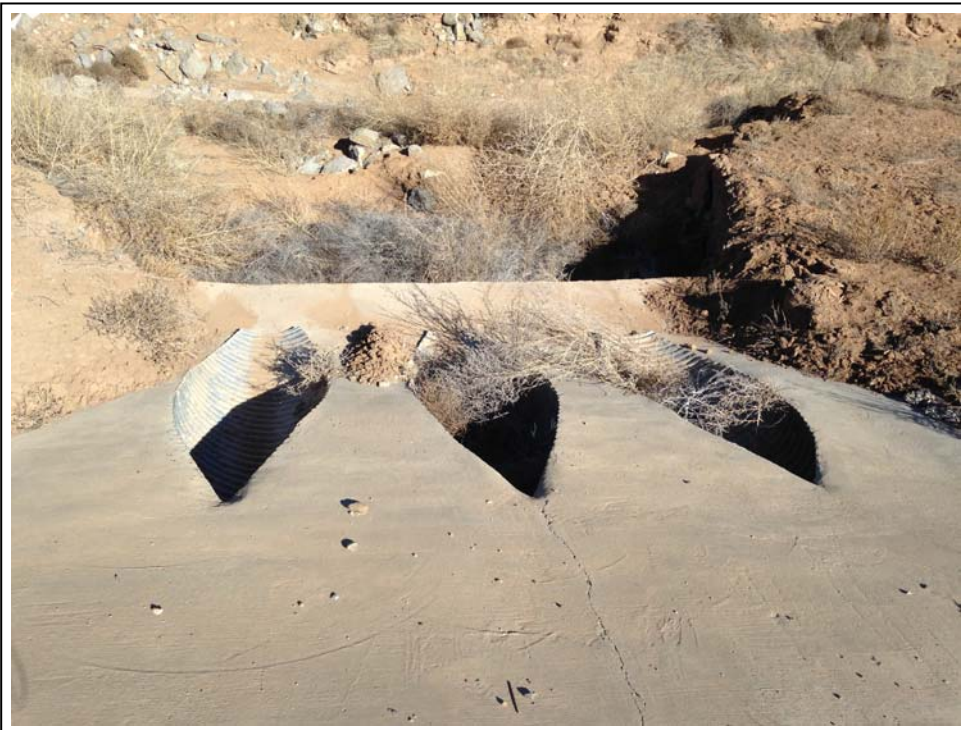
12. Tijeras Arroyo-7: outfall appears to be part of the former USFS irrigation holding ponds.

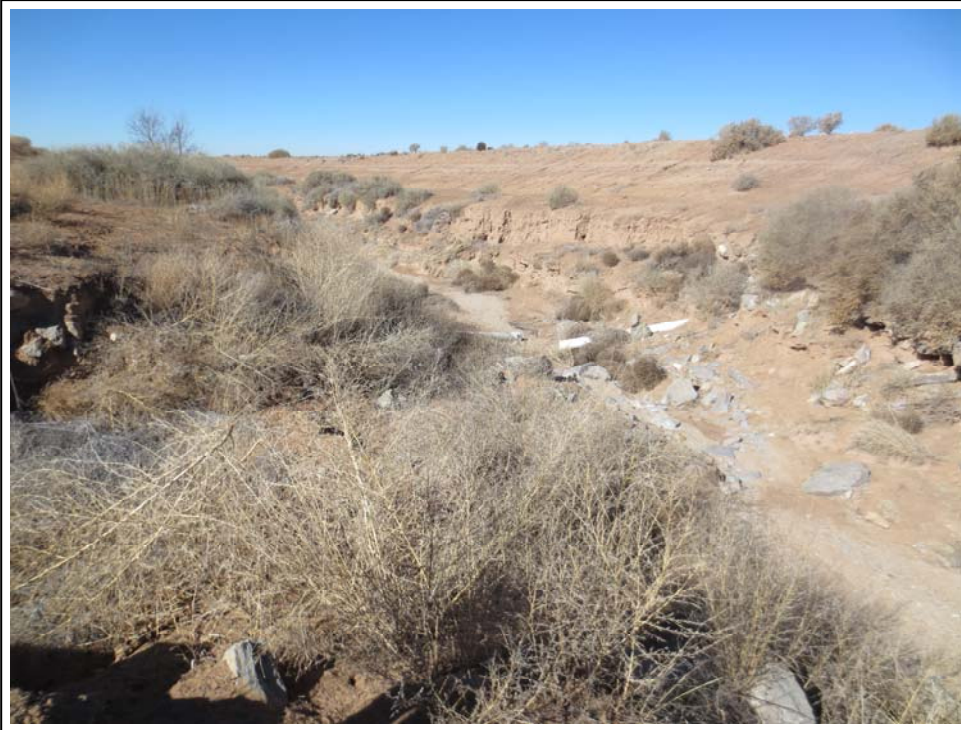
13. Tijeras Arroyo-7: looking west down the Tijeras Arroyo.

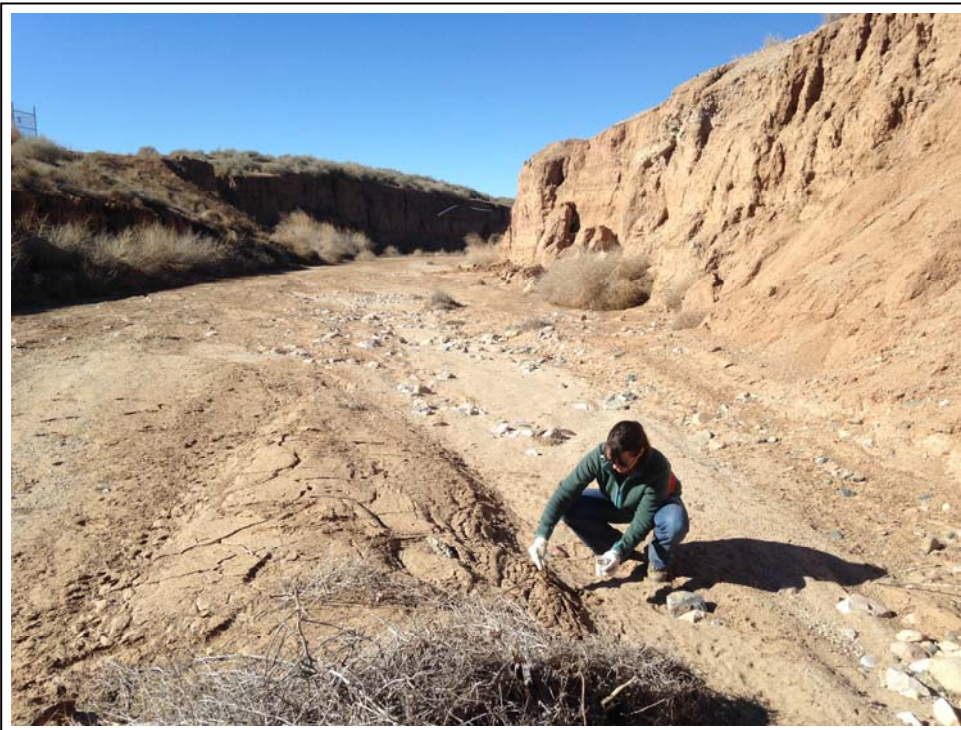
14. Tijeras Arroyo-8 sampling location; looking west down the arroyo.

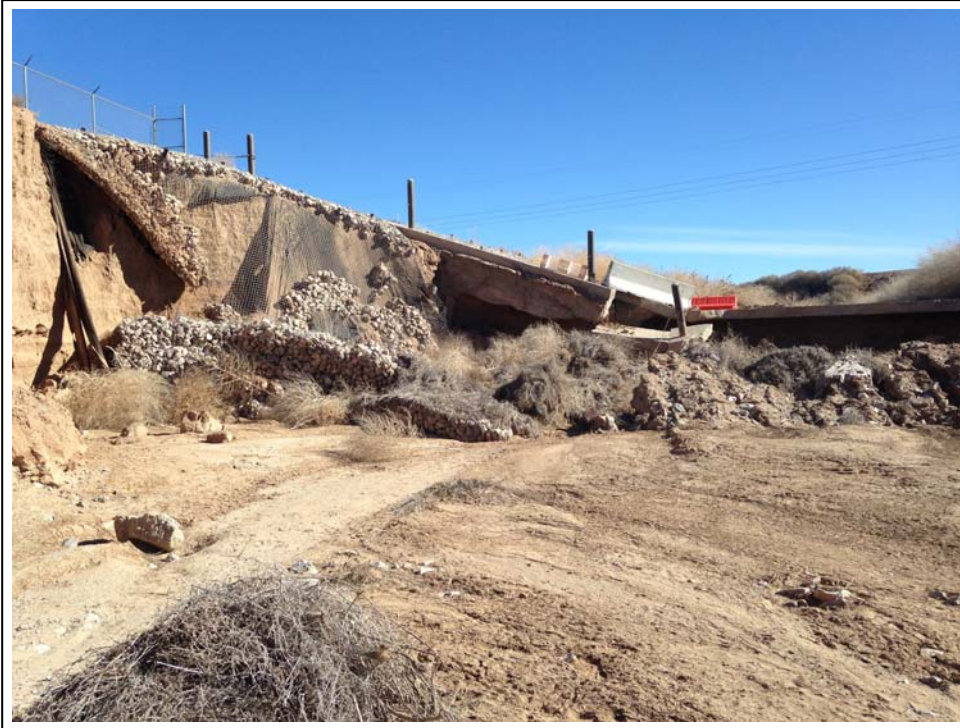
15. Tijeras Arroyo-8 sampling location; looking east at a water control feature on KAFB.

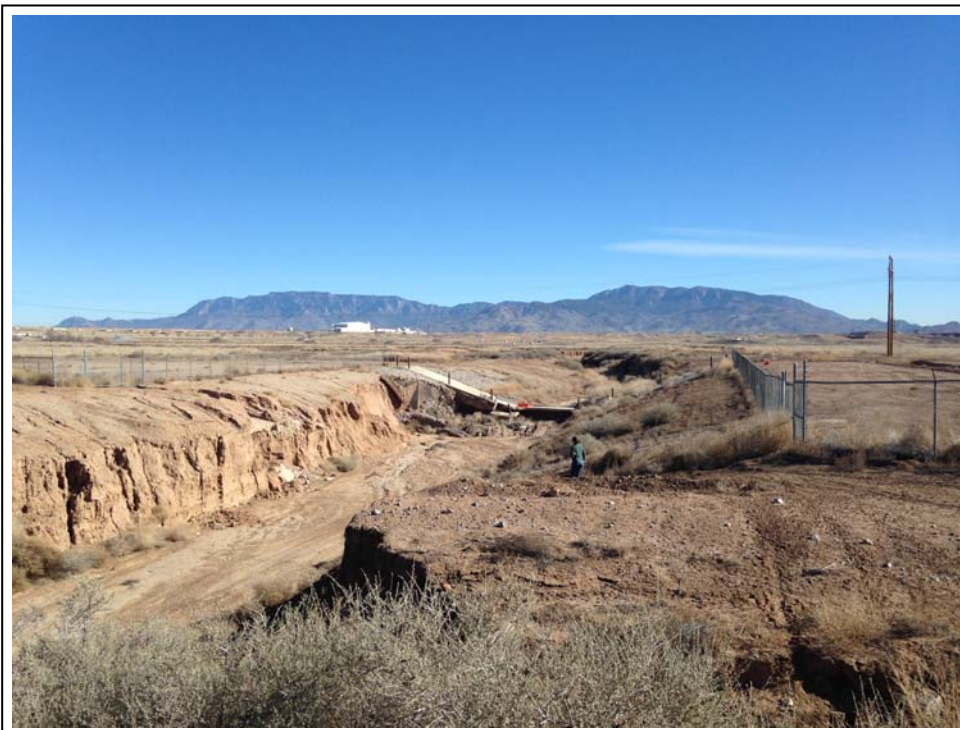
16. Tijeras Arroyo-8 sampling location; looking east at a water control feature on KAFB and onto KAFB.
