City of Albuquerque Facility Condition Assessment De Anza Motor Lodge

2014 REPORT

August 05, 2014

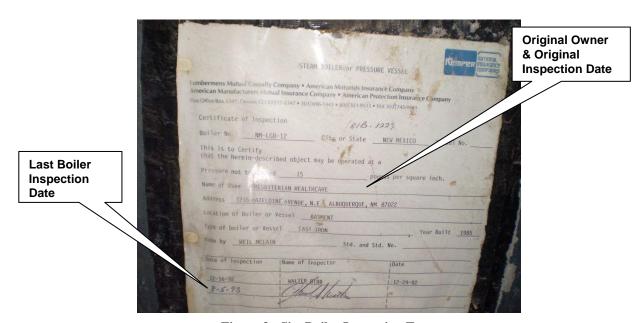
The installed boiler was used at another location, prior to the current location, as noted on the boiler inspection tag. One other important factor, the gas meter was removed at some point after 2003. The only heat available in areas would be from any remaining PTAC's and the electric heating convectors in the Lobby area. We have no information when the gas meter assemblies were removed.

Figure 3 - Site Boiler Inspection Tag

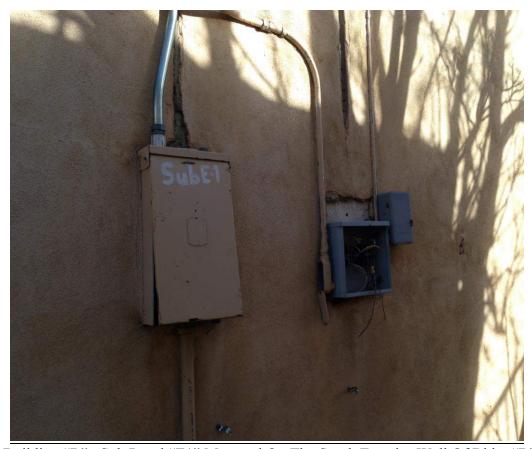
1.1.3 Sub-Panels: Vintage 1939 Sub-Panels "E1" have been used as a pull box when new Service was installed.

Building "B" - Sub Panel "E1" Mounted On The South Exterior Wall Of Bldg. "B"

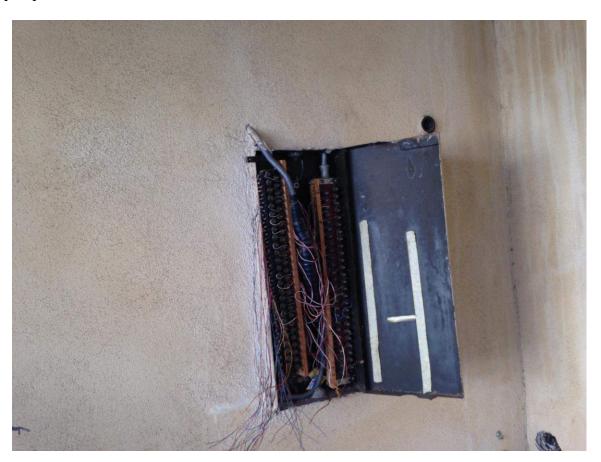
Telephone Terminal Cabinet At South Exterior Wall Of Bldg "B"

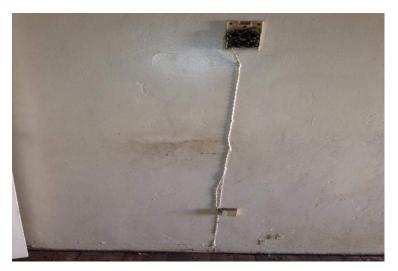
1.2 Telephone Terminal Cabinet Entrance: The Telephone extend to the guest rooms with two twisted pair telephone cable that is stapled to the wall and other building components. The telephone jacks are surface mounted to the walls and jacks and cable are not in usable condition.

Guest Room Telephone Line and Telephone Jack Connector

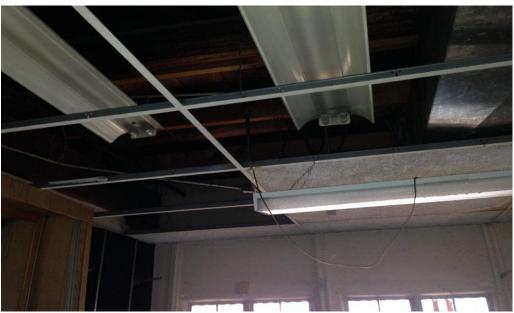
Office light fixtures at Building "E"

1.3.2 The fixtures in Building "E", consist of industrial fluorescent, wraparound fluorescent type, square recessed incandescent type and pendant type light fixtures that have been vandalized at some point in the office. There are multiple code violations including no exit lights and emergency lights for path of Egress. All the lighting, switches and conductors in all areas of the site are not energy efficient, in code violations and life safety code concerns.

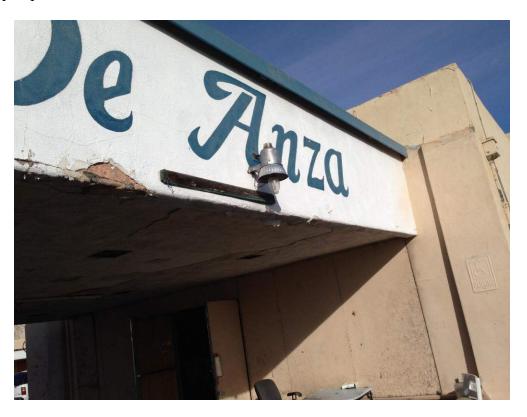
De Anza Entry To Office Lobby with HID Surface Mount Fixtures

1.3.3 The fixtures at exterior of Building "E", consist of HID type fixtures, wraparound fluorescent type, square recessed incandescent type and wall mount HPS with broken lenses that have been vandalized at some point.

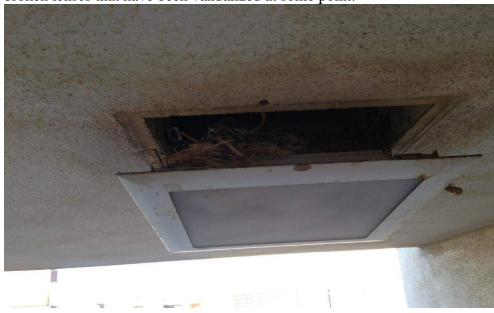
Exterior Incandescent Light Fixtures At Canopy Entrance

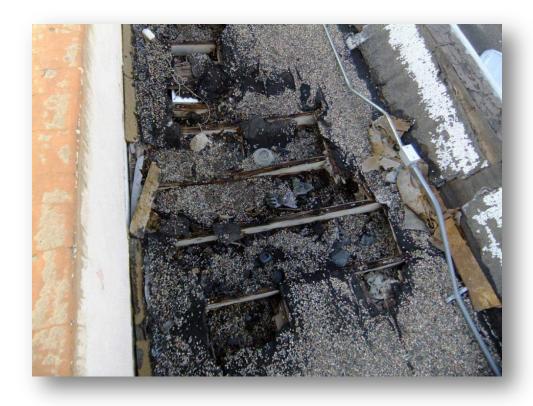
- Roof Deck: Very Poor numerous holes open to daylight with extensive water infiltration. Any potential building modifications would mandate a total roof deck replacement. Partial Fire Damage.
- Roof Structure: Poor A significant number of members would need to be replaced due to water and/or fire damage.
- Walls: Fair The extent of damage due to water intrusion is unknown in many locations due to lack of access. Multiple exterior wall studs were cut in the majority of rooms (typical all buildings), which greatly reduces the integrity of the exterior walls. (See figure 15 Building B)
- Floor Deck: Poor Concrete slabs on grade are in good shape, however a large portion of floor decking will need to be replaced due to water infiltration or other physical damage.
- Floor Structure: Poor selective replacement required in many rooms.

Figure 1 - Building A Roof

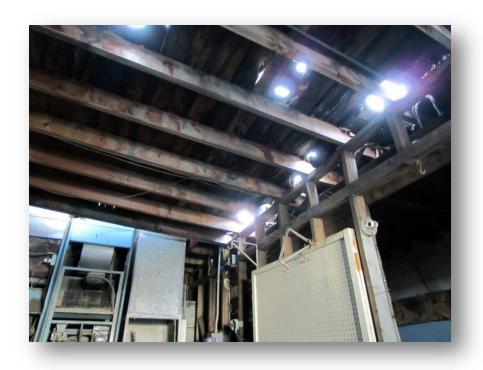
Figure 3- Building A Room 103 – Fire Damaged Room

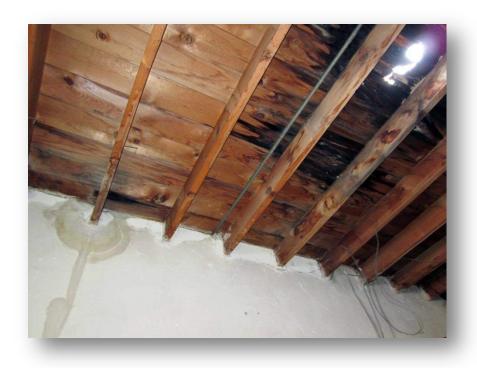
Figure 4- Building A Room 103 – Roof Deterioration

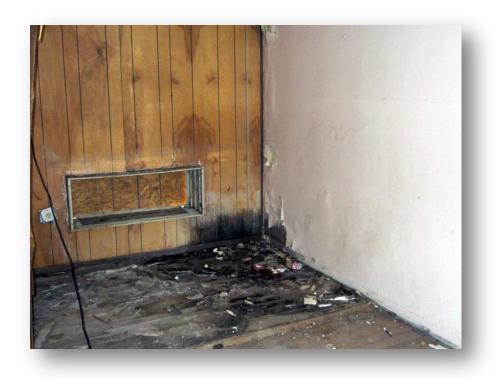
Figure 5- Building A Room 105 – Floor Water Damage

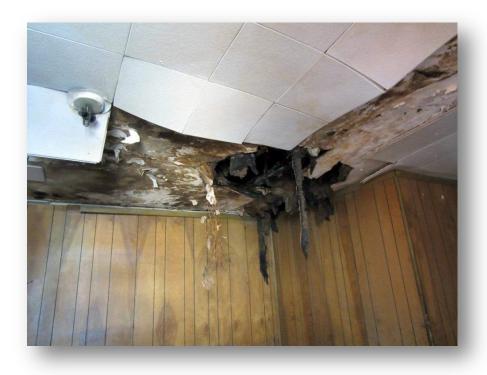
Figure 6- Building A Room 106 – Ceiling Collapse

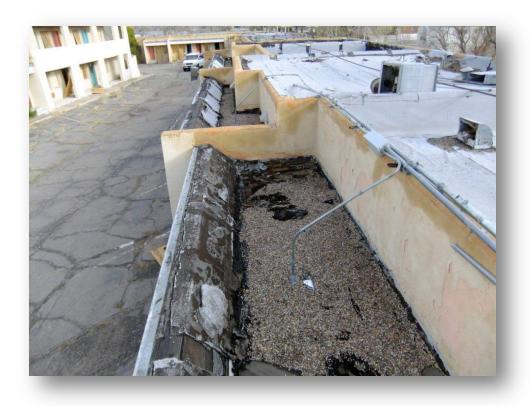
- Roof Deck: Very Poor numerous holes open to daylight with extensive water infiltration. Any potential building modifications would mandate a total roof deck replacement.
- Roof Structure: Poor A significant number of members would need to be replaced due to water and/or fire damage.
- Walls: Fair The extent of damage due to water intrusion is unknown in many locations due to lack of access.
- Floor Deck: Poor A large percentage of floor decking will need to be replaced due to water infiltration or physical damage.
- Floor Structure: Poor selective replacement required in many rooms.

Figure 8- Building B Roof Deterioration on West Canopy

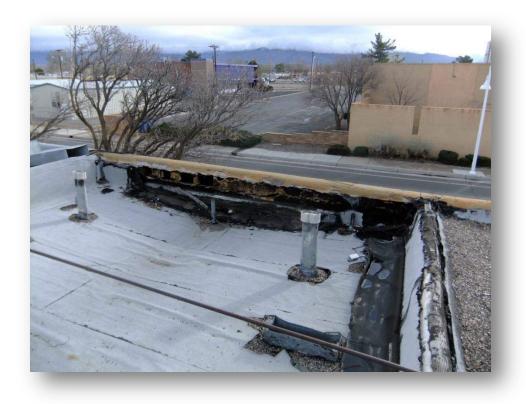
Figure 9- Building B Roof Deterioration at Partial Collapse

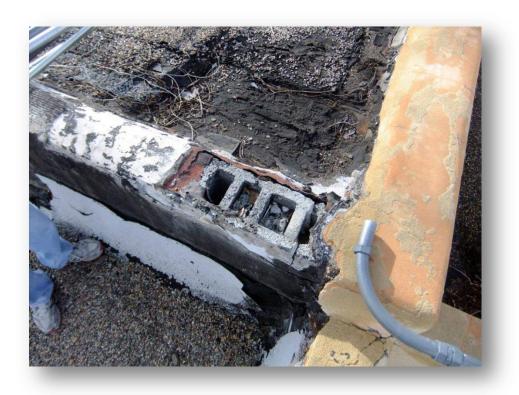
Figure 10- Building B Envelope Deterioration at CMU Wall

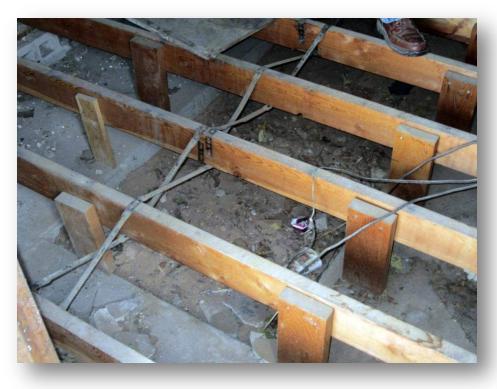
Figure 11- Building B Room 107 Exposed Floor System on Concrete Foundation

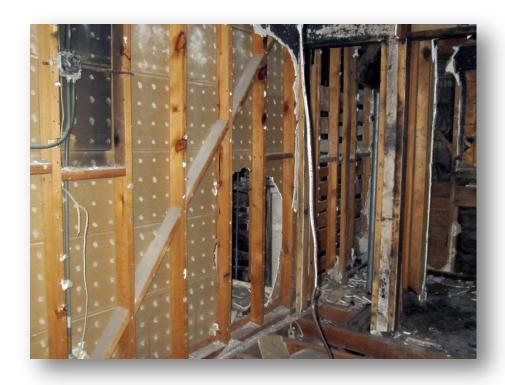
Figure 12- Building B Room 107 Fire Damaged Room

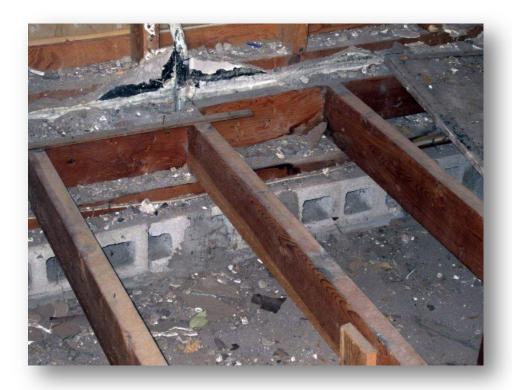
Figure 13- Building B Room 107 Floor Bearing Detail

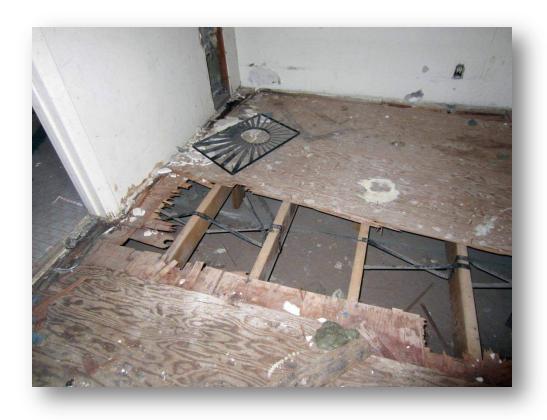
Figure 16- Building B Room 115 Floor Damage

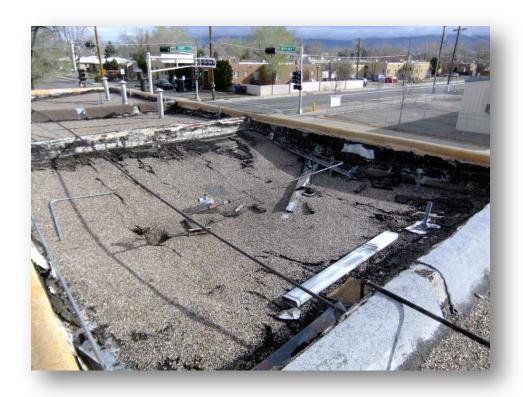
- Roof Deck: Very Poor numerous holes open to daylight with extensive water infiltration. Any potential building modifications would mandate a total roof deck replacement.
- Roof Structure: Very Poor A significant number of members would need to be replaced due to water and/or fire damage. Access should be prohibited at mechanical room due to imminent life safety hazard at the partially collapsed roof structure.
- Walls: Fair The extent of damage due to water intrusion is unknown in many locations due to lack of access.
- Floor Deck/Structure: Poor A large portion of floor decking will need to be replaced due to water infiltration or other physical damage.

Figure 17- Building C Partially Collapsed Roof Structure

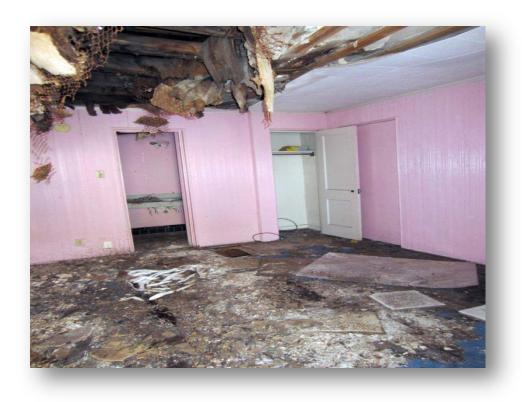
Figure 19- Building C Room 119 Ceiling Collapse at Water Damage

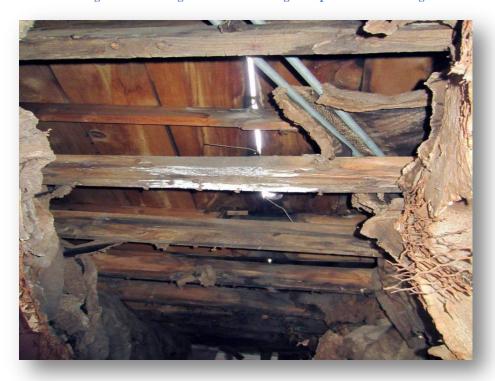
Figure 20- Building C Room 119 Roof Structure Deterioration

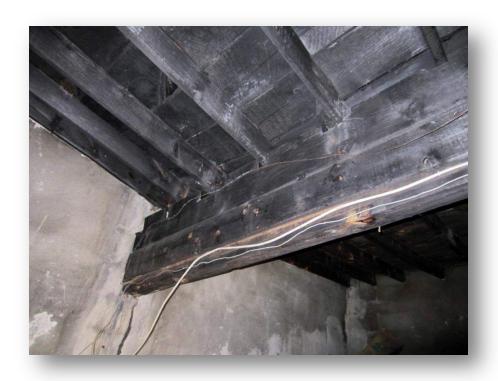
Figure 21- Building C Room 119 Fire Damage – Unsupported Roof Beam

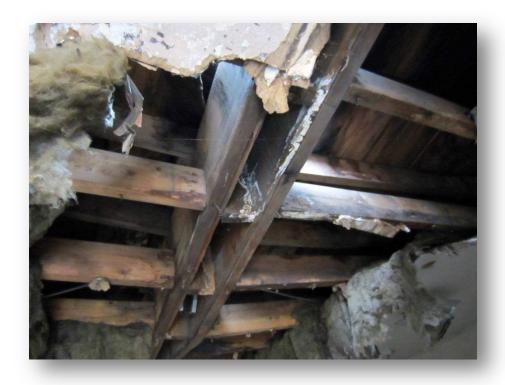
Figure 22- Building C Room 123 Damaged Roof Structure

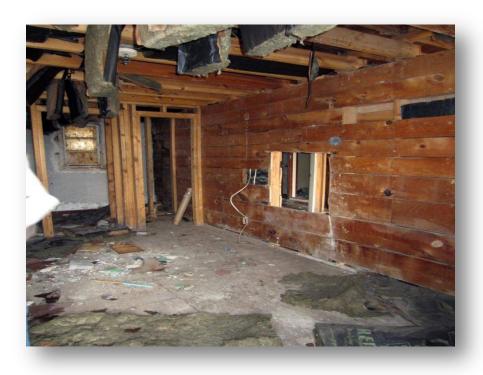
Figure 23-Building C Room 127 Exposed Structure at Partially Demolished Room

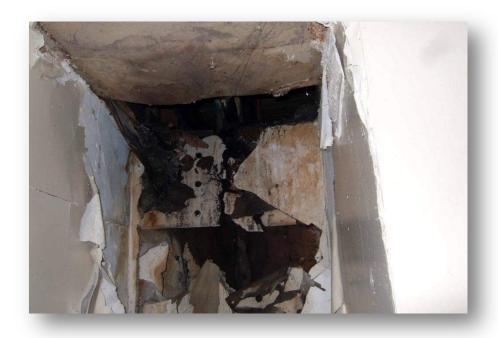
- Roof Structure: Poor A significant number of members would need to be replaced due to water and/or fire damage.
- Walls: Fair The extent of damage due to water intrusion is unknown in many locations due to lack of access.
- Floor Deck/Structure: Poor A large portion of floor decking will need to be replaced due to water infiltration or other physical damage.

Figure 24- Building D Room 145 Water Damage

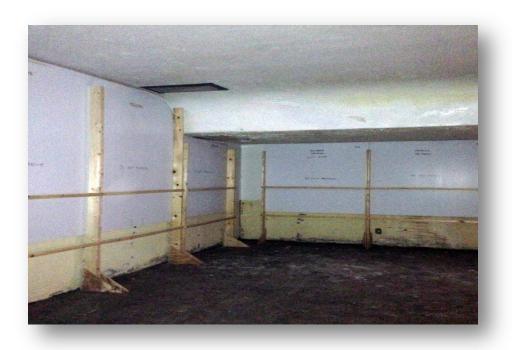
Figure 25- Building D Basement

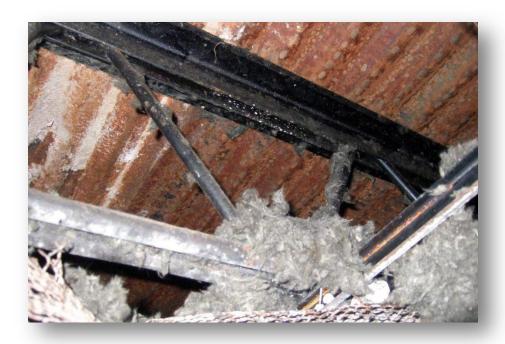
Figure 26- Building D Room 131 Corroded Deck

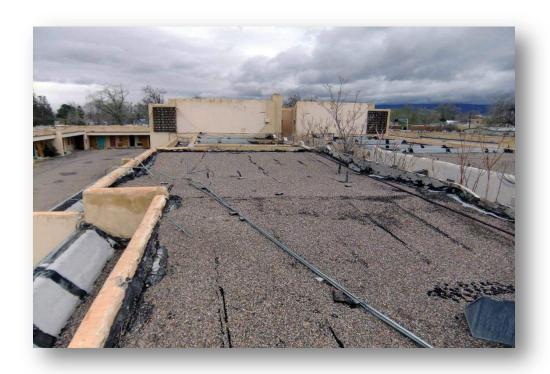
Figure 27-Building D Roof Damage

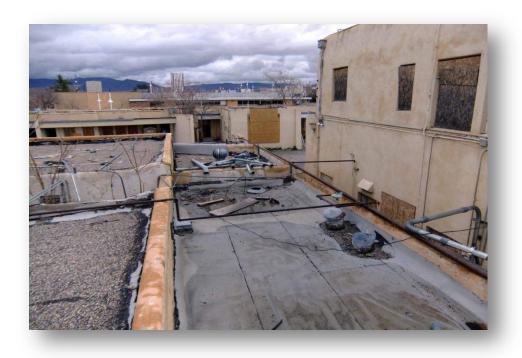
Figure 28- Building D Utility Area Roof

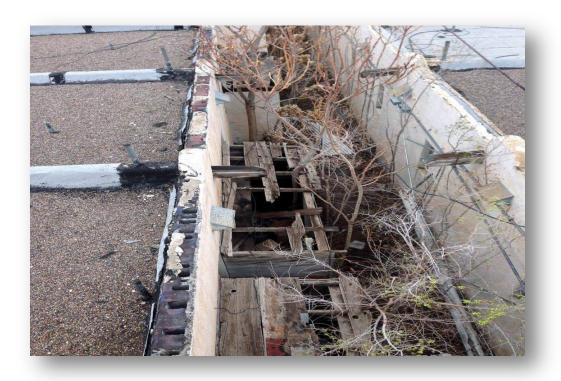
Figure 29- Building D Roof Damage

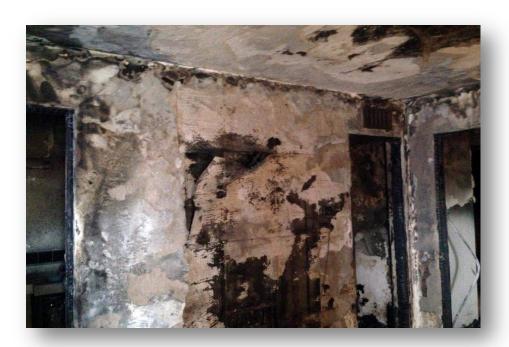
Figure 30- Building D Room 131 Fire Damage

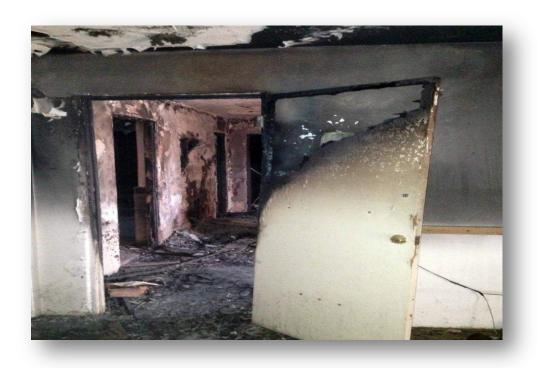
Figure 31- Building D Room 132 Fire Damage

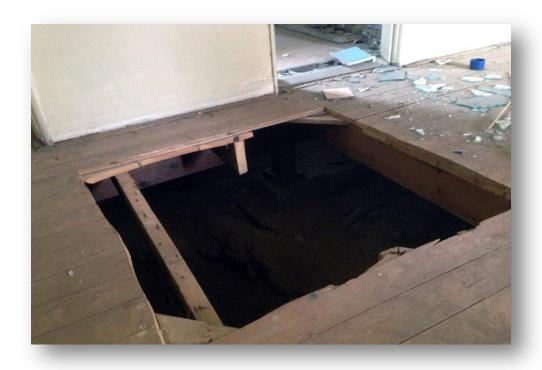
Figure 32- Building D Room 137 Floor Opening

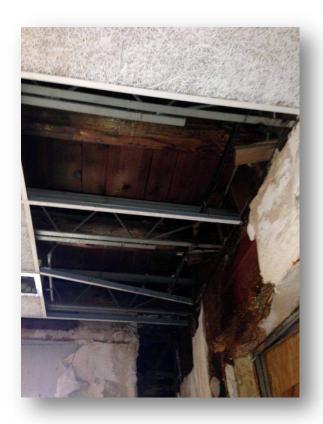
- Roof Deck: Poor Significant water infiltration at perimeter.
- Roof Structure: Fair, some water damage.
- Walls: Fair The extent of damage due to water intrusion is unknown in many locations due to lack of access.
- Floor Deck: Fair, water damage in select areas.
- Floor Structure: Fair.

Figure 33- Building E-Lobby - First Floor Ceiling

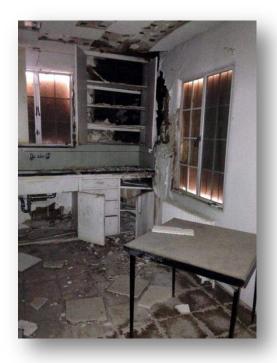
Figure 34-Building E Kitchen Water Infiltration

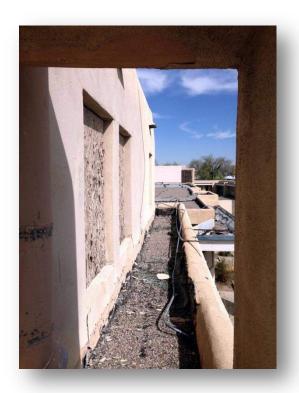
Figure 35- Building \mathbf{E} – Roof Setback

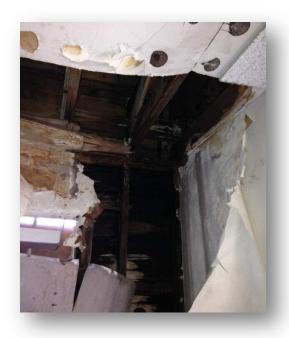
Figure 36- Building E 2^{nd} Floor Water Infiltration

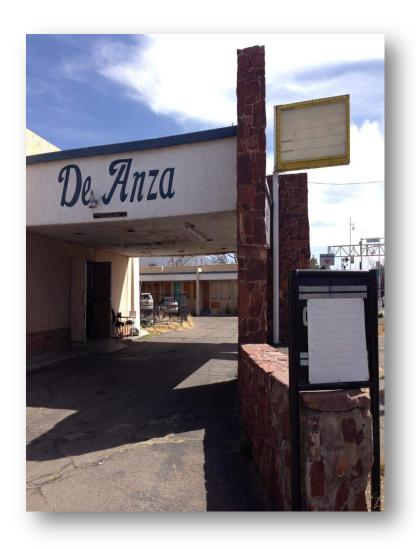
Figure 37- Building E Porte Cochere

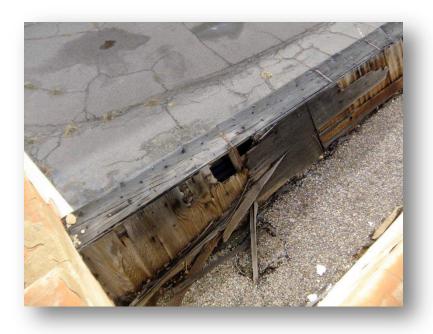
- Roof Deck: Very Poor numerous holes open to daylight with extensive water infiltration. Any potential building modifications would mandate a total roof deck replacement.
- Roof Structure: Poor A significant number of members would need to be replaced due to water and/or fire damage.
- Walls: Fair The extent of damage due to water intrusion is unknown in many locations due to lack of access.
- Floor Deck/Structure: Poor A large portion of floor decking will need to be replaced due to water infiltration or other physical damage.

Figure 38- Building F Roof – Missing Flashing

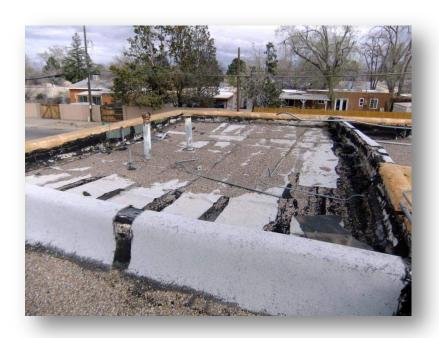
Figure 39- Building F Roof Deterioration

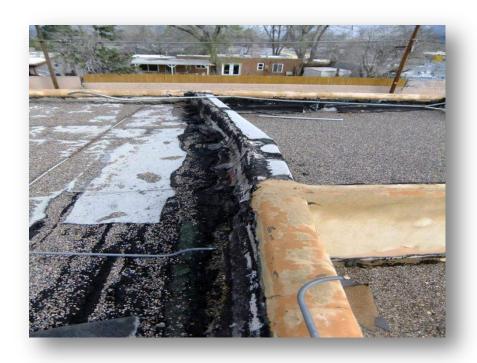
Figure 40 – Building F Distortion at Unit 159

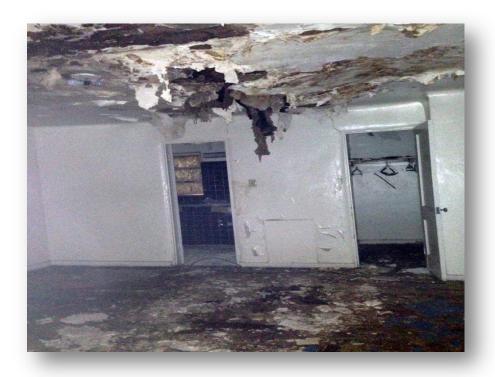
Figure 41- Building F Room 159 Water Damage

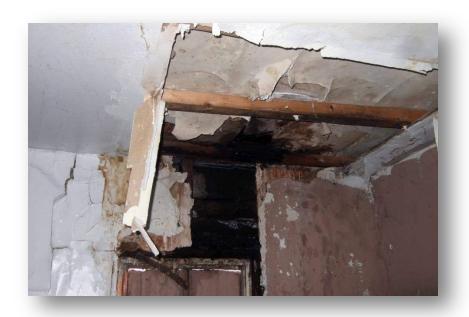
- Restaurant Area is in better shape than much of the facility. Minor water infiltration and damage only.
- Roof Deck: Very Poor numerous holes open to daylight with extensive water infiltration. Any potential building modifications would mandate a total roof deck replacement.
- Roof Structure: Very Poor Several collapsed areas. A significant number of members would need to be replaced due to water and/or fire damage.
- Walls: Fair The extent of damage due to water intrusion is unknown in many locations due to lack of access. Significant mold throughout.
- Floor Deck/Structure: Poor A large portion of floor decking will need to be replaced due to water infiltration or other physical damage.

Figure 42- Building G Room 171 Water Damage

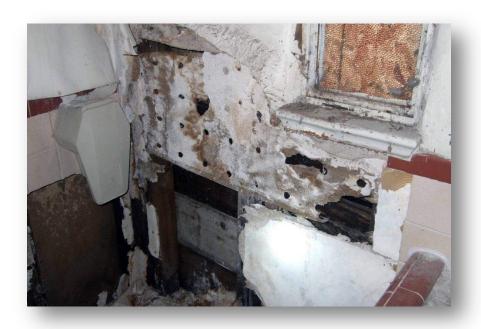
Figure 43- Building G Room 174 Water Damage

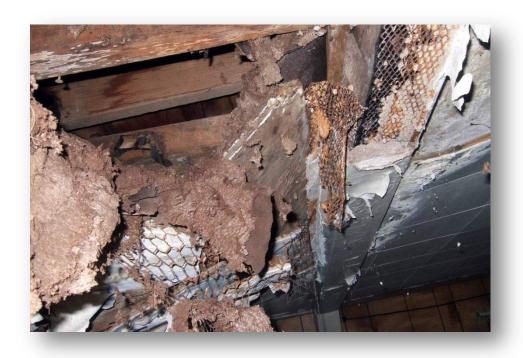
Figure 44- Building G Room 177 Ceiling Collapse

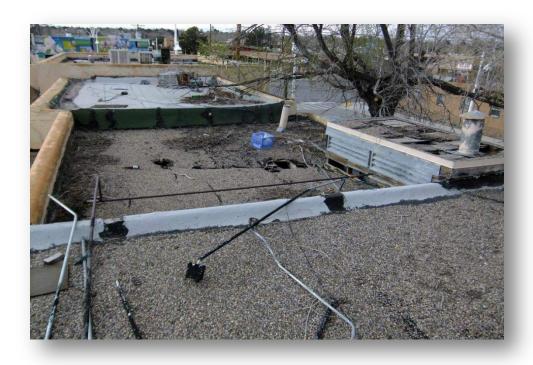
Figure 46- Building G Roof Failure

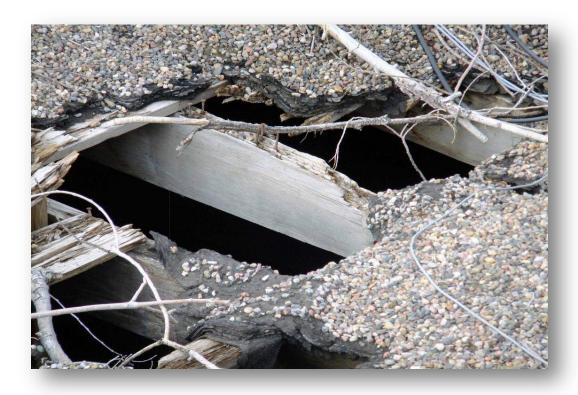
Figure 47-Building G Roof Structure Deterioration
