City of Albuquerque  
Facility Condition Assessment  
De Anza Motor Lodge

2014 REPORT

## 1.0 Executive Summary

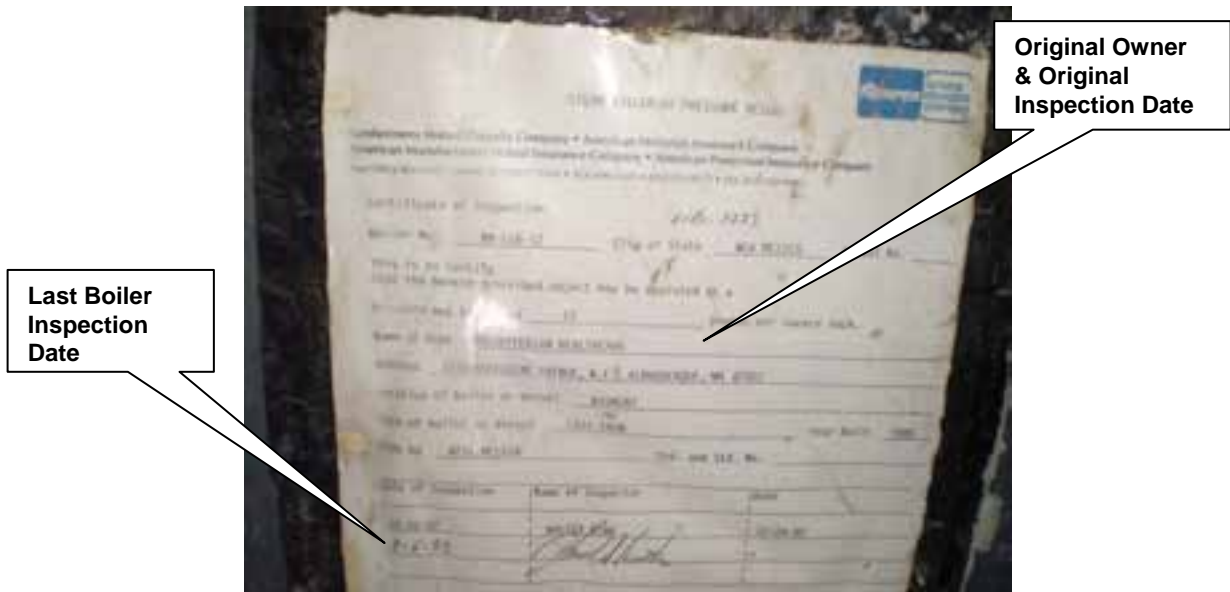
The installed boiler was used at another location, prior to the current location, as noted on the boiler inspection tag. One other important factor, the gas meter was removed at some point after 2003. The only heat available in areas would be from any remaining PTAC's and the electric heating convectors in the Lobby area. We have no information when the gas meter assemblies were removed.

Figure 3 - Site Boiler Inspection Tag

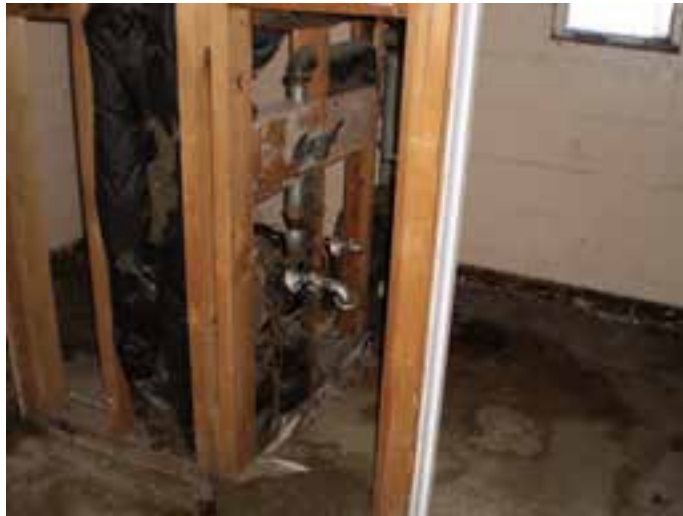
Missing Plumbing Fixtures, Water Closet and Lavatory

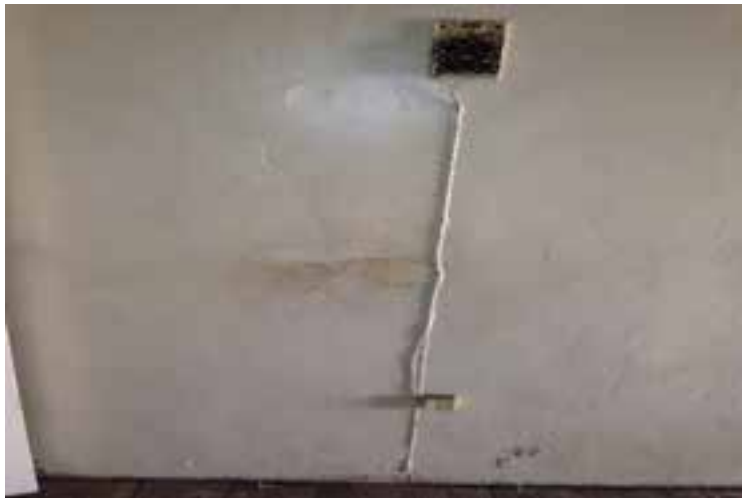
- 1.2 Telephone Terminal Cabinet Entrance: The Telephone extend to the guest rooms with two twisted pair telephone cable that is stapled to the wall and other building components. The telephone jacks are surface mounted to the walls and jacks and cable are not in usable condition.

Guest Room Telephone Line and Telephone Jack Connector

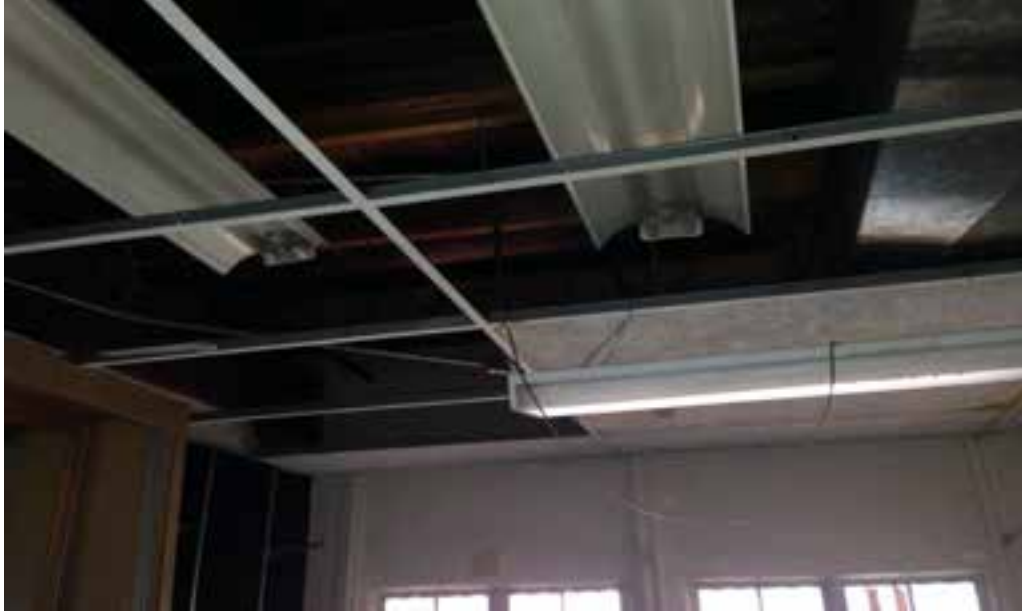
Office light fixtures at Building "E"

- 1.3.2 The fixtures in Building "E", consist of industrial fluorescent, wraparound fluorescent type, square recessed incandescent type and pendant type light fixtures that have been vandalized at some point in the office. There are multiple code violations including no exit lights and emergency lights for path of Egress. All the lighting, switches and conductors in all areas of the site are not energy efficient, in code violations and life safety code concerns.

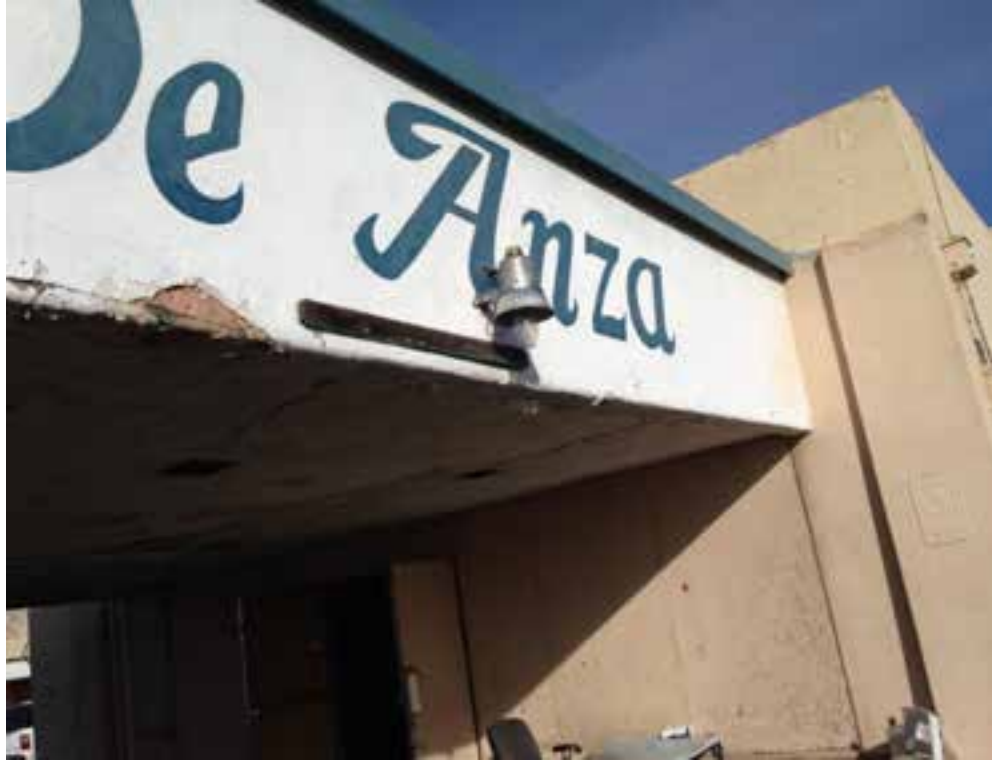
De Anza Entry To Office Lobby with HID Surface Mount Fixtures

- 1.3.3 The fixtures at exterior of Building “E”, consist of HID type fixtures, wraparound fluorescent type, square recessed incandescent type and wall mount HPS with broken lenses that have been vandalized at some point.

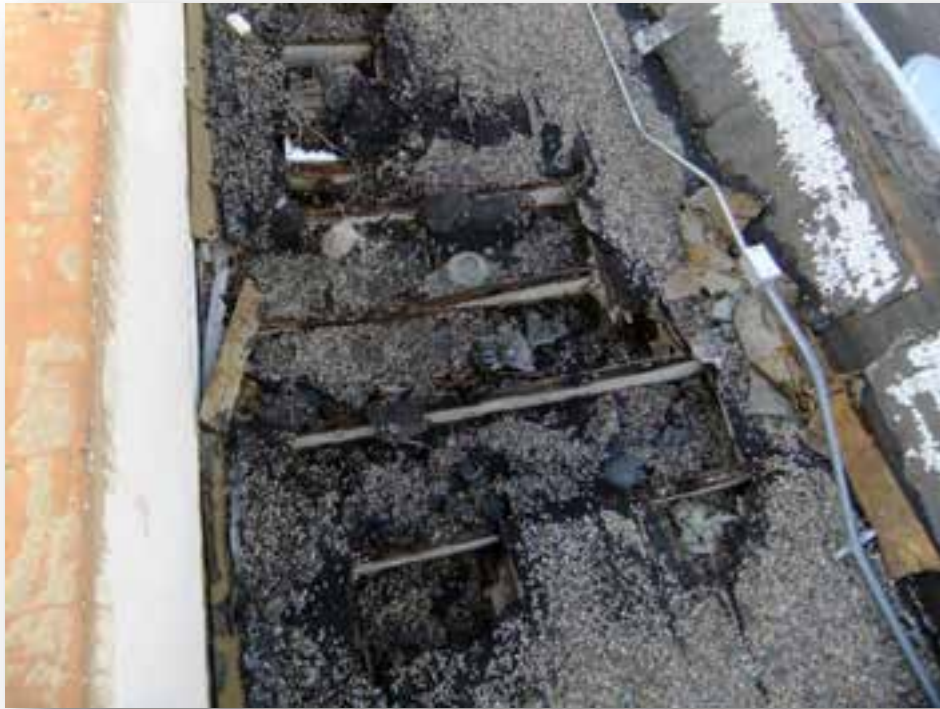
Figure 1 - Building A Roof

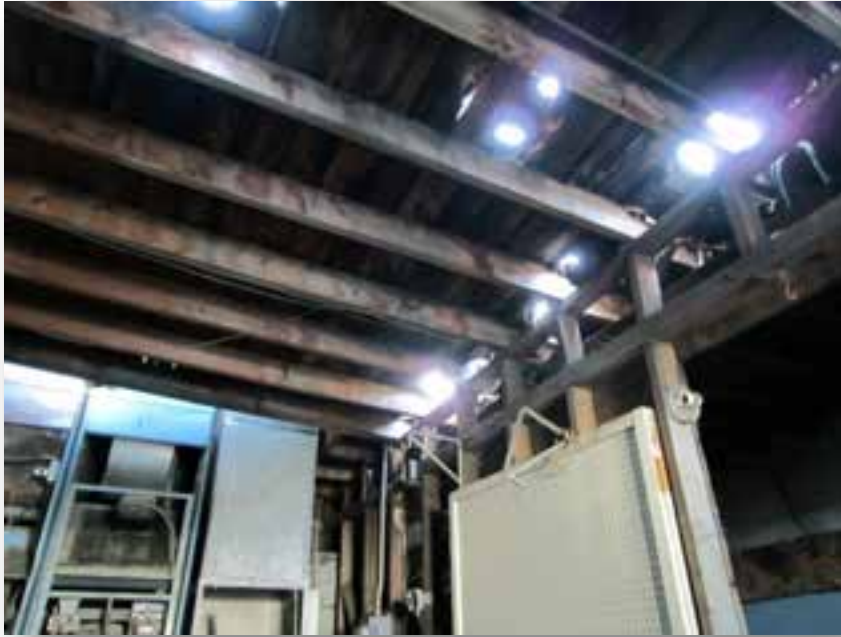
Figure 3- Building A Room 103 – Fire Damaged Room

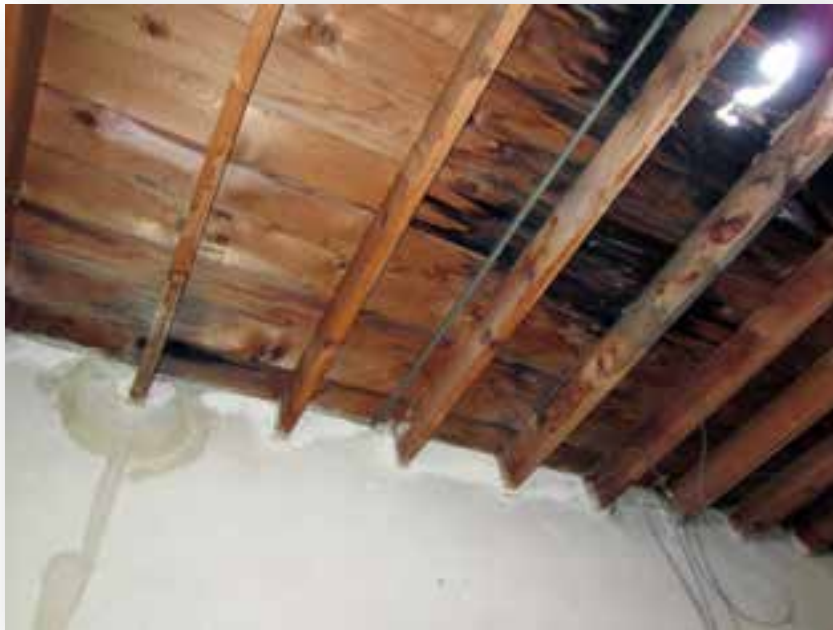
Figure 4- Building A Room 103 – Roof Deterioration

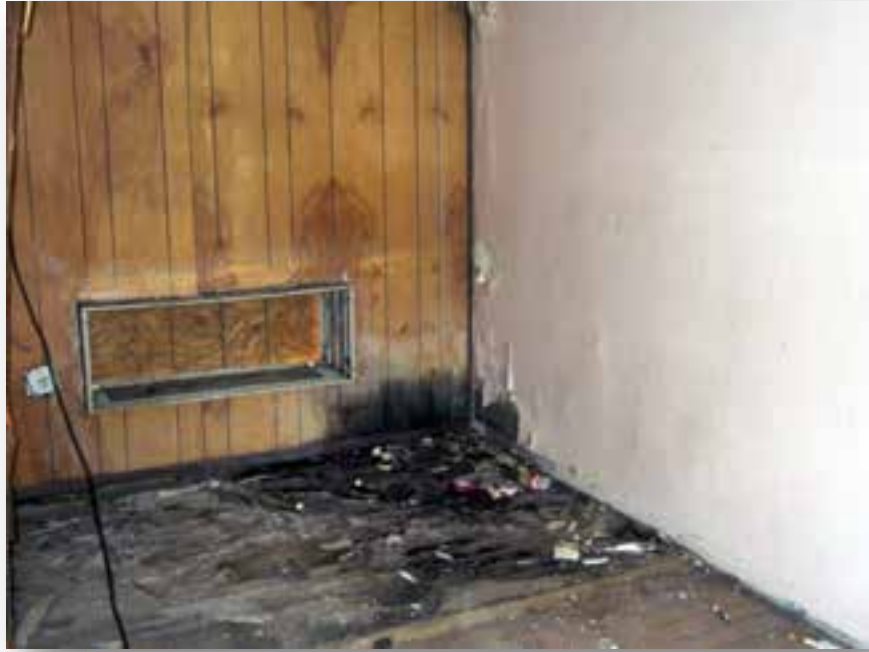
Figure 5- Building A Room 105 – Floor Water Damage

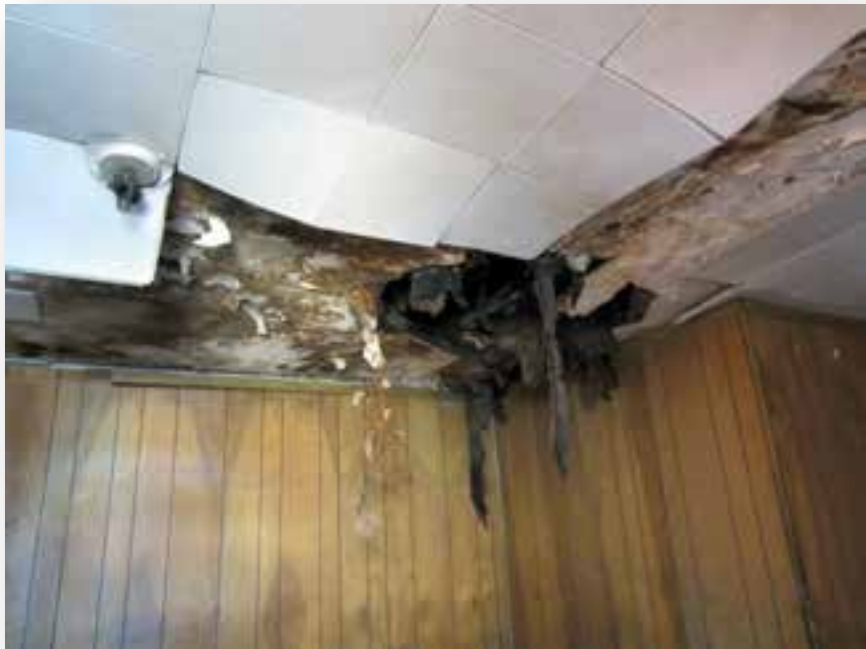
Figure 6- Building A Room 106 – Ceiling Collapse

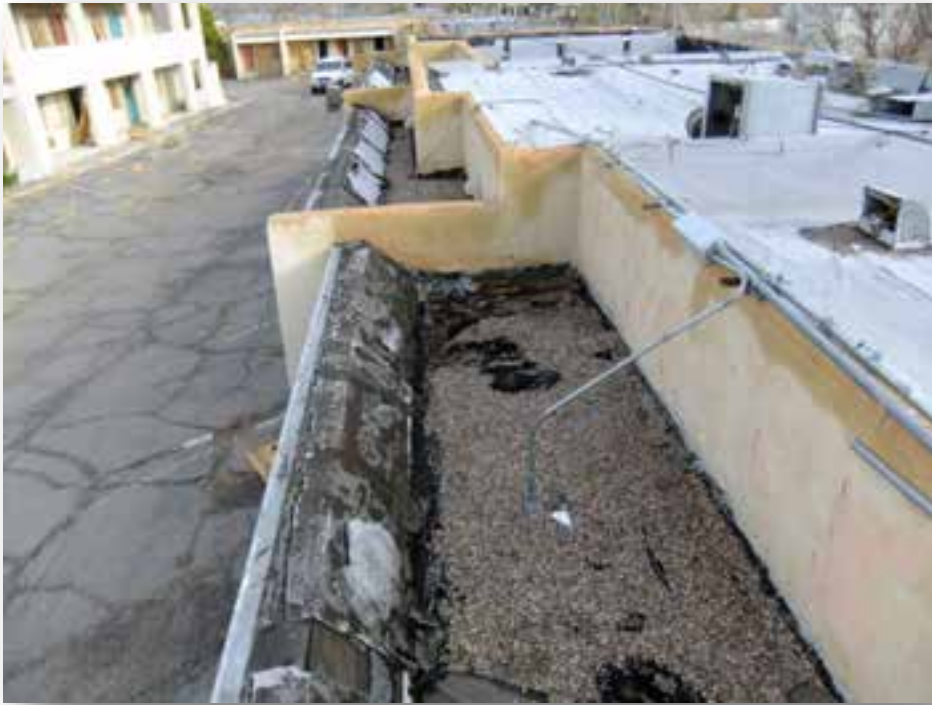
Figure 8- Building B Roof Deterioration on West Canopy

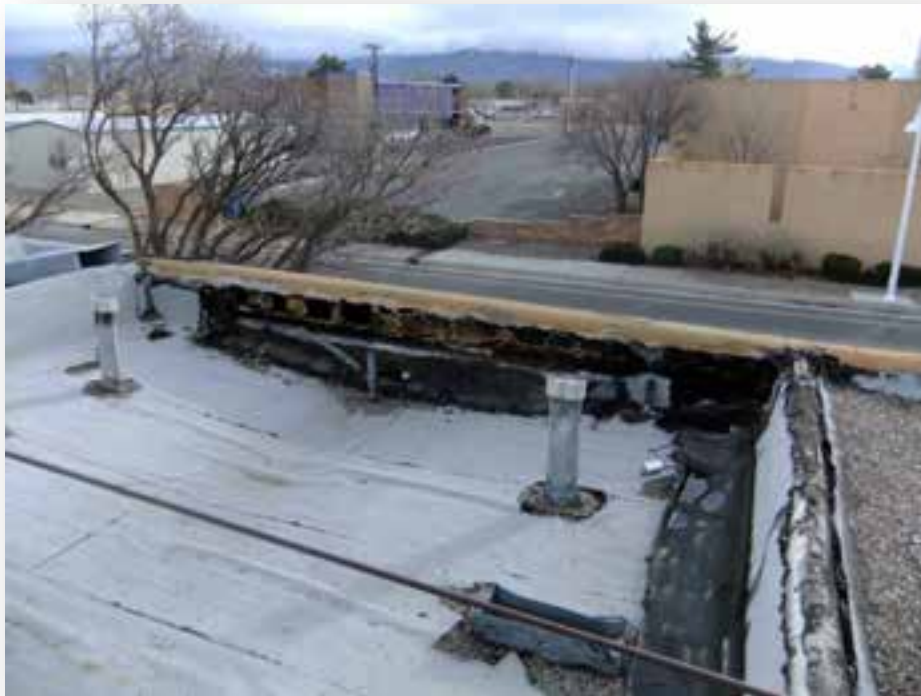
Figure 9- Building B Roof Deterioration at Partial Collapse

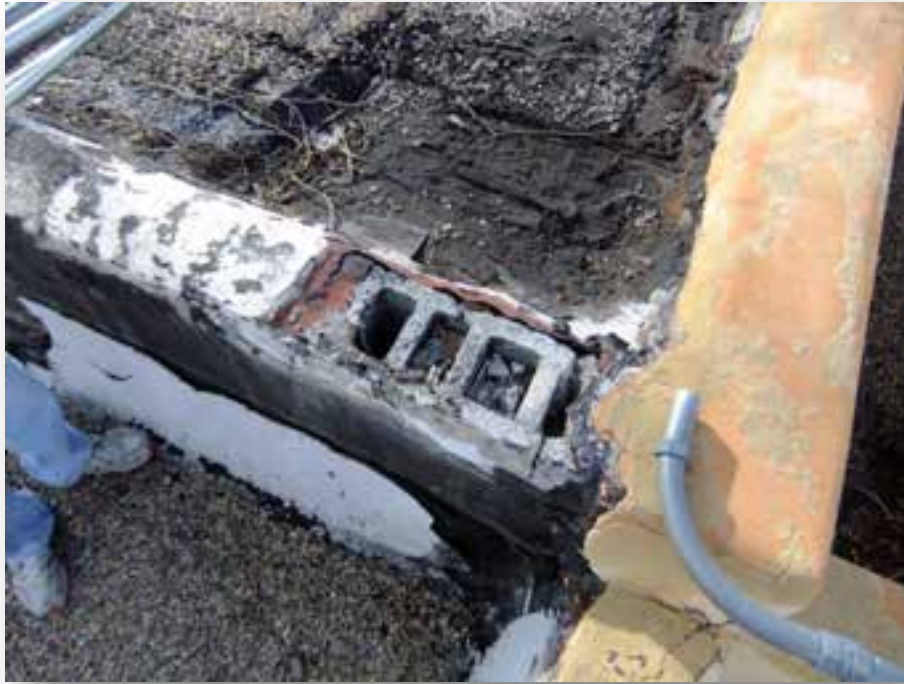
Figure 10- Building B Envelope Deterioration at CMU Wall

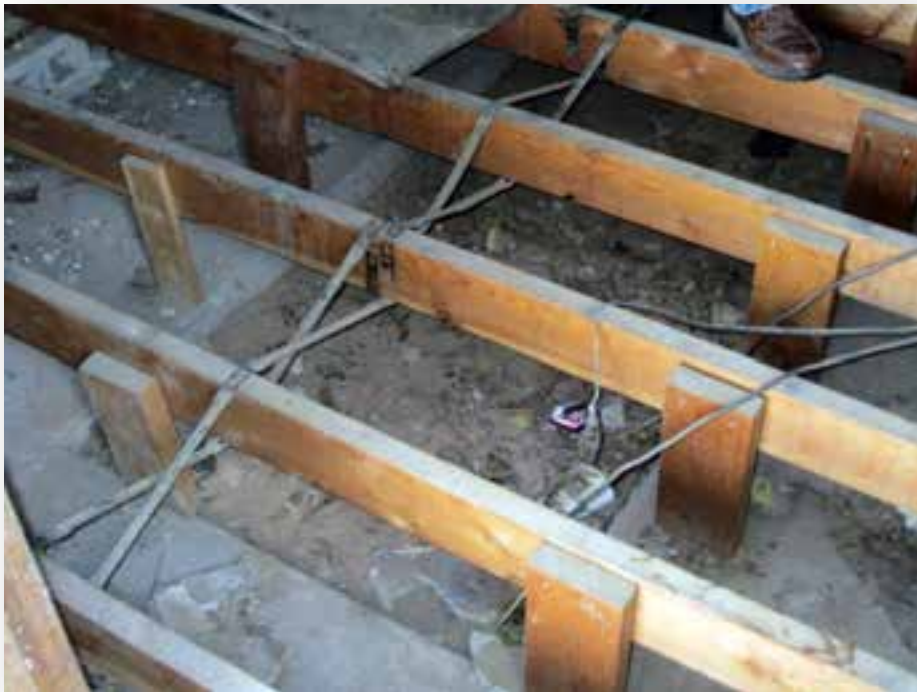
Figure 11- Building B Room 107 Exposed Floor System on Concrete Foundation

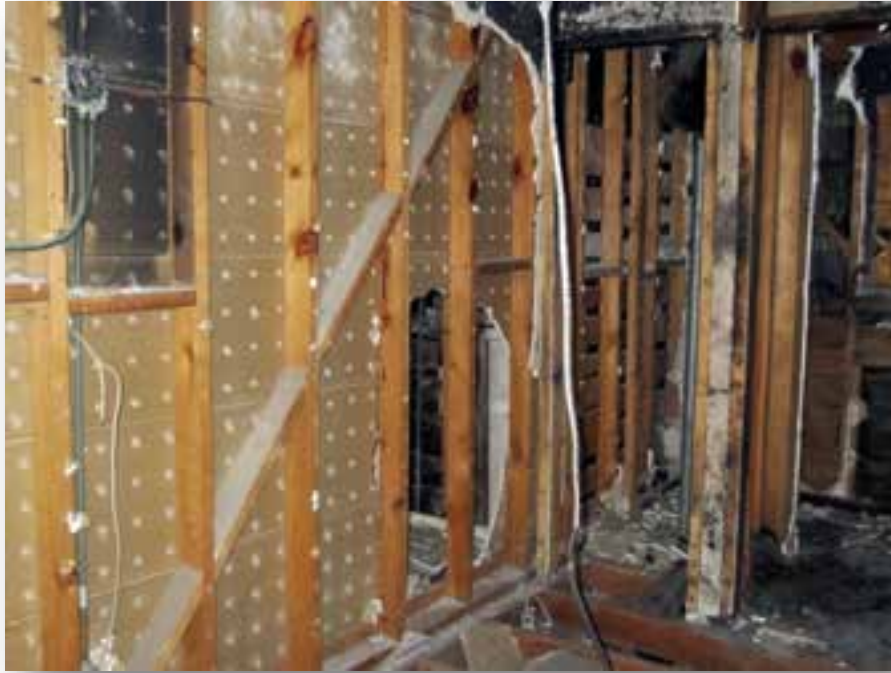
Figure 12- Building B Room 107 Fire Damaged Room

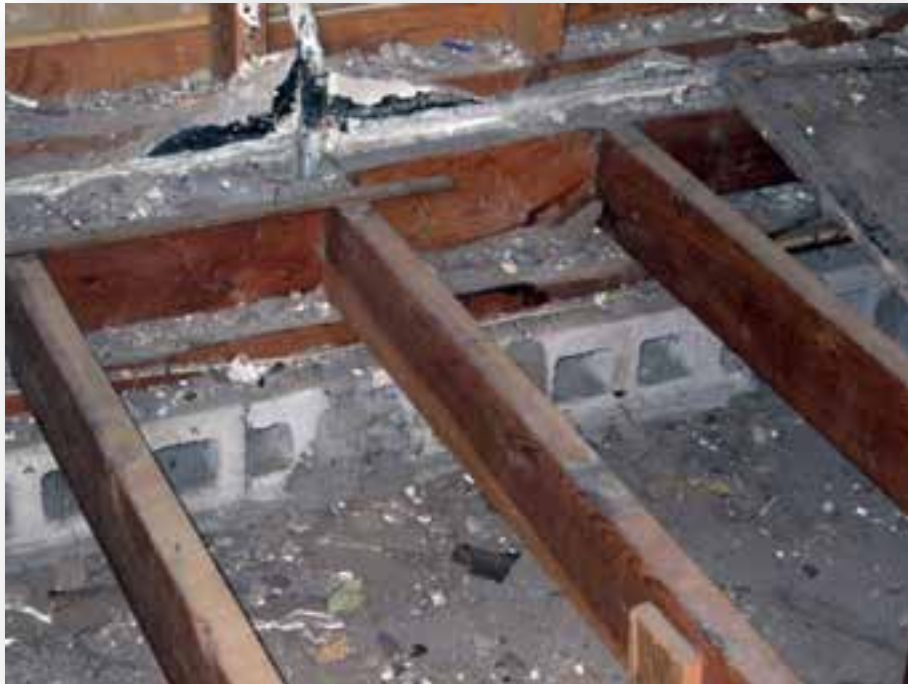
Figure 13- Building B Room 107 Floor Bearing Detail

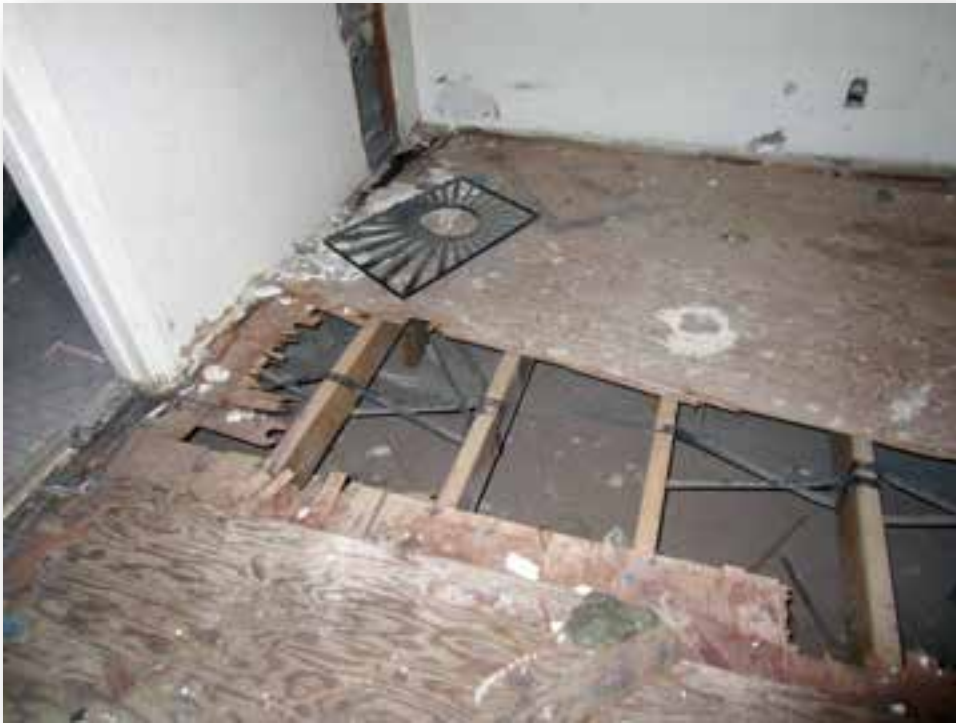
Figure 16- Building B Room 115 Floor Damage

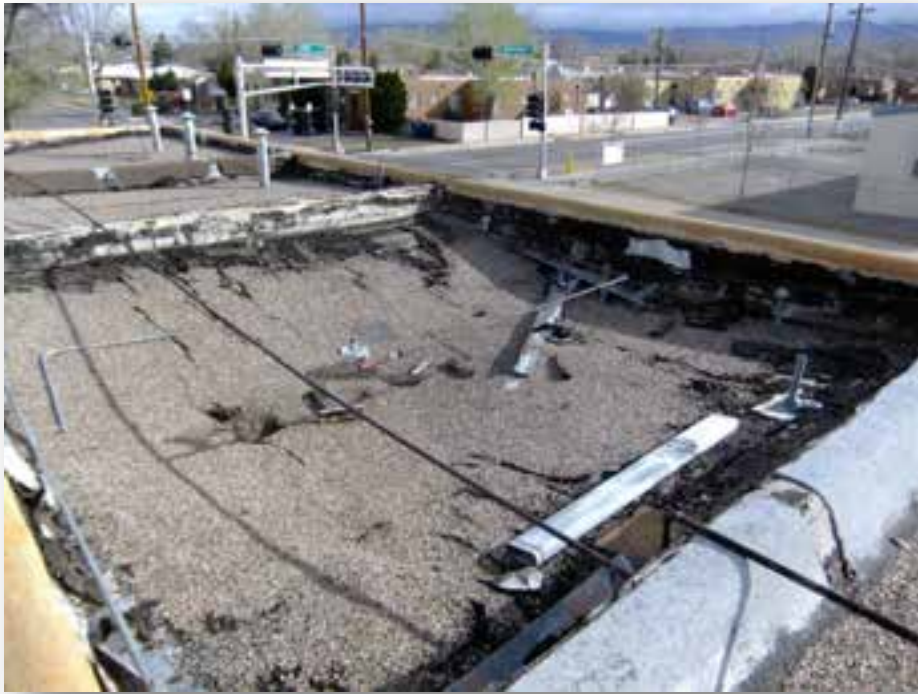
Figure 17- Building C Partially Collapsed Roof Structure

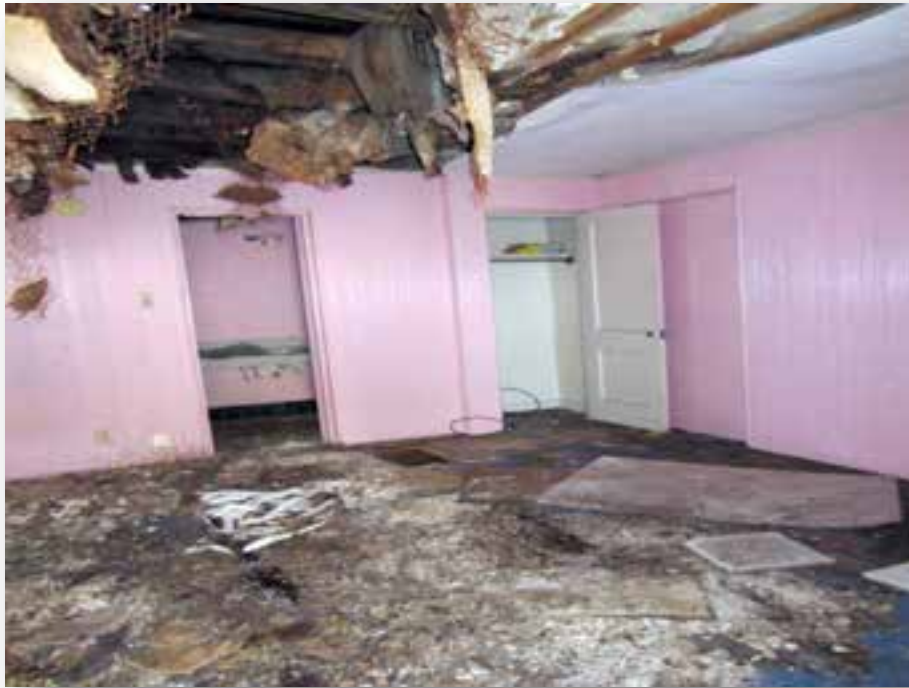
Figure 19- Building C Room 119 Ceiling Collapse at Water Damage

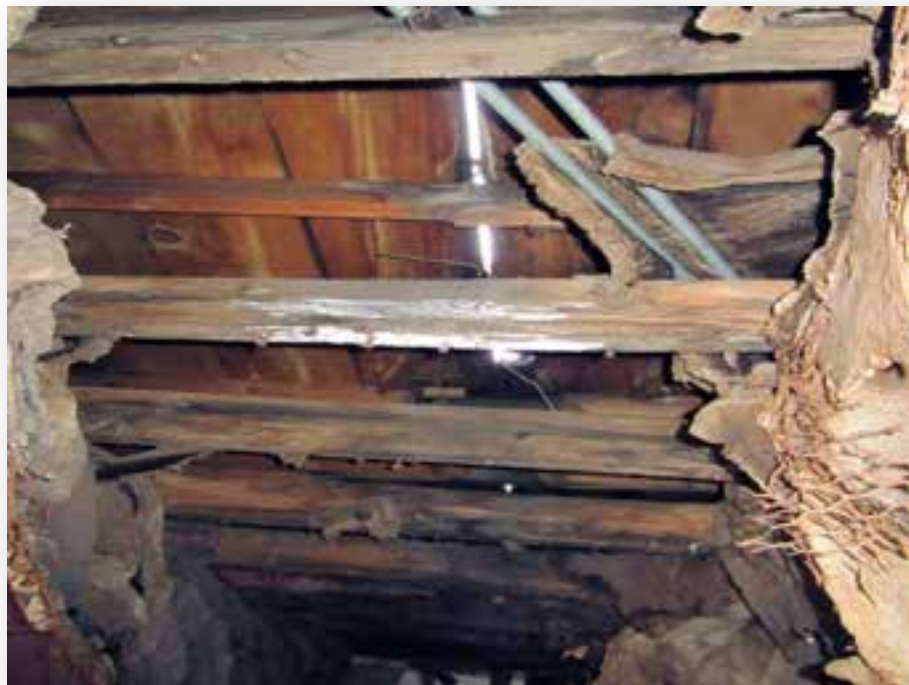
Figure 20- Building C Room 119 Roof Structure Deterioration

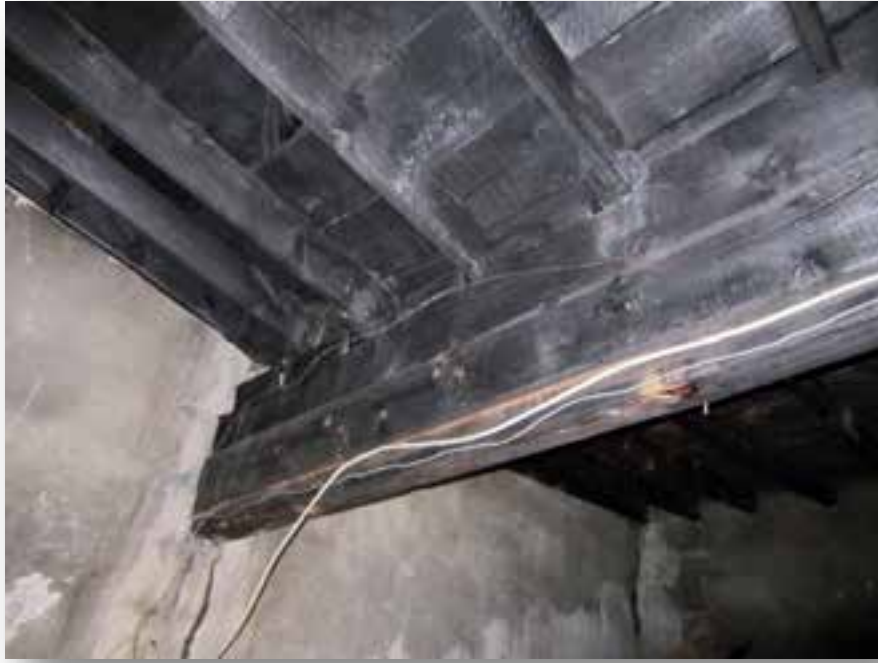
Figure 21- Building C Room 119 Fire Damage – Unsupported Roof Beam

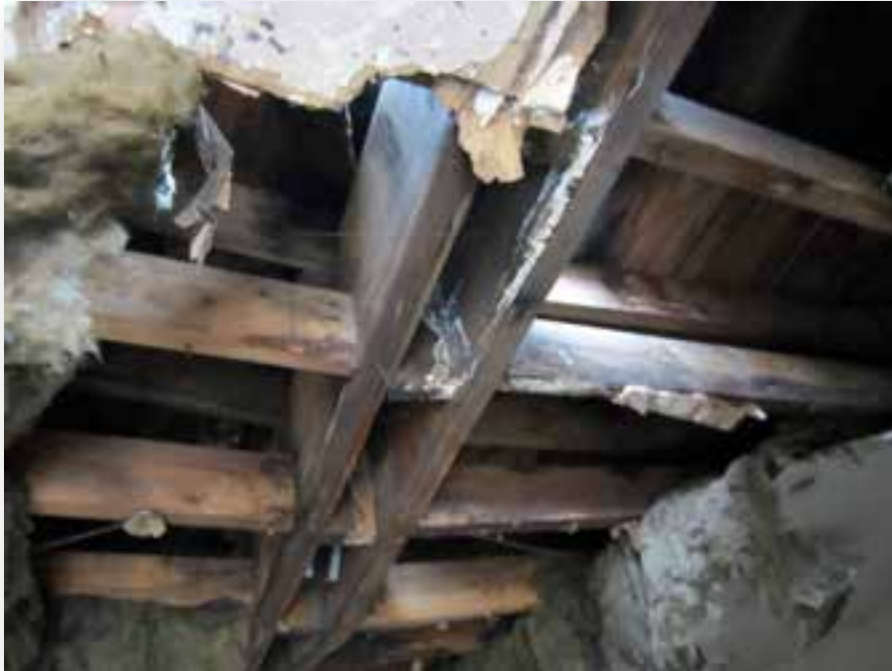
Figure 22- Building C Room 123 Damaged Roof Structure

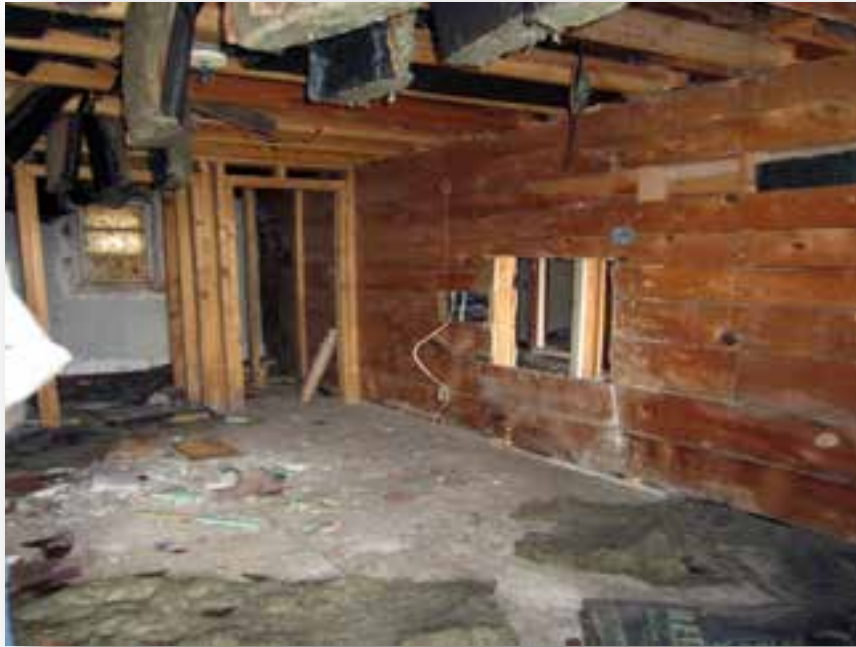
Figure 23-Building C Room 127 Exposed Structure at Partially Demolished Room

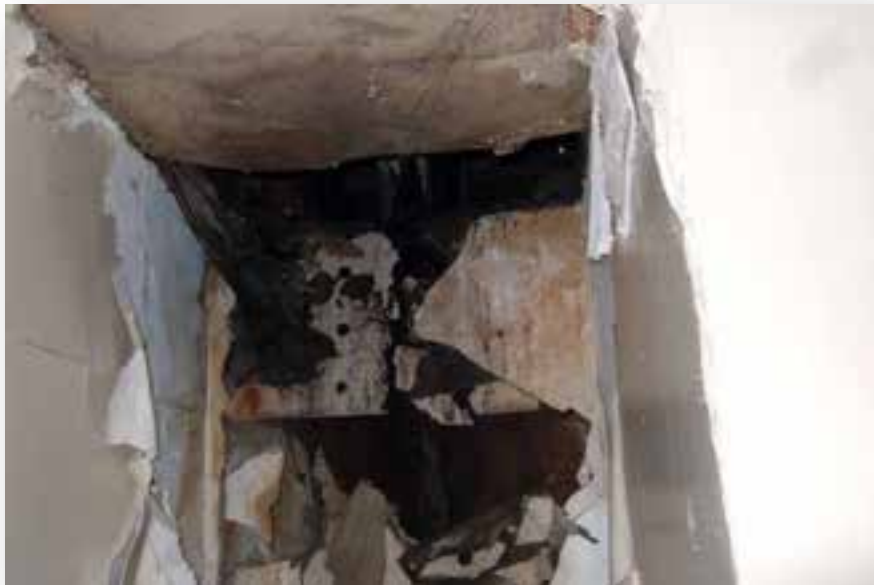
Figure 24- Building D Room 145 Water Damage

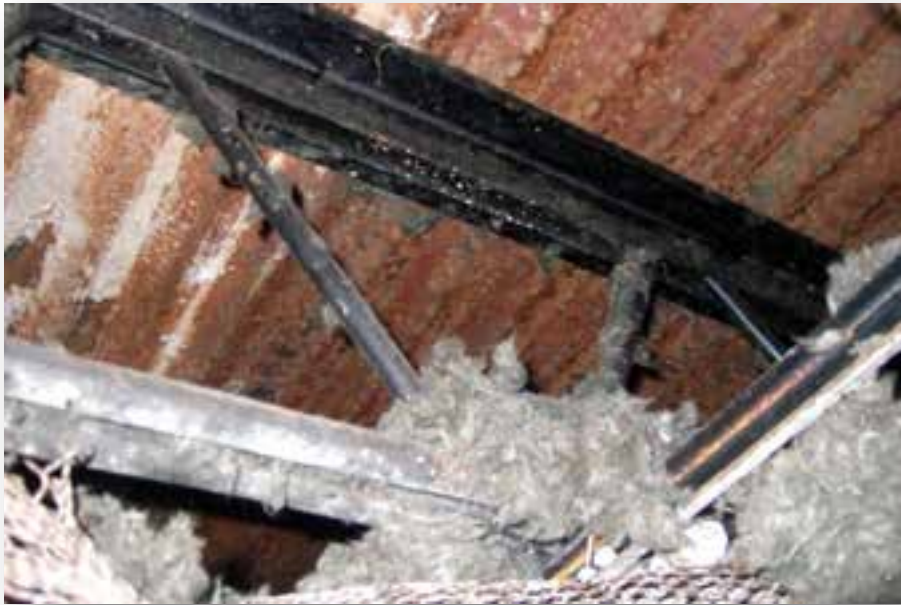
Figure 26- Building D Room 131 Corroded Deck

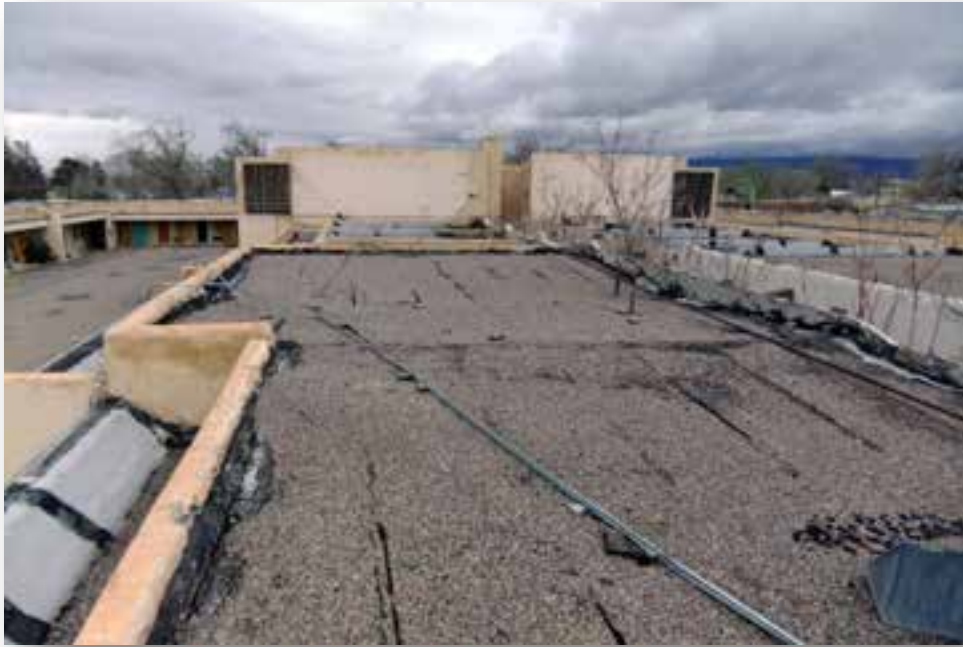
Figure 27-Building D Roof Damage

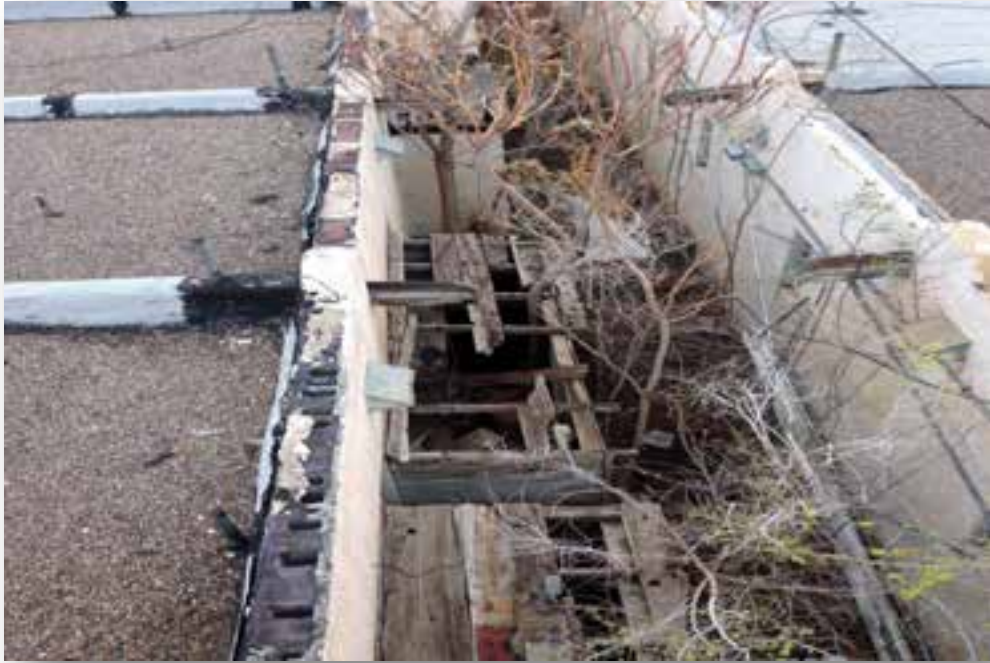
Figure 29- Building D Roof Damage

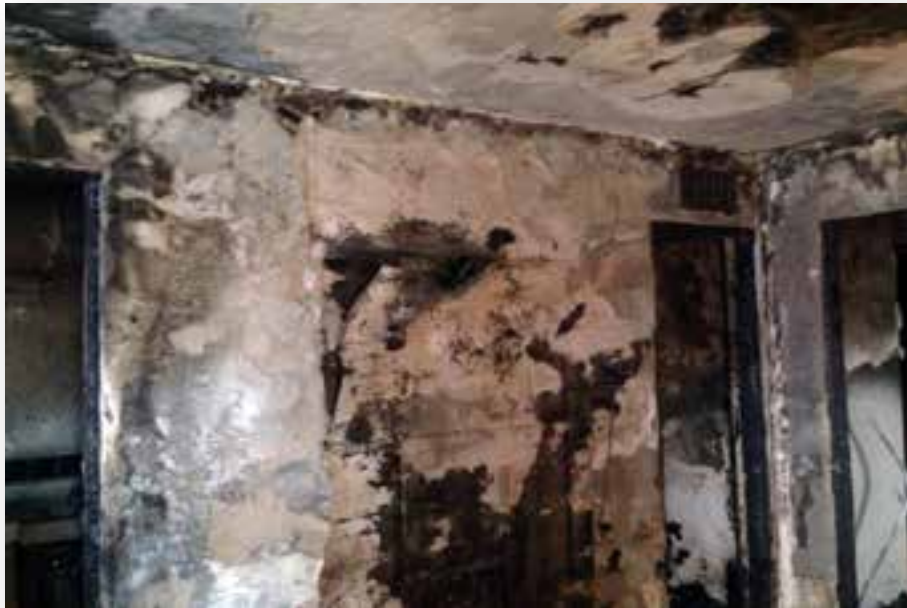
Figure 30- Building D Room 131 Fire Damage

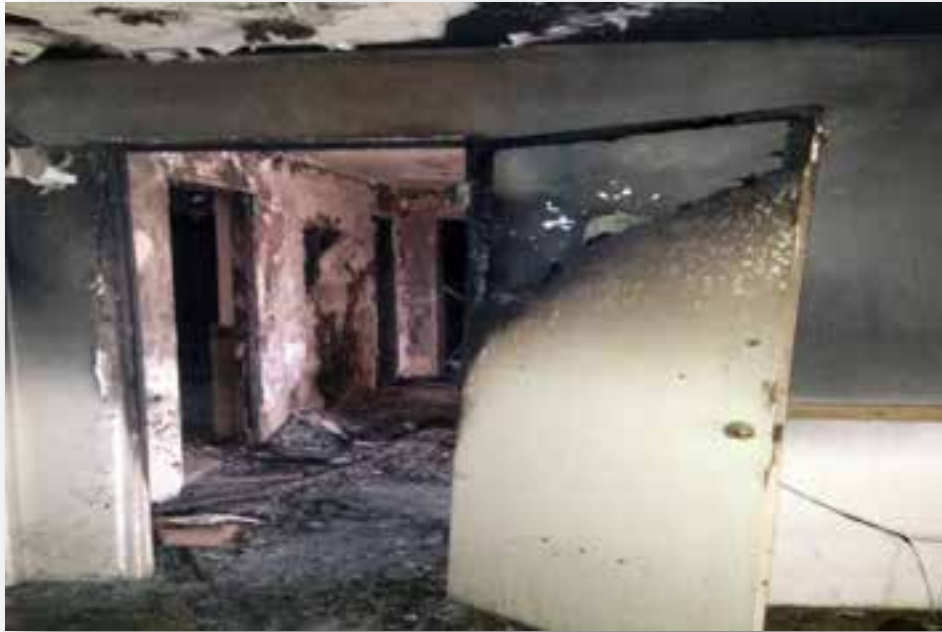
Figure 31- Building D Room 132 Fire Damage

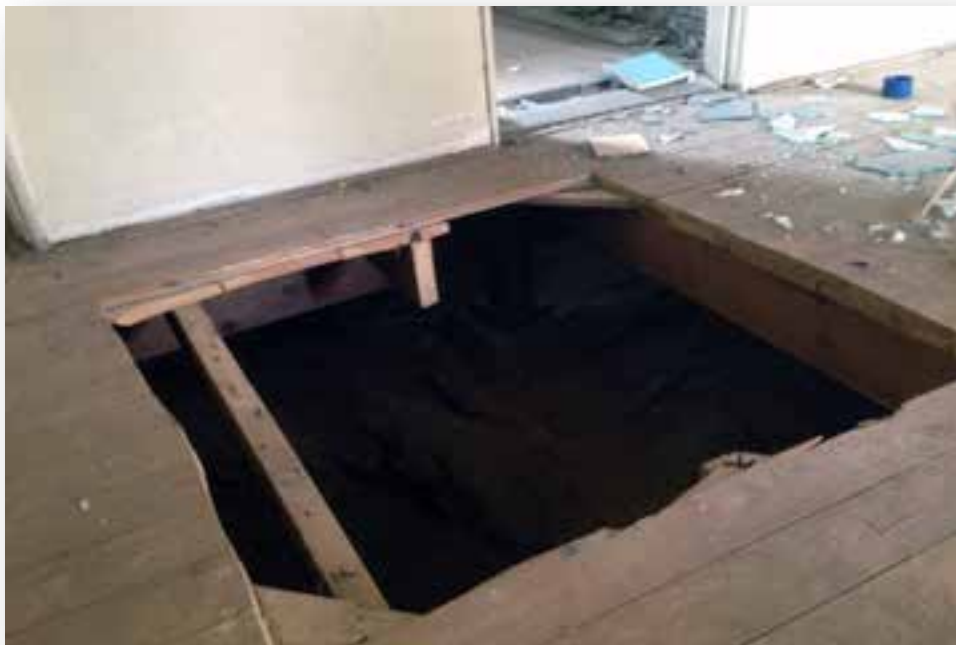
Figure 32- Building D Room 137 Floor Opening

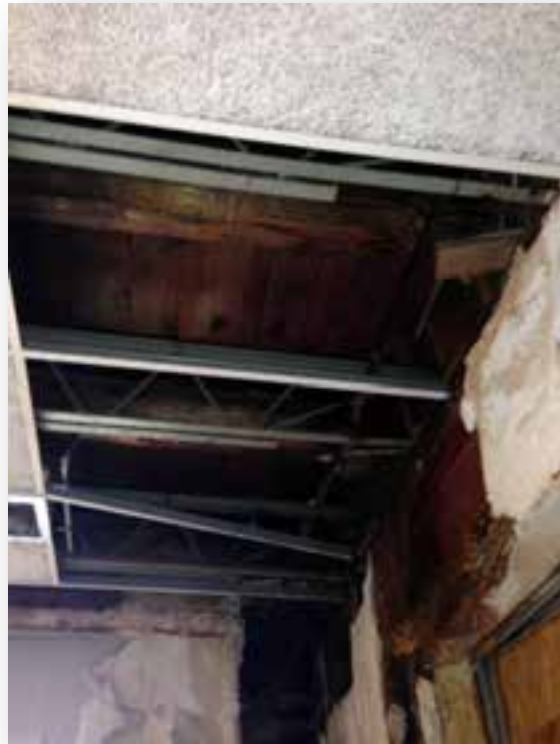
Figure 33- Building E – Lobby - First Floor Ceiling

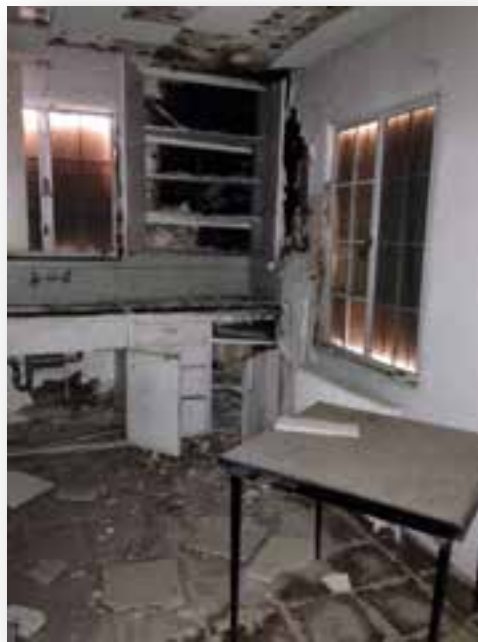
Figure 34-Building E Kitchen Water Infiltration

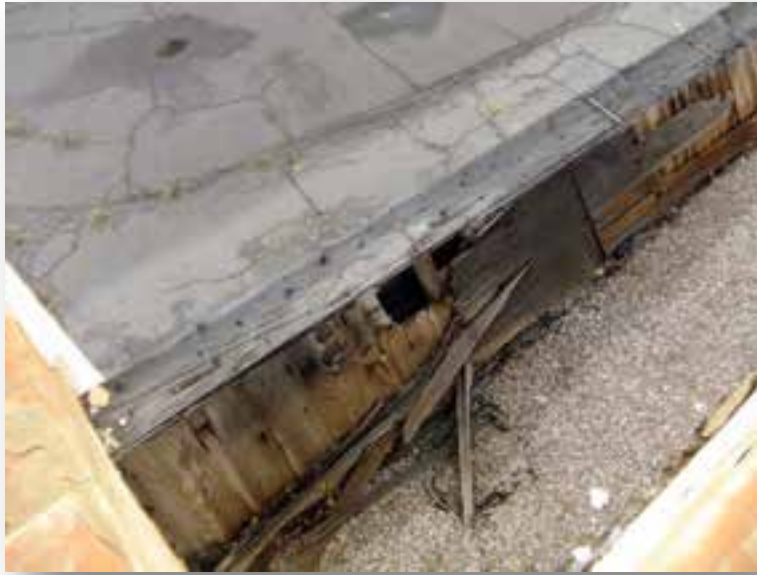
**Figure 38- Building F Roof – Missing Flashing**

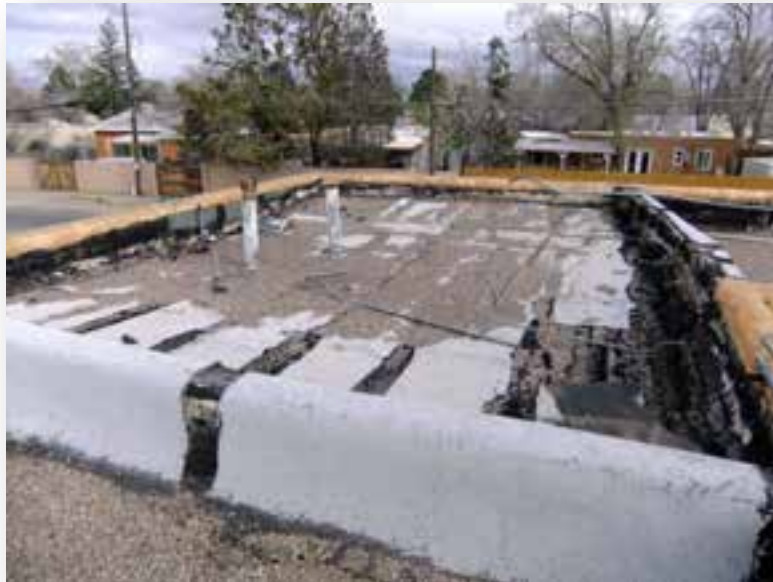
**Figure 39- Building F Roof Deterioration**

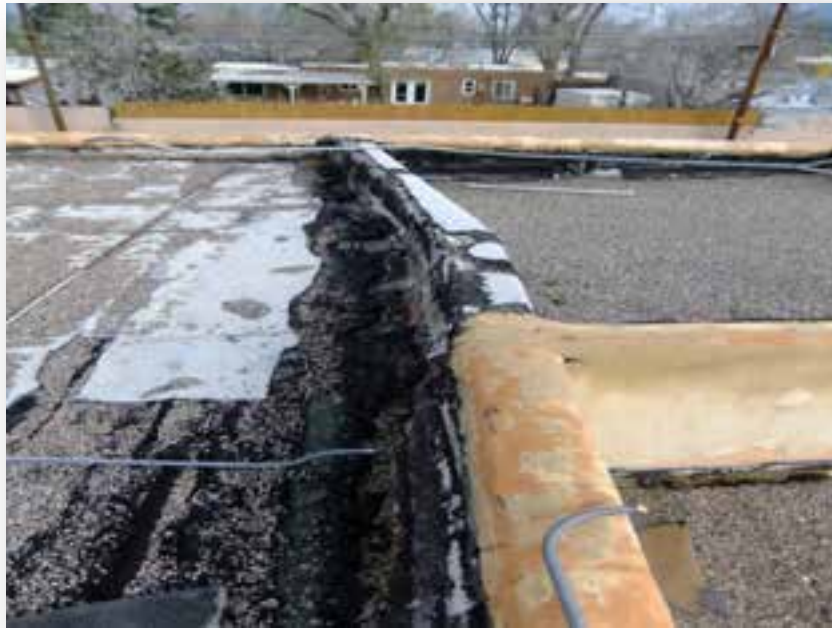
Figure 40 – Building F Distortion at Unit 159

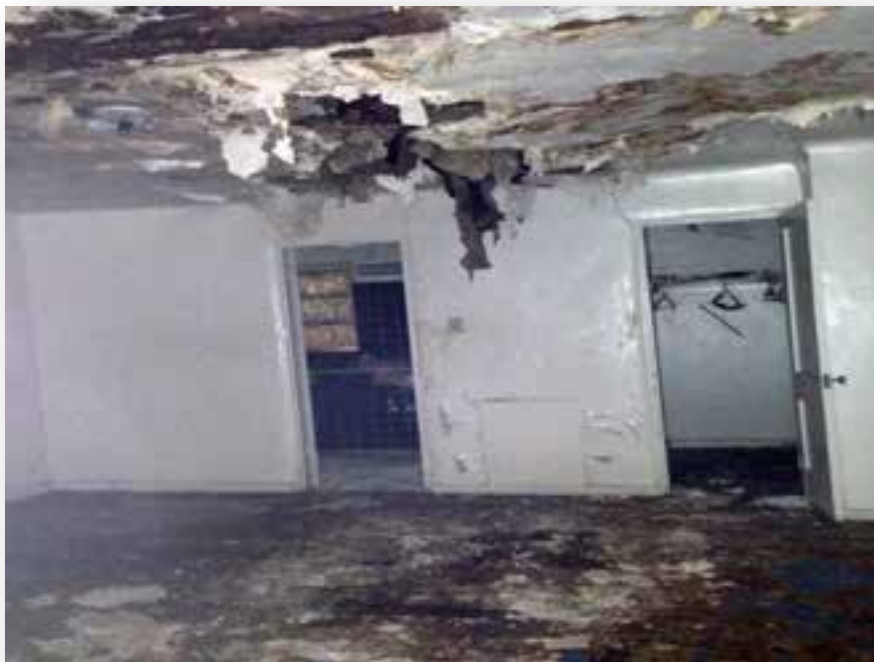
Figure 41- Building F Room 159 Water Damage

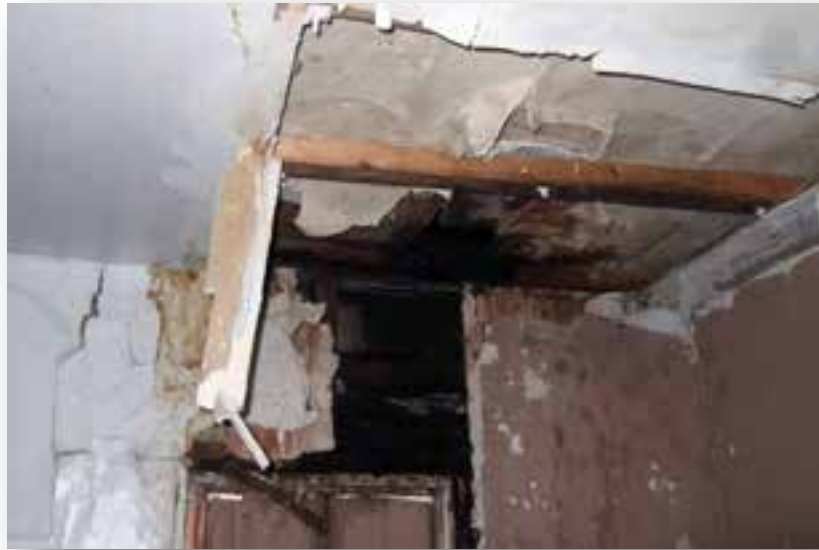
Figure 42- Building G Room 171 Water Damage

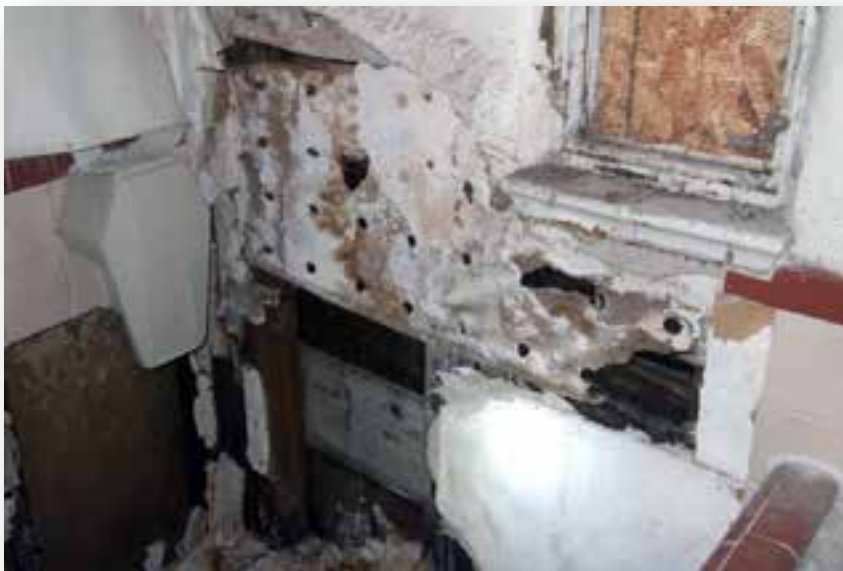
Figure 43- Building G Room 174 Water Damage

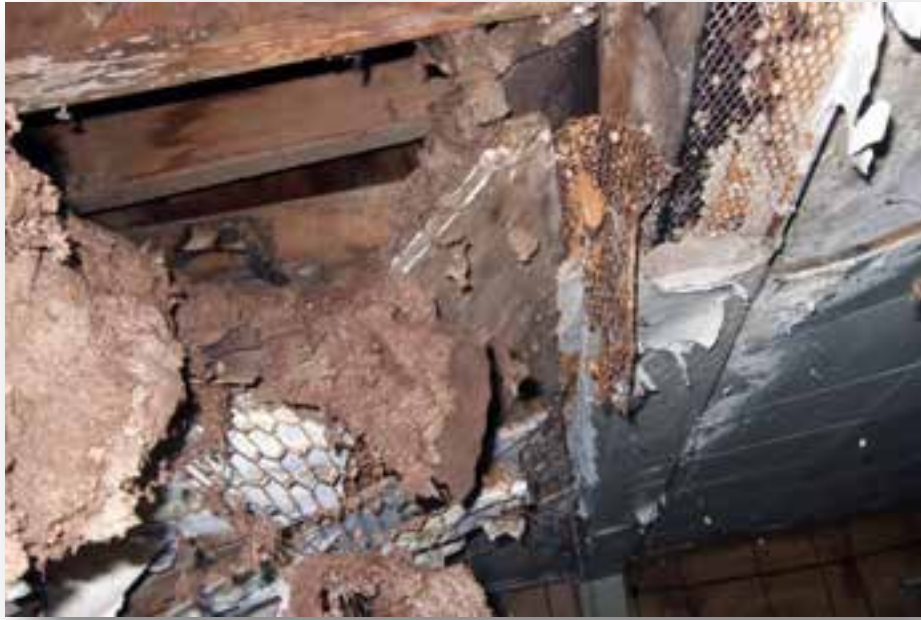
Figure 44- Building G Room 177 Ceiling Collapse
