City of Albuquerque  
Facility Condition Assessment  
De Anza Motor Lodge

2014 REPORT

## 1.0 Executive Summary

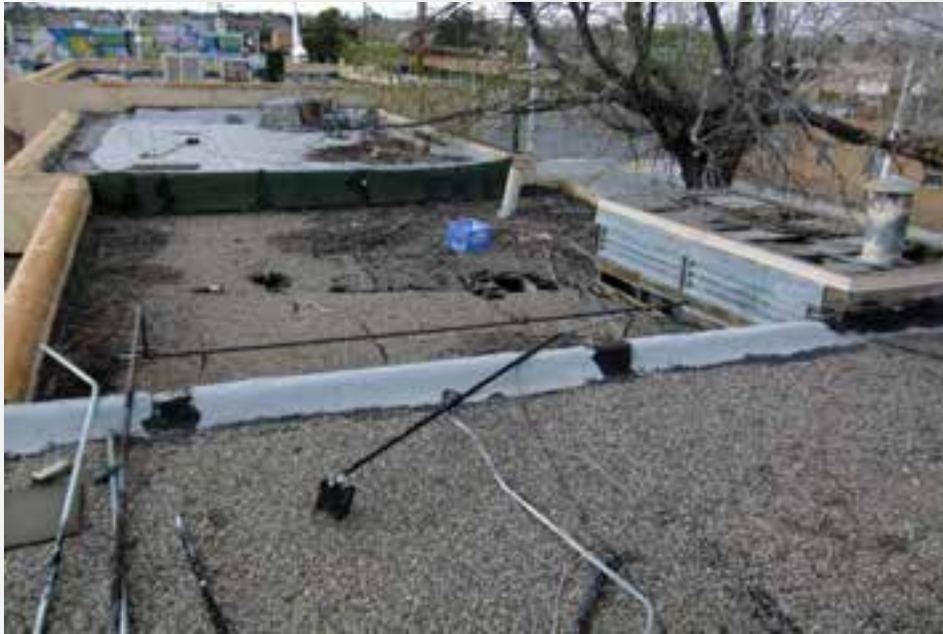
Figure 46- Building G Roof Failure

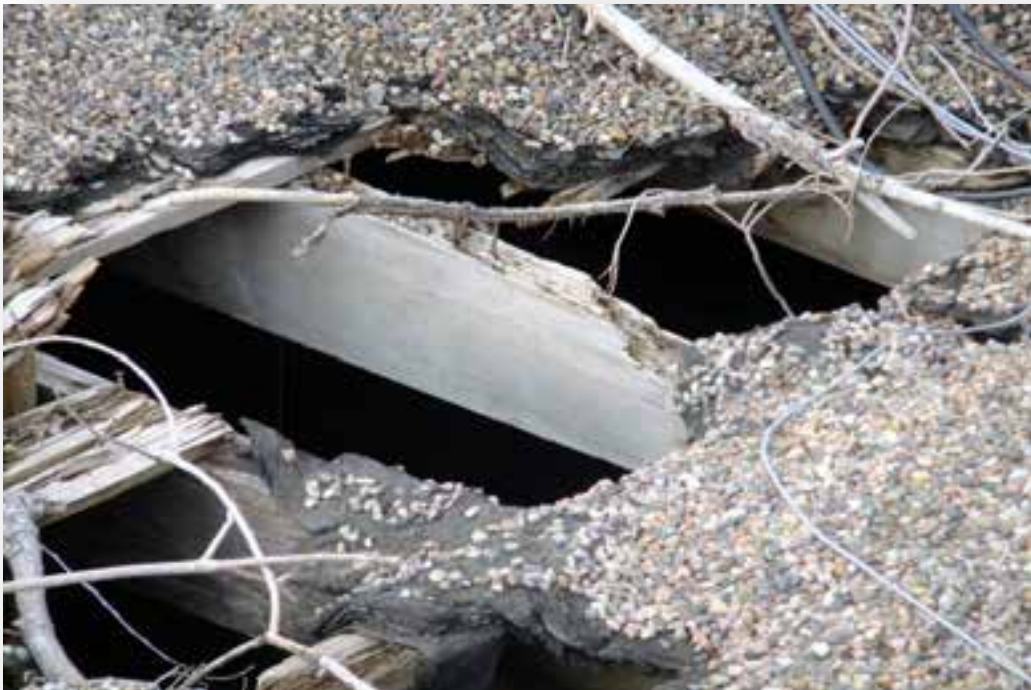
Figure 47-Building G Roof Structure Deterioration
