# National Register of Historic Places Registration Form

Historic name: Atchison, Topeka, & Santa Fe Railway Locomotive Shops

Other names/site number: Albuquerque Rail Yards

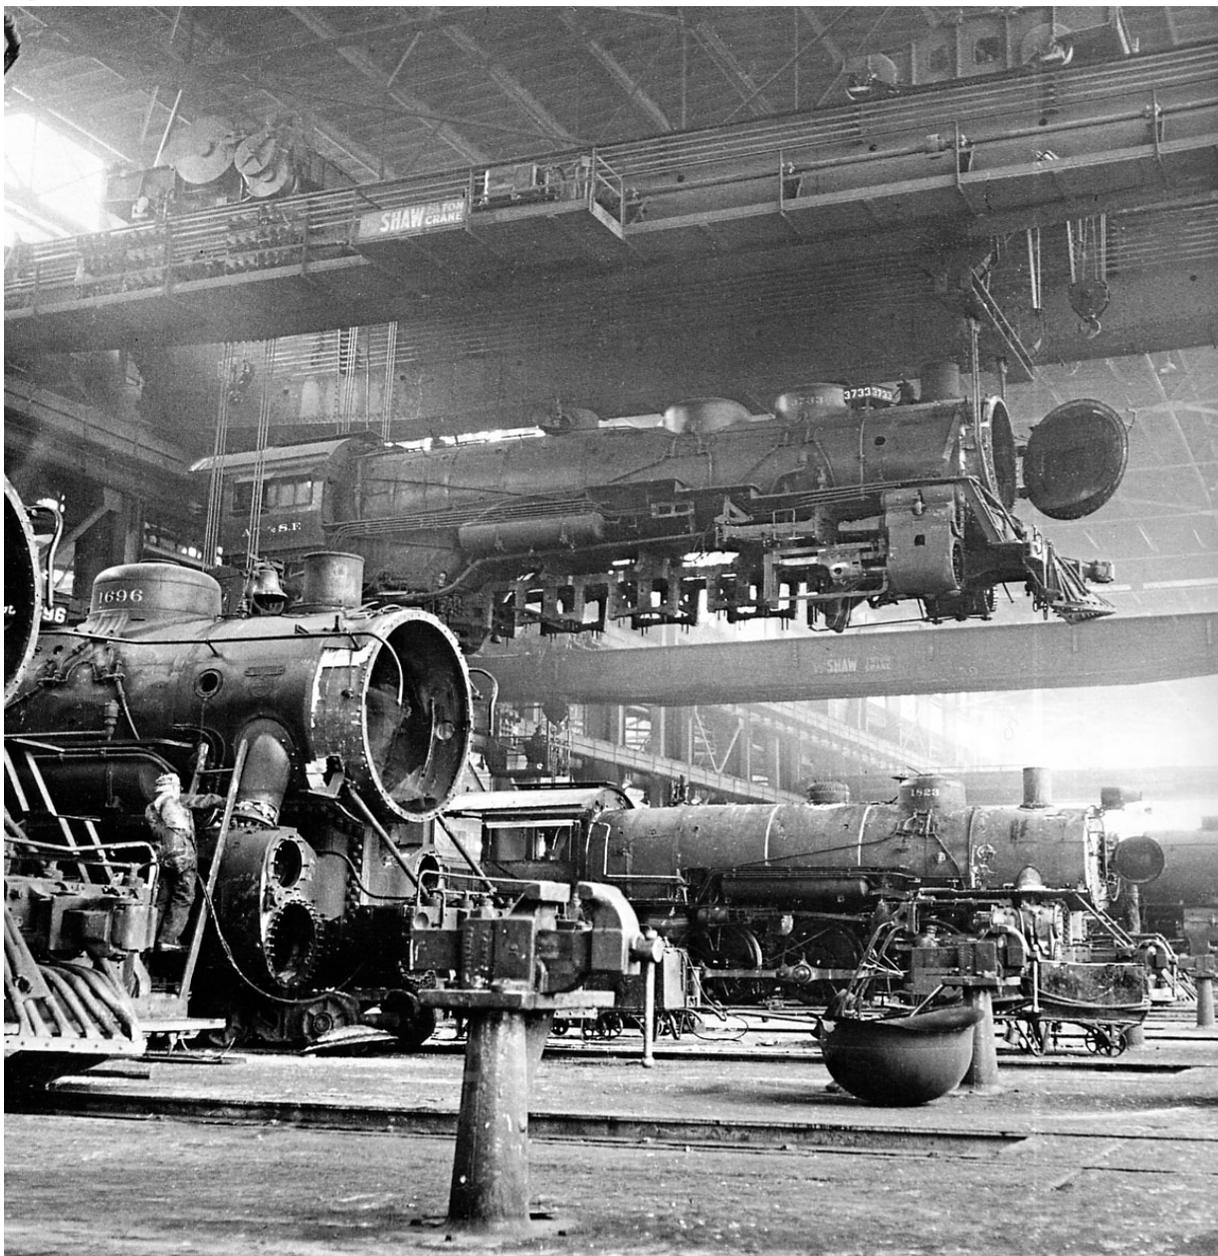
*Figure 1. In the erecting bay of the machine shop the locomotive was dismantled and the parts sent for cleaning, inspection and repair to various shops in the complex. Note the locomotive on the bridge crane.*

In the erecting bays of the machine and boiler shops, for instance, the engine was completely dismantled and the parts sent for cleaning, inspection and repair to various departments housed in the lower bays of the machine and boiler shops and in the blacksmith, flue, tender repair, welding and babbitt shops (see Figure 1). After being cleaned in a lye vat, working parts were reconditioned and necessary replacements fabricated. Lathes turned the large driving wheels so that all were exactly the same size. Breaks in the frame were repaired. The boiler and fire box were patched with steel plate or, if needed, replacements were fabricated. Each part was given a final inspection and tested to meet precise standards before the locomotive was reassembled. On average, a complete overhaul took about a month to perform. Over the fifteen year life of an average locomotive, it might be rebuilt or receive other major shop repairs once every twelve to eighteen months. In the twentieth century, the Albuquerque shops serviced forty locomotives in a normal month (Wilson 1986: 7).

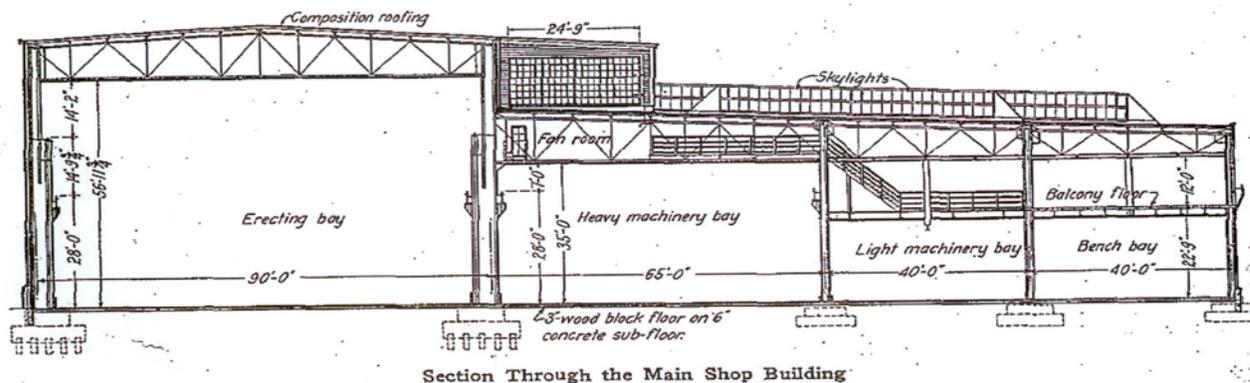
Figure 2. Work in the machine shop was distributed between four interior bays.

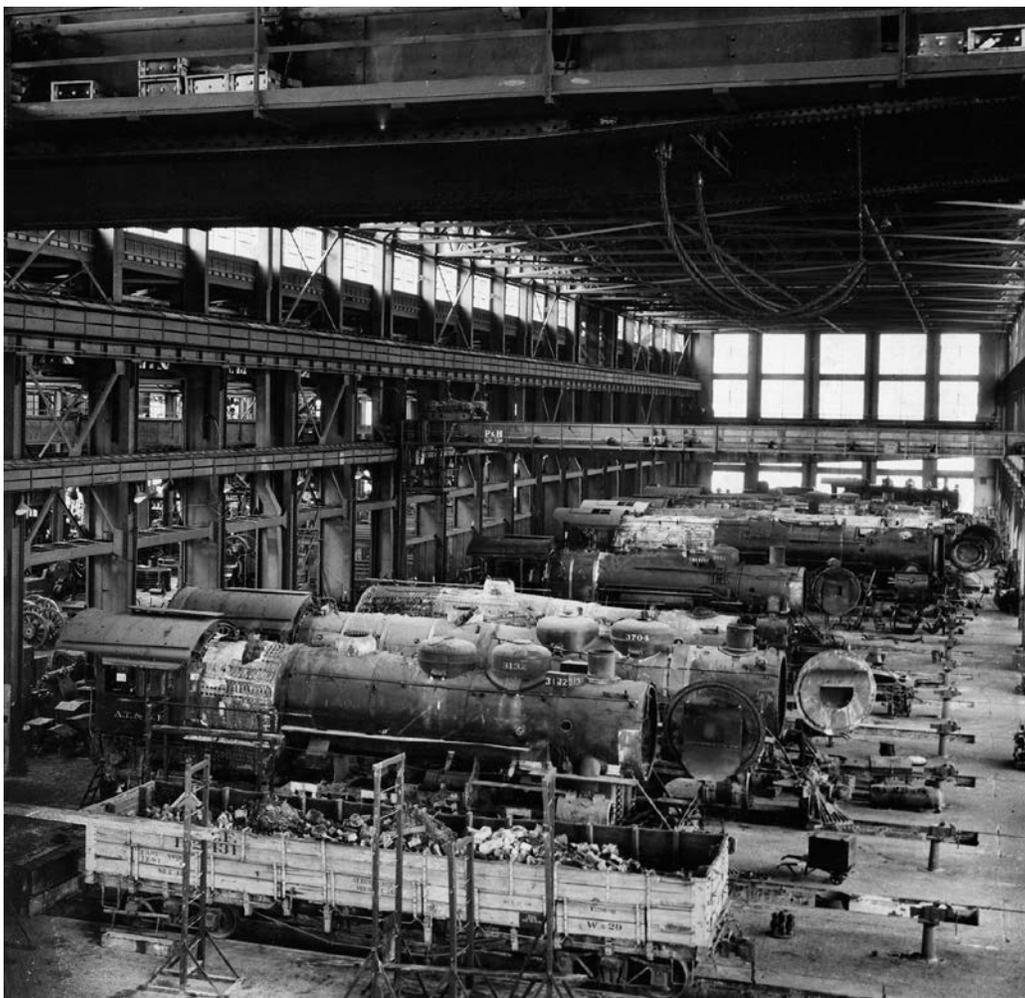
*Figure 3. Locomotives in the erecting bay, looking southwest, note concrete pits and 250 ton bridge crane above.*

The machine shop's erecting bay is the complex's largest open volume under roof. It is about 600 feet by 90 feet in plan and 57 feet in clear height. It includes concrete engine repair pits side-by-side along the length of the bay. Originally the bay had twenty-six pits, one of which was 136 feet long. Twelve of the pits have been filled with concrete and the remaining fourteen pits are 63 feet long and about 3 feet deep (See Figure 3). Each pit had connections for steam, gas, and electricity. The erecting bay has one 250-ton-capacity bridge crane on an upper rail and two 15-ton-capacity cranes on a lower rail.

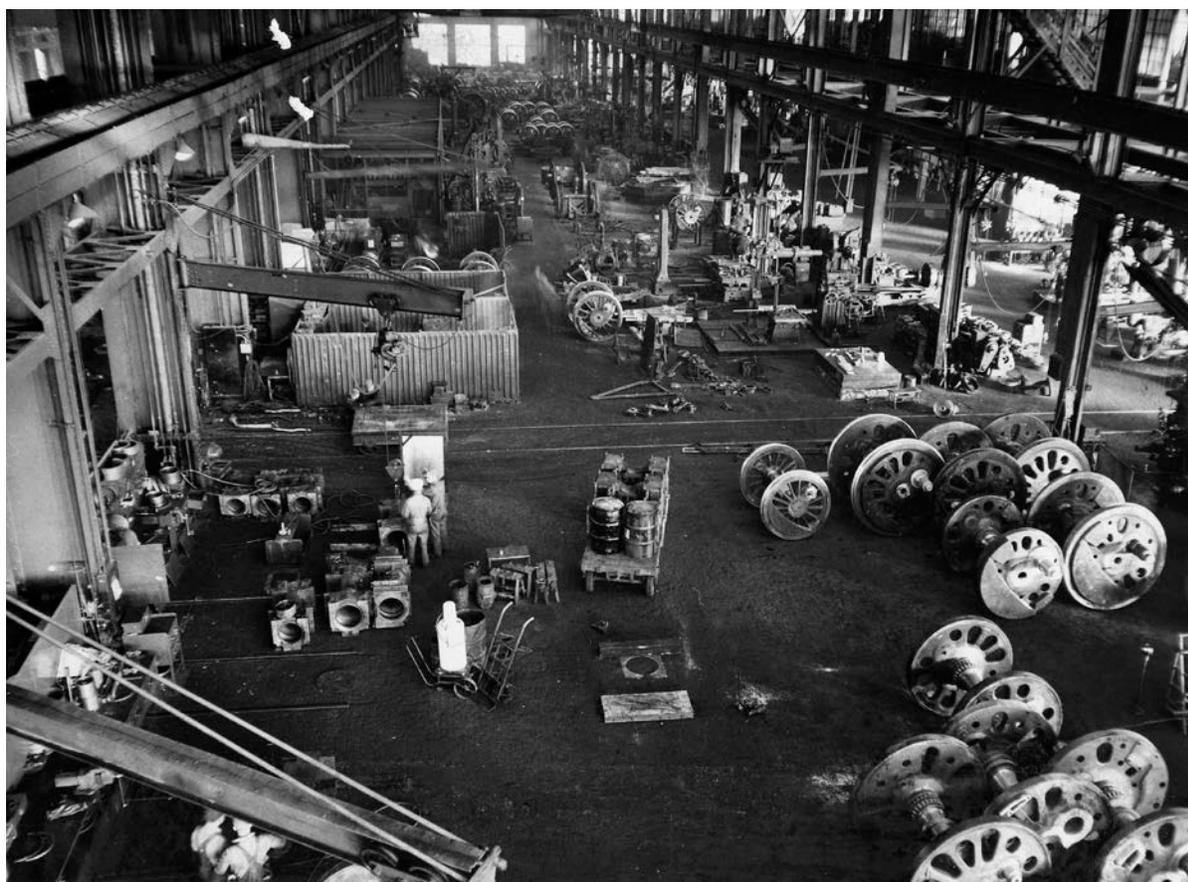
*Figure 4. Locomotive parts in the heavy machinery bay, looking east.*

The heavy machinery bay is 65 feet wide, runs the full length of the machine shop, and has 35 feet of clear height. It is well illuminated in daylight by twenty-three skylights. Its crane rail matches heights with the lower crane rail of the neighboring erecting bay. As indicated by the name, this bay was where especially heavy locomotive parts such as driver wheel sets were repaired. It had two 15-ton capacity bridge cranes and many jib cranes mounted on the building's columns. One of this bay's bridge cranes remains but none of the jib cranes. The tool room for hand tools remains near the midpoint of the bay's north side, but part of its original steel panel-and-mesh partition has been removed.

The light machinery bay's original 5-ton-capacity monorail crane has been removed. The monorail crane ran along the centerline of the bay, supported from above by a balcony-level grid of I-sections riveted together and connected to the roof trusses above. Also missing are the many jib cranes that lined this bay (See Figure 4).

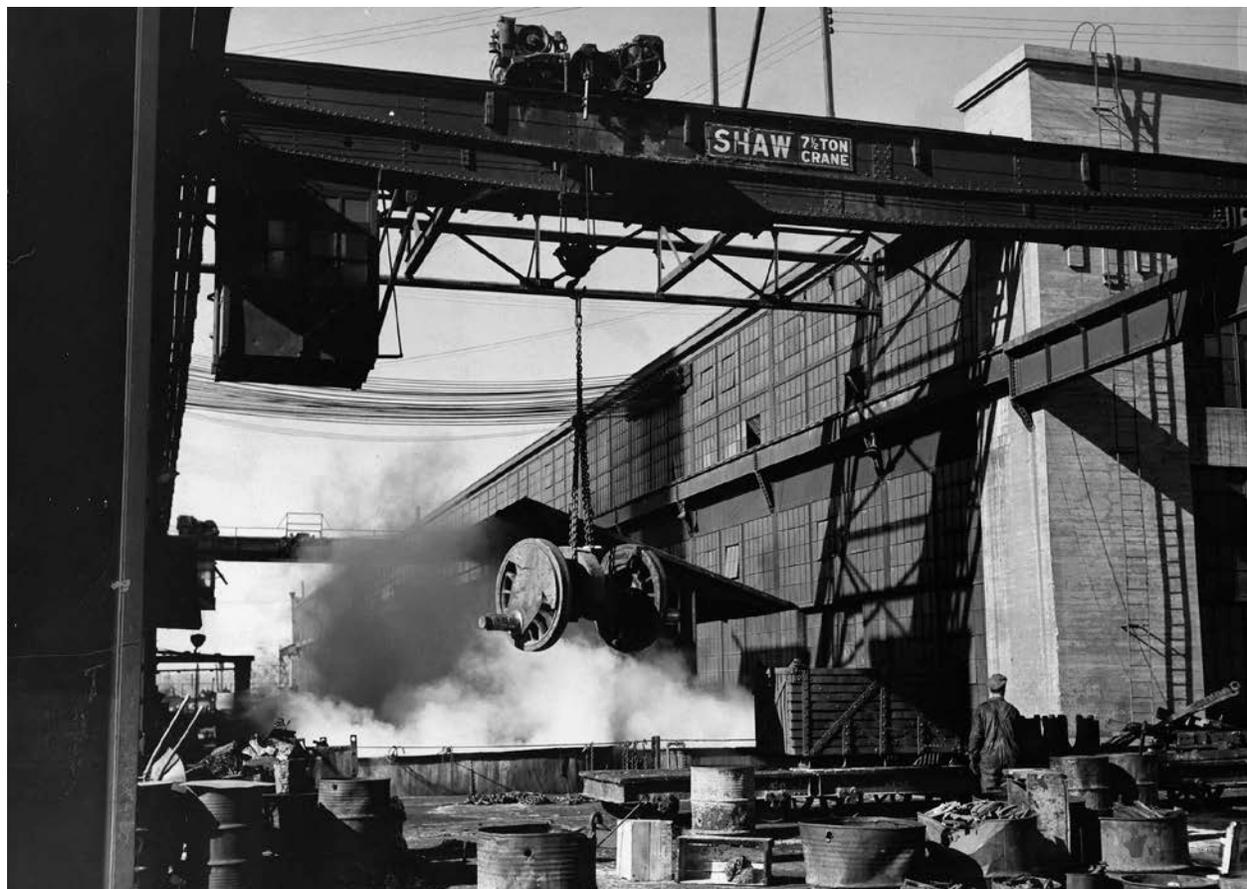
*Figure 5. Crane runway with bridge cranes on the south side of the machine shop.*

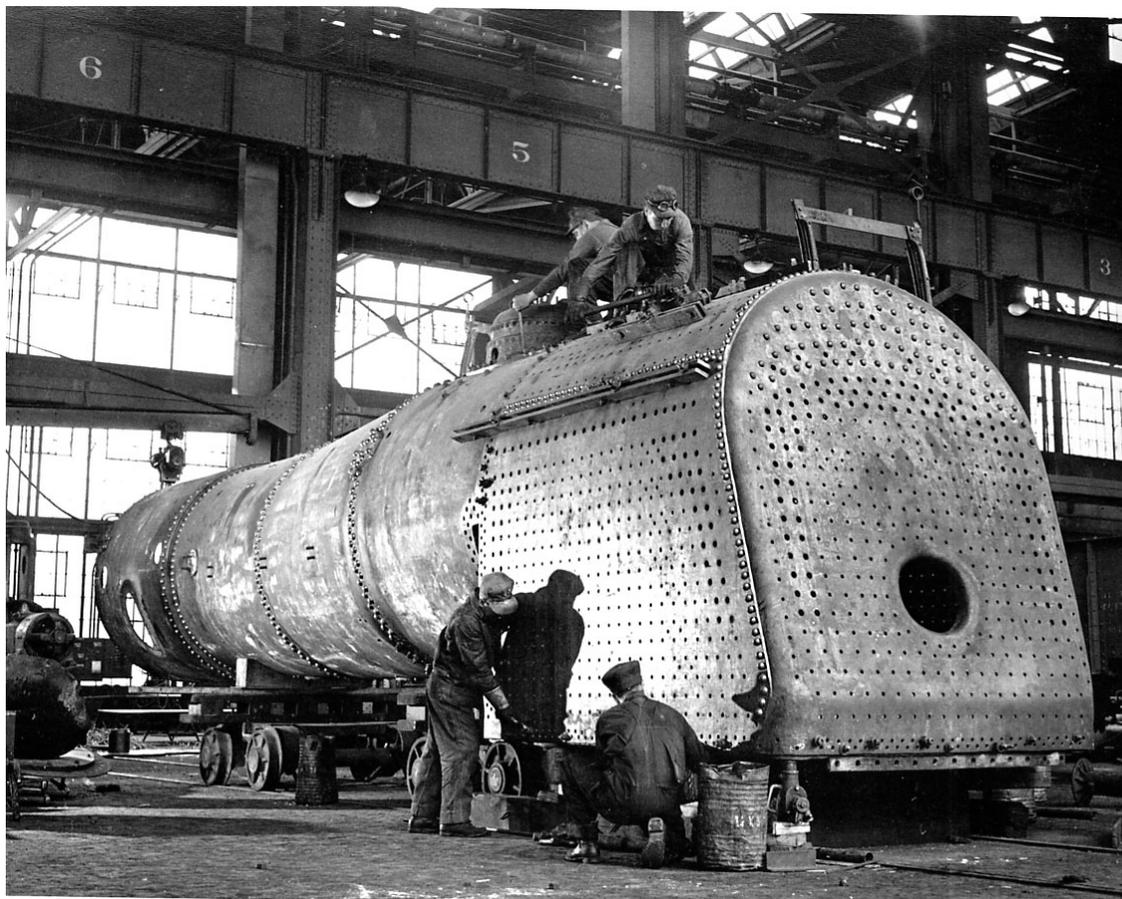
*Figure 6. Working on the fire box of an engine, in the boiler shop.*

The boiler shop stands just north of the machine shop, joined by the transfer table. Repair and rebuilding of boilers and fireboxes took place in the boiler shop. This included installation of new braces, flue sheets, tubes and flues, entire new boiler courses, new fireboxes, replacement of broken stays, boiler and fire box side sheet patches, and similar work (See Figure 6).

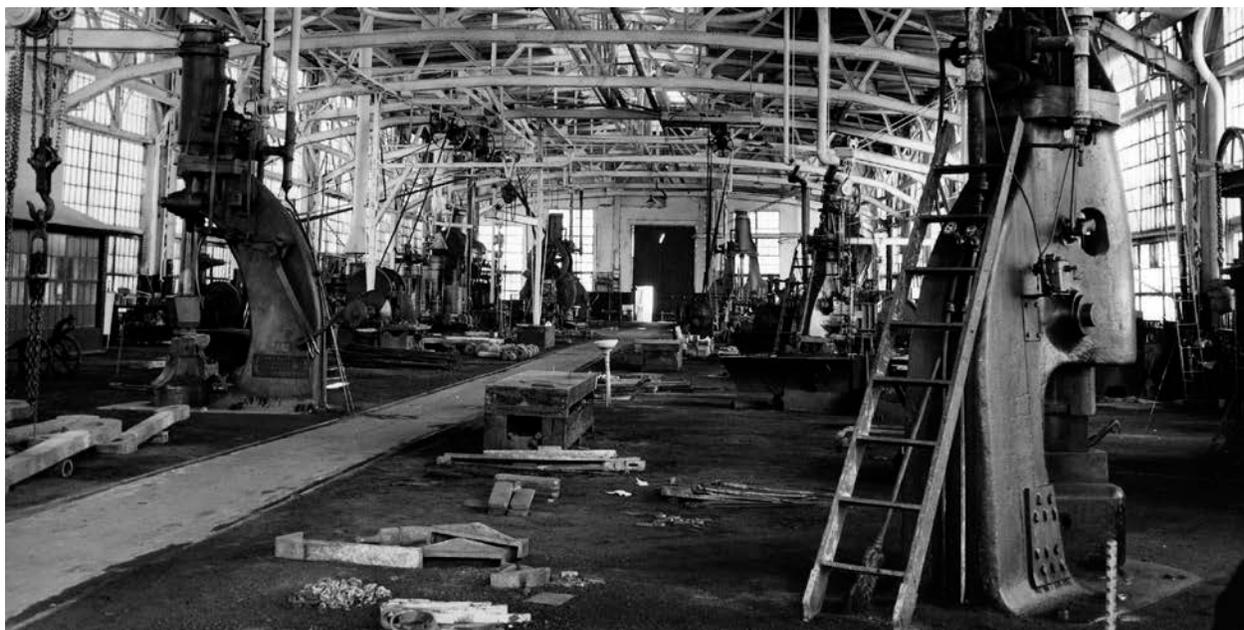
*Figure 7. View of blacksmith shop interior with presses. Steel trusses span the full width of the blacksmith shop.*

The blacksmith shop has the third largest floor area of the buildings in the district and measures 80 feet by 306 feet in plan. There are thirteen structural bays, and the built-up steel

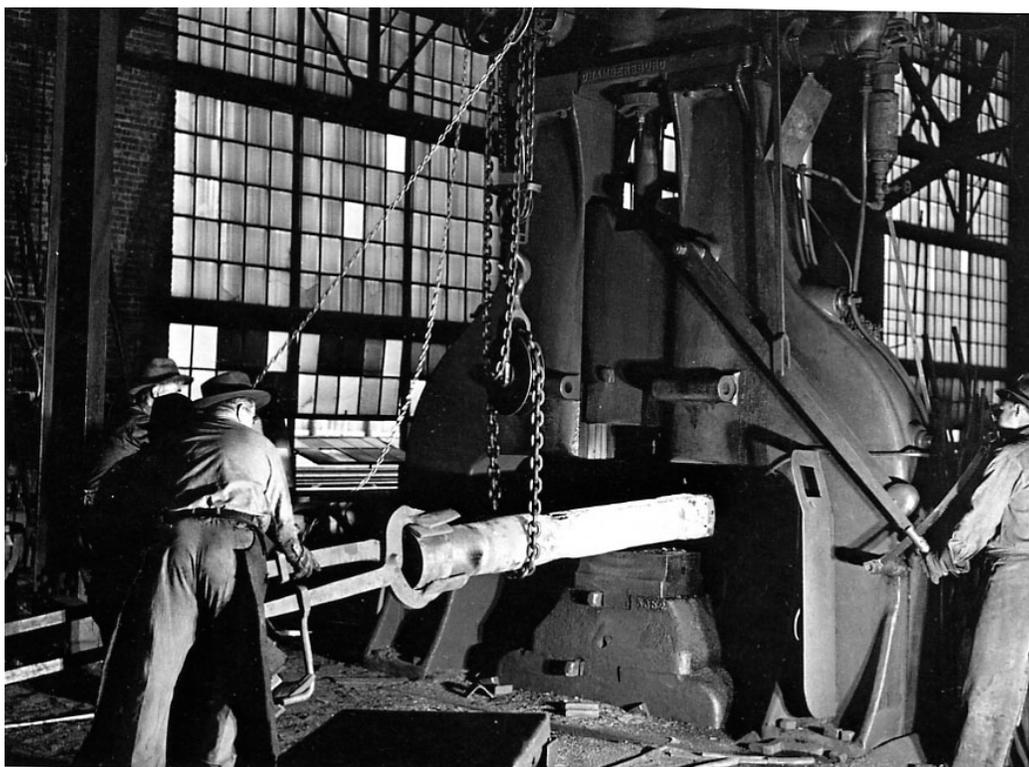
*Figure 8. Hammering out a drawbar under the steam hammer in the blacksmith shop.*

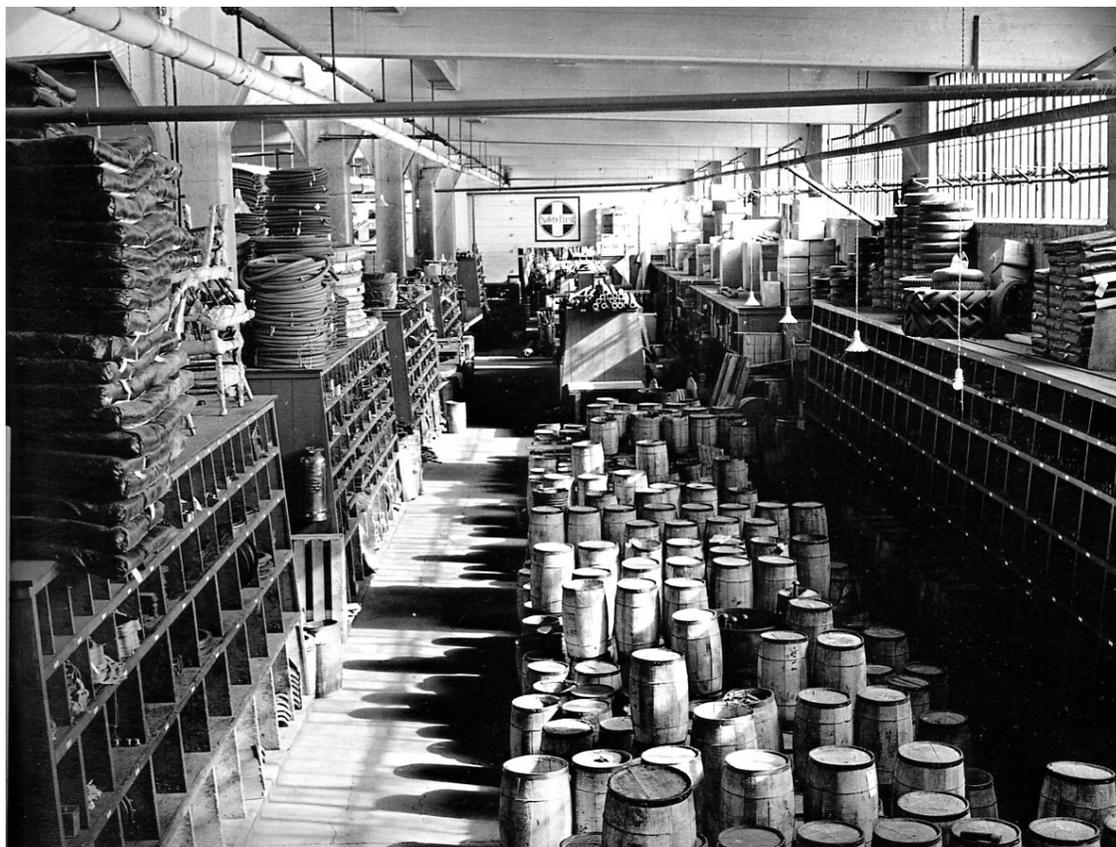
*Figure 9. Storehouse interior with materials in stock, part of the store department, which carried over 35,000 different items.*

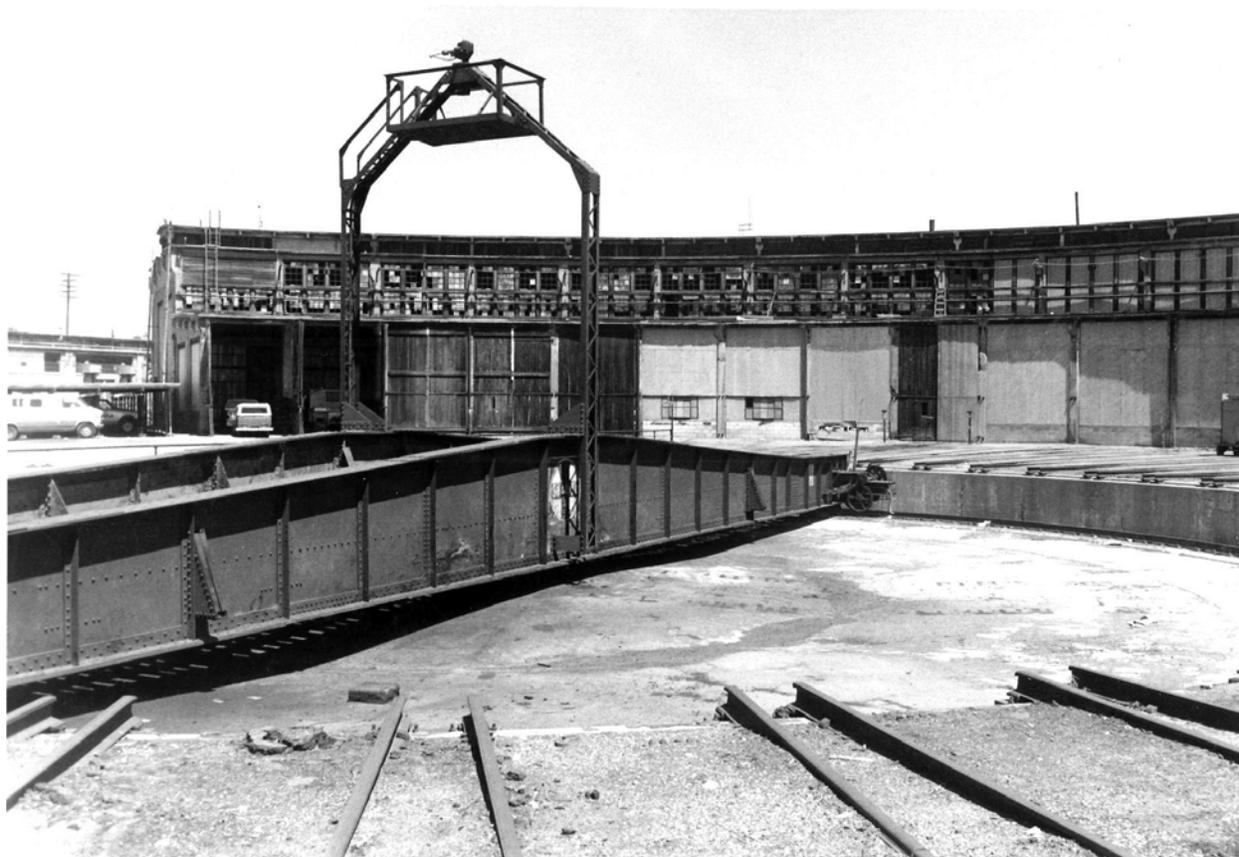
*Figure 10. Turntable with roundhouse in background. Roundhouse was demolished in 1986.*

The turntable is a remnant of the 1924 roundhouse (See Figure 10) located at the center of the southern portion of the district south of the machine shop. The plate girder steel turntable with head frame is set in a 120 foot – diameter, 4 foot deep cylindrical pit with poured concrete walls. Motorized by an internal combustion engine, the turntable is still operable and used occasionally by the BN & SF Railroad who currently owns an access easement from its adjacent property.

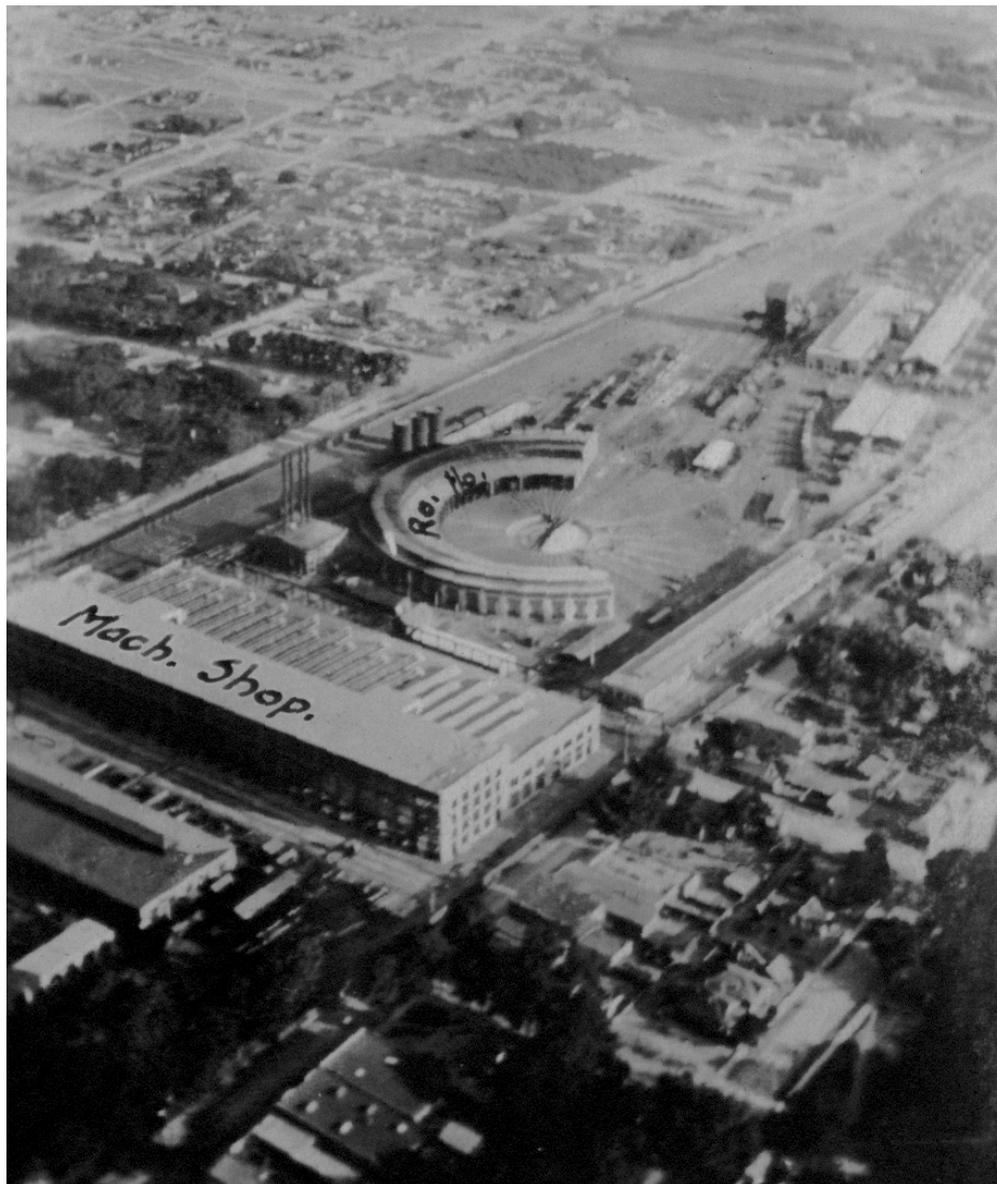
*Figure 11. Aerial view looking southwest showing the 1915 roundhouse, reservoir and tanks, the power house with smokestack, and machine shop.*

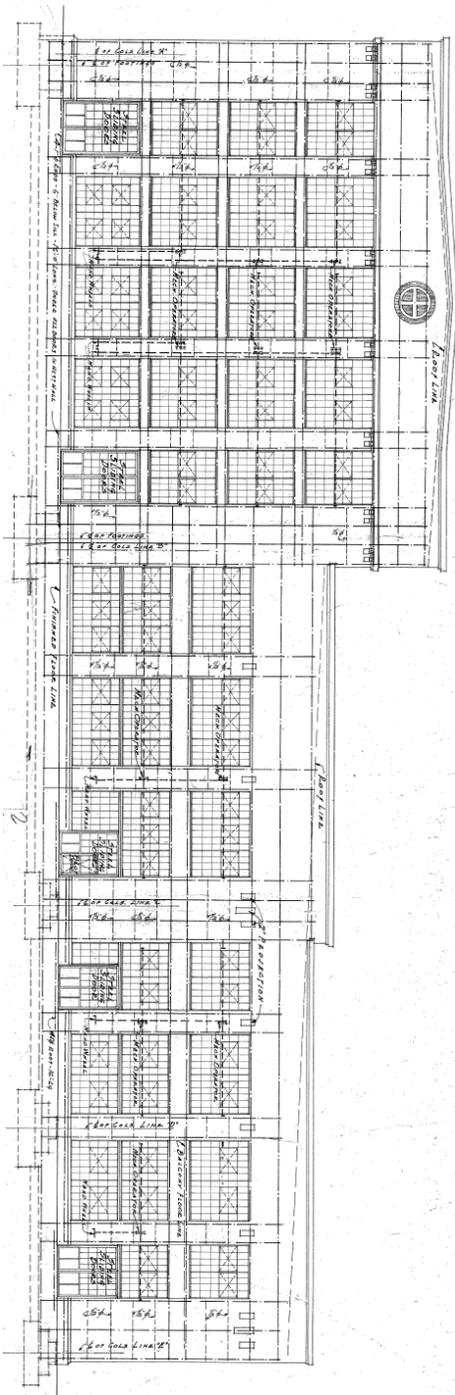
Figure 14. West elevation drawing of machine shop. AT & SF Engineers, drawing, c.1920

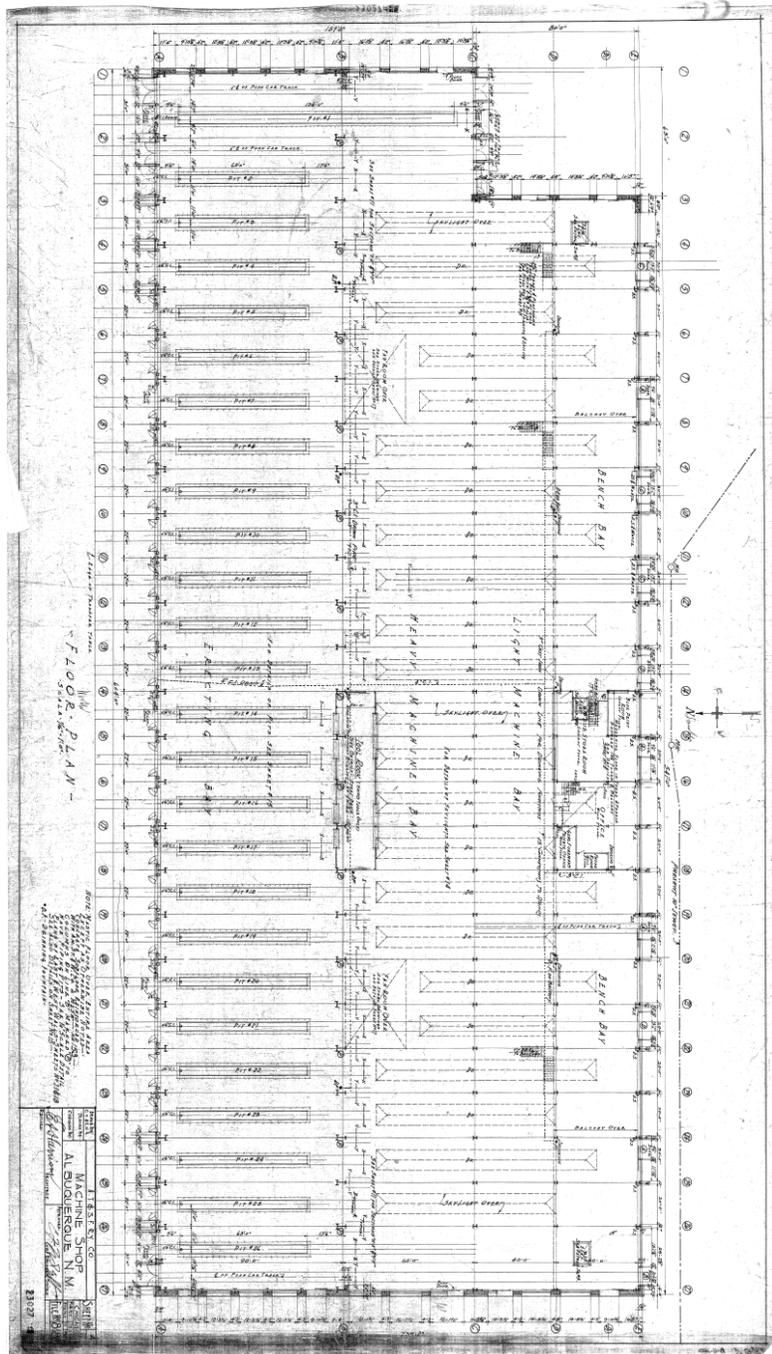
Figure 15. Floor Plan of machine shop. AT & SF Engineers, drawing, c.1920

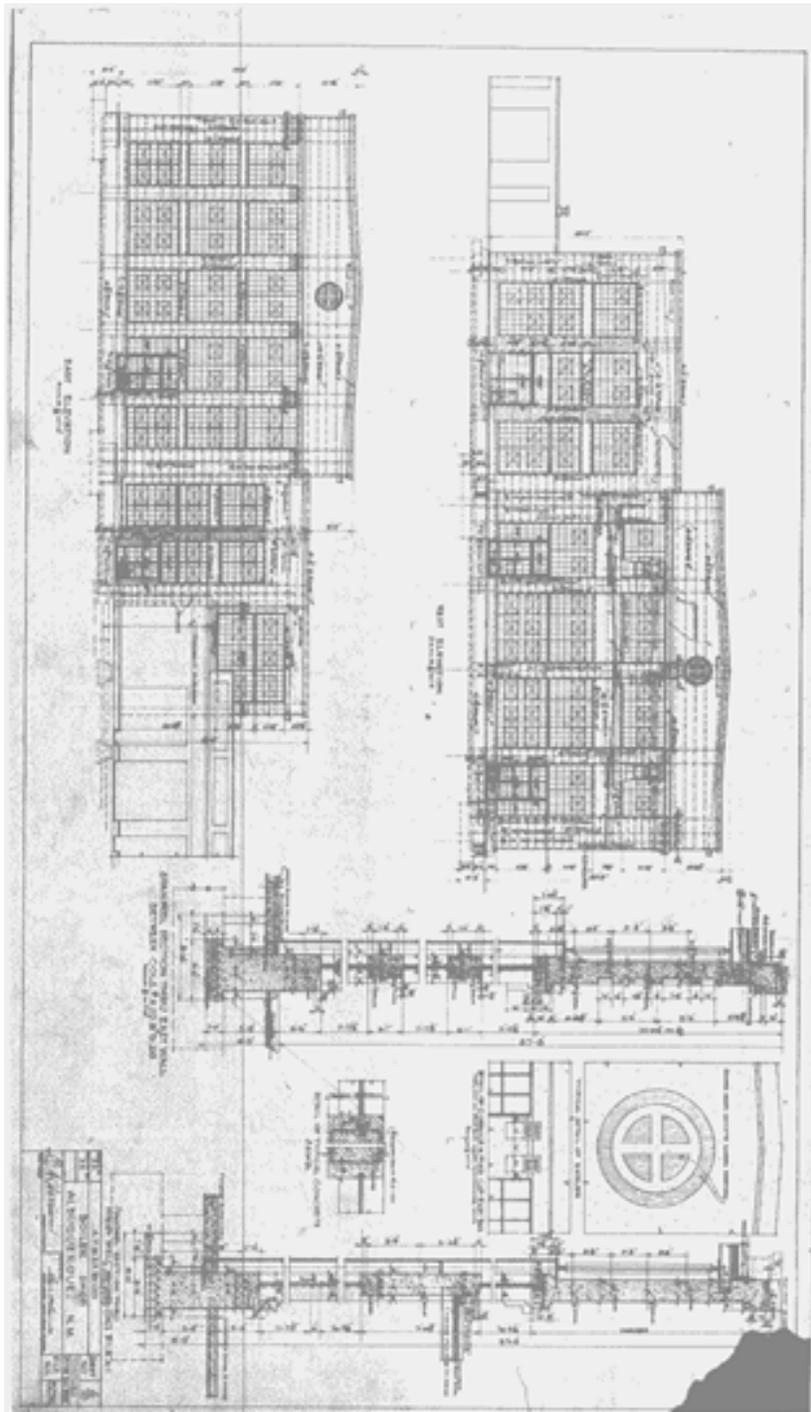
Figure 16. East and west elevations of boiler shop. Drawn by AT & SF engineers, drawing ca. 1922

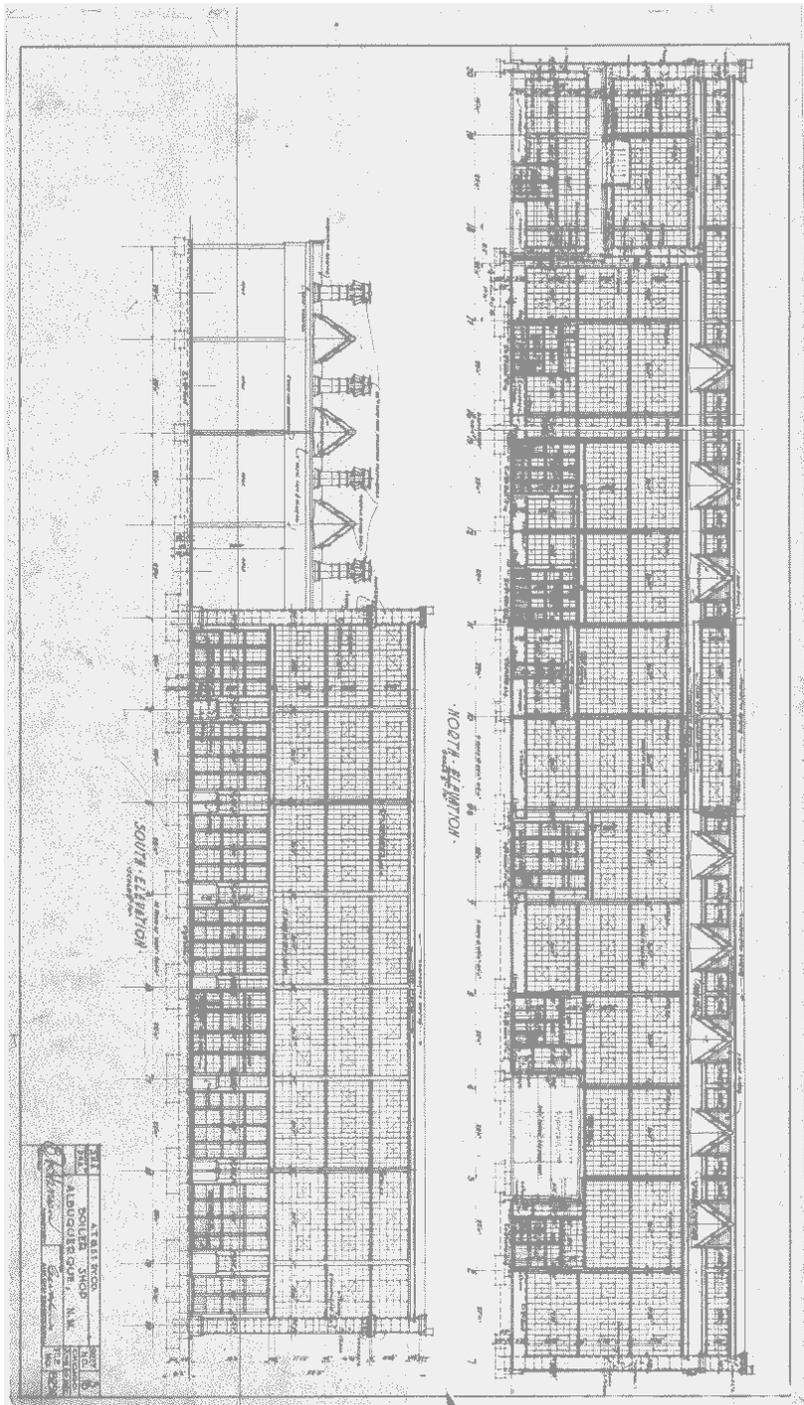
Figure 17. North and South elevations of boiler shop; note original configuration of firing shed. Drawn by AT & SF engineers, drawing ca. 1922

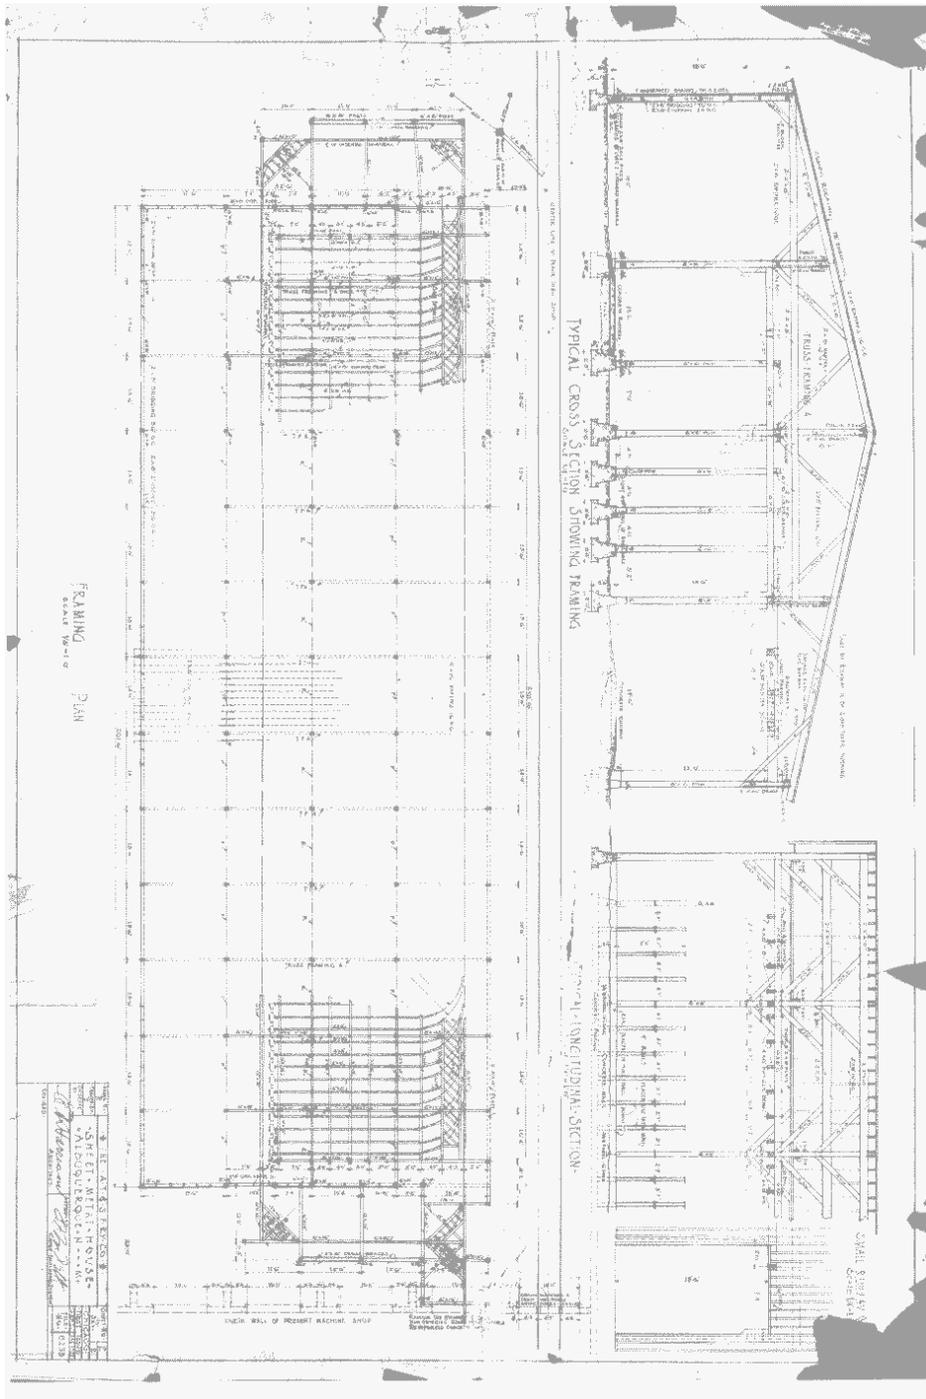
Figure 18. Plan and sections of sheet metal house. Drawn by AT & SF engineers, drawing ca. 1917

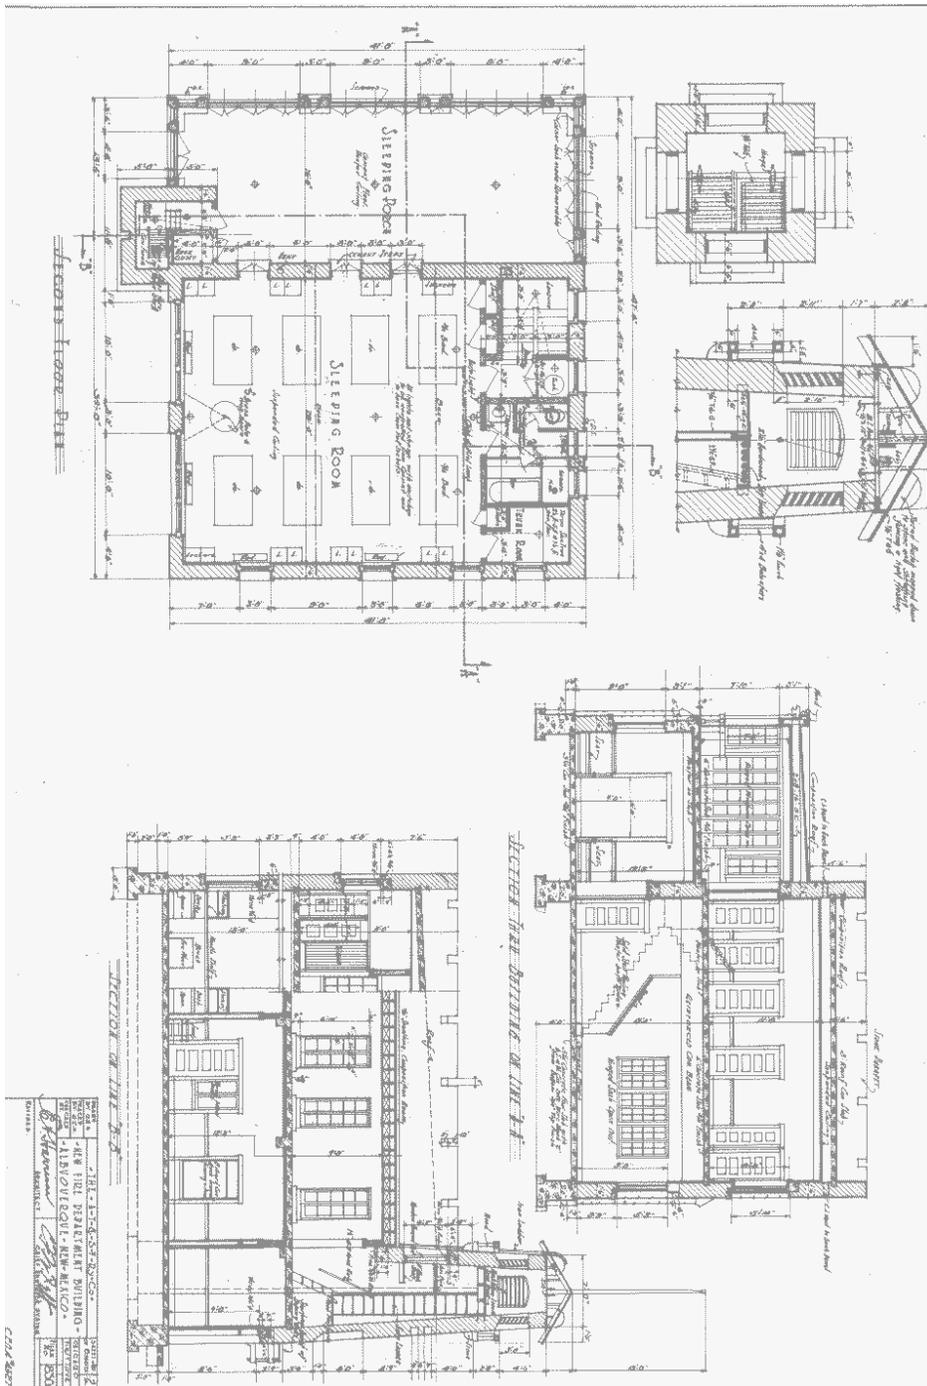
Figure 21. Construction drawing showing plan, sections and tower details. Drawn by AT & SF engineers, drawing ca. 1919

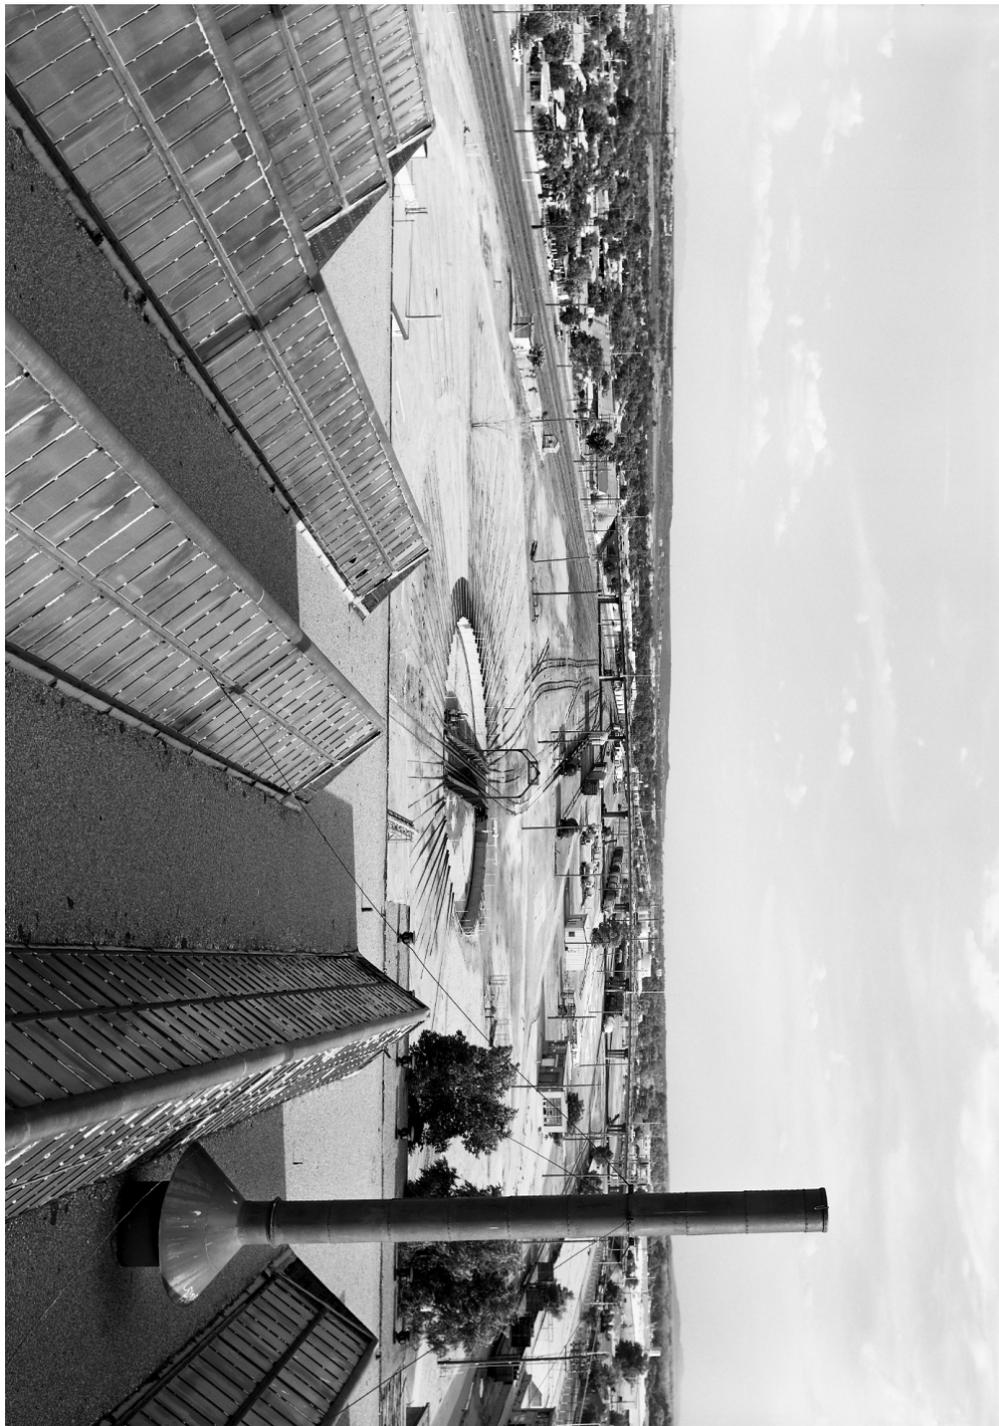
Figure 22. Turntable seen from roof of machine shop looking south. Photograph by Jet Lowe, April 8, 2009
---
