Locations of the Public Calls in 2014

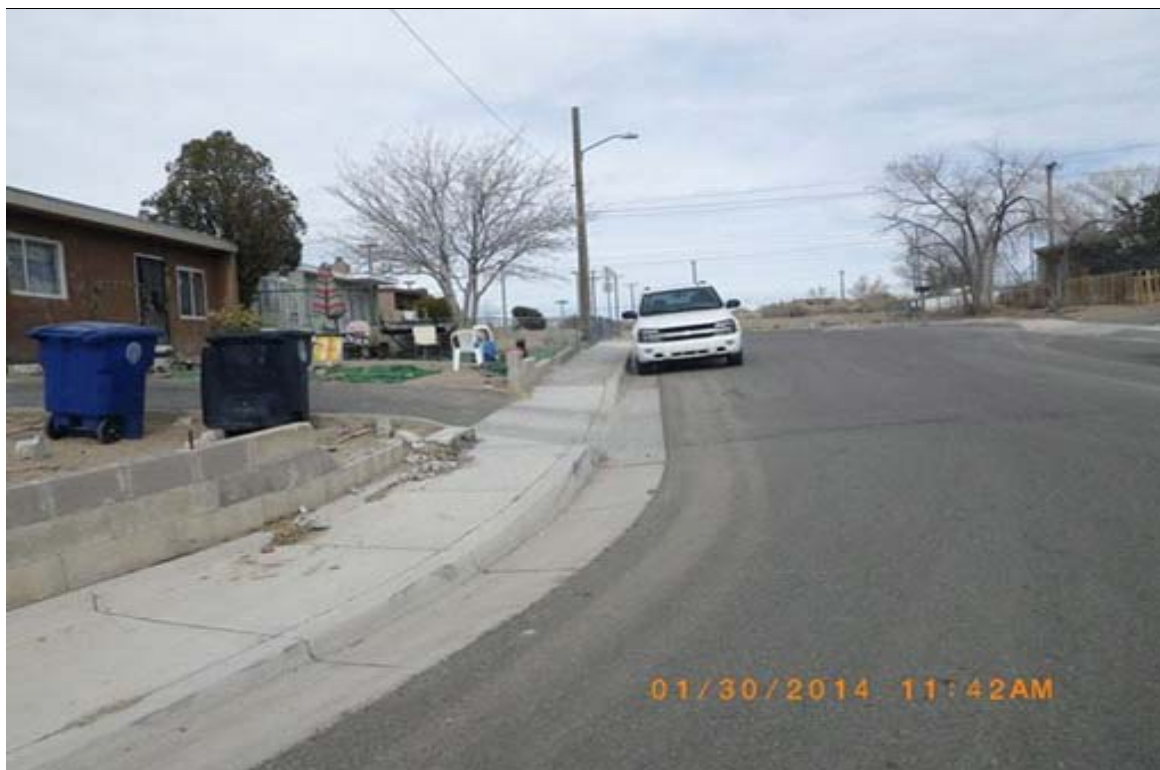
Address	2509 MESA ST SE				
Event ID	384	REPORTING SOURCE	311	Complaint Date	1/28/2014
CUSTOMER	STREET MAINTENANCE-G		311CASE ID	12080688	e-mail
CUSTOMER Ph#	857-8052	SharePointLink: http://sharepoint.cabq.gov/dmd/storm/STORMWATER%20POLLUTION			
Description:	STREET URGENT PARKED CAR IS LEAKING OIL ONTO THE STREET.				
Suspected Facility	HOME		Type of Complaint	OIL	
Inspection Date	1/30/2014	Number of Field Visits	1	Inspector	SK
Facility Contact	NA	Facility Ph. #			
FIELD OBSERVATION	I DID NOT SEE ANY OIL SPOTS OR LEAKING CAR AT THIS ADDRESS.				
INITIAL ACTION	I DISTRIBUTED POLLUTION PREVENTION BROCHURES AT THIS NEIGHBORHOOD.

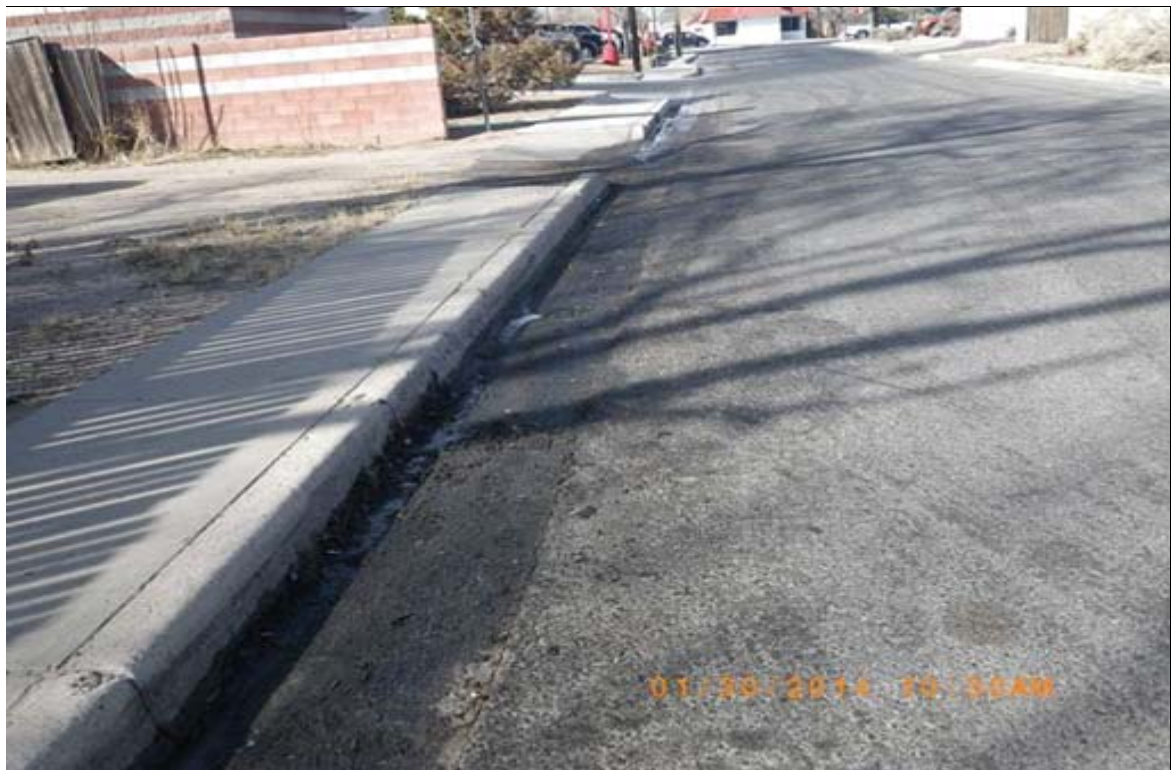
Address	MCDONALDS AT 5324 4TH ST NW				
Event ID	382	REPORTING SOURCE	311	Complaint Date	1/29/2014
CUSTOMER	STEVEN SANCHEZ		311CASE ID	12091326	e-mail na
CUSTOMER Ph#	261-4325		SharePointLink: http://sharepoint.cabq.gov/dmd/storm/STORMWATER%20POLLUTION		
Description:	CITIZEN REPORTING MCDONALDS ON 4TH AND HENDRIX HAS BEEN CLEANING OUT THEIR DUMPSTER AND THE GREASE FROM IT HAS BEEN DRAINING INTO AND INLET INFRONT OF 232 HENDRIX ON THE SOUTHSIDE OF HENDRIX. NO DROP DOWN APPROPRIATE				
Suspected Facility	MCDONALDS		Type of Complaint	COOKING GREASE	
Inspection Date	1/30/2014		Number of Field Visits	1	Inspector SK
Facility Contact	MANAGER		Facility Ph. #	344-6314	
FIELD OBSERVATION	I SAW GREASE COMING OUT FROM THE DUMPESTER AREA. I SPOKE TO THE MANAGER ON THIS ISSUE BUT HE DID NOT KNEW HOW IT HAPPENED.				
INITIAL ACTION	I ASKED HIM TO CLEAN UP THE AREA AND TO MAKE SURE THAT HIS GREASE TANK DO NOT OVERFLOW, ALSO I GAVE HIM SOME POLLUTION PREVENTION BROCHURES.

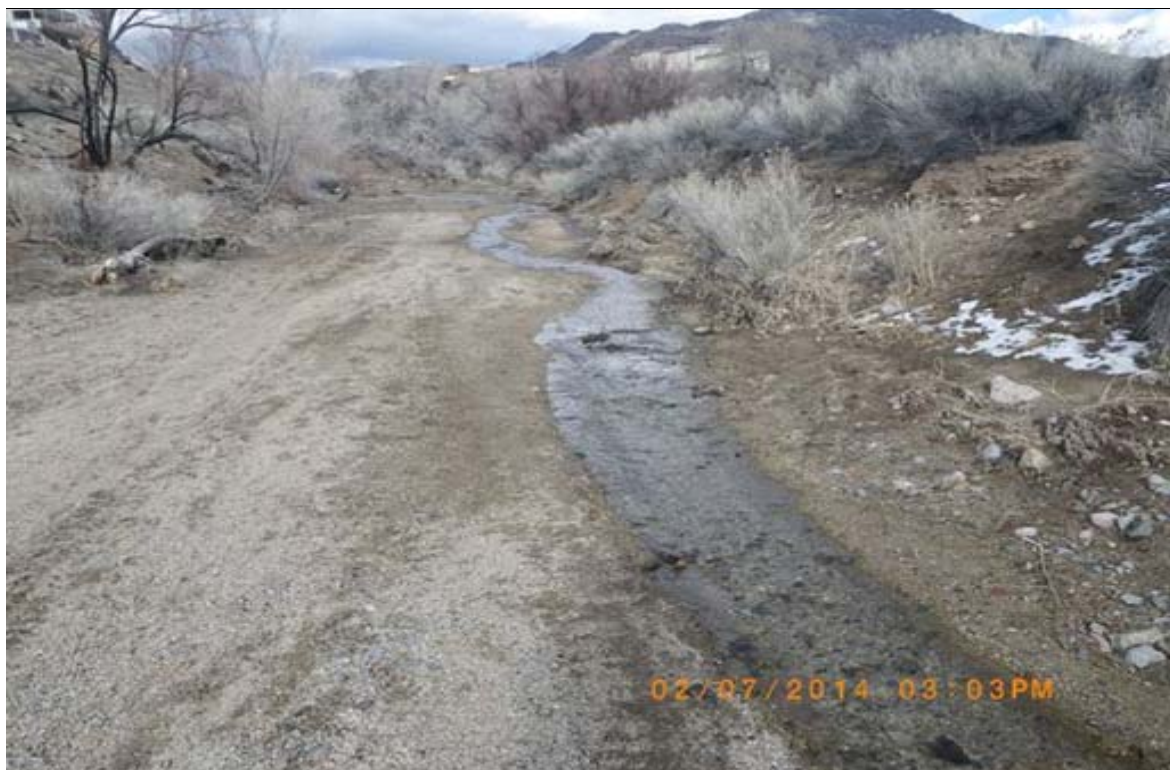
Address	TIJERAS ARROYO EAST OF 4 HILLS				
Event ID	389	REPORTING SOURCE	WEB	Complaint Date	2/6/2014
CUSTOMER	TOM ST. AUBIN	311CASE ID	WEB	e-mail	saintaubin@juno.com
CUSTOMER Ph#	717-1373	SharePointLink: http://sharepoint.cabq.gov/dmd/storm/STORMWATER%20POLLUTION			
Description:	CARPET REMNANTS,PLASTIC STORAGE BIN PARTS, WOOD CRATE.OIL CONTAINERS				
Suspected Facility	ARROYO	Type of Complaint	TRASH		
Inspection Date	2/7/2014	Number of Field Visits	1	Inspector	SK
Facility Contact	NA	Facility Ph. #	na		
FIELD OBSERVATION	I DID NOT SEE ANY OF THE LISTED ITEMS.				
INITIAL ACTION	I E-MAILED THE REPORTER ASKING A BETTER DESCRIPTION OF THE LOCATION, BUT I DID NOT RECEIVE ANY RESPONSE FROM HIM.

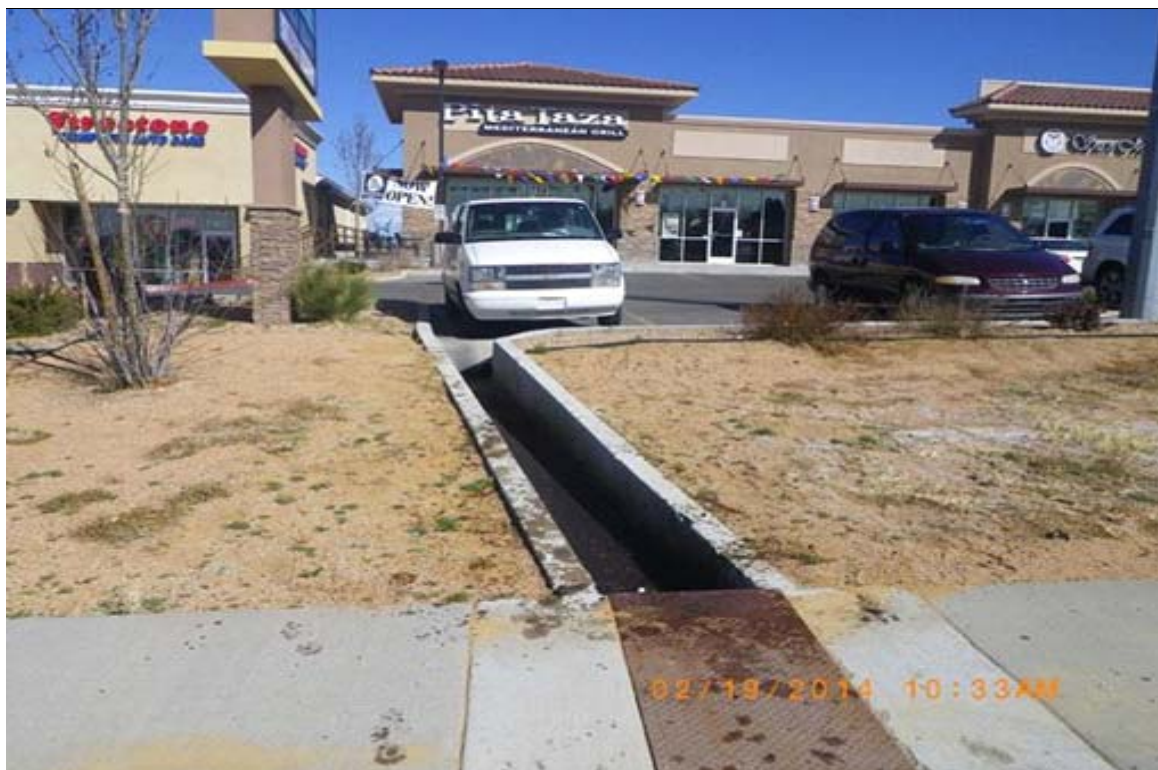
Address	PITA TAZA GRILL AT 7441-A PASEO DEL NORTE				
Event ID	390	REPORTING SOURCE	E-MAIL	Complaint Date	2/14/2014
CUSTOMER	NMDOT	311CASE ID	E-MAIL	e-mail	TimothyR.Trujillo@state.nm.us
CUSTOMER Ph#	798-6690	SharePointLink: http://sharepoint.cabq.gov/dmd/storm/STORMWATER%20POLLUTION			
Description:	GREASE ENTERING THE ROW OF NMDOT FROM THIS RESTURANT				
Suspected Facility	PITA TAZA GRILL	Type of Complaint	COOKING GREASE		
Inspection Date	2/19/2014	Number of Field Visits	1	Inspector	SK
Facility Contact	MANAGER	Facility Ph. #			
FIELD OBSERVATION	I SPOKE TO THE MANAGER ON THIS ISSUE, HE TOLD ME THAT IT WAS AN ACCIDENT THAT THE GREASE TANK SPILL. HE SAID THAT HE HIRED ATLAS CLEAN UP SERVICES TO DEGREASE ALL THESE AREAS AND DISPOSE THE WASTE.				
INITIAL ACTION	I GAVE HIM POLLUTION PREVENTION BROCHURES.

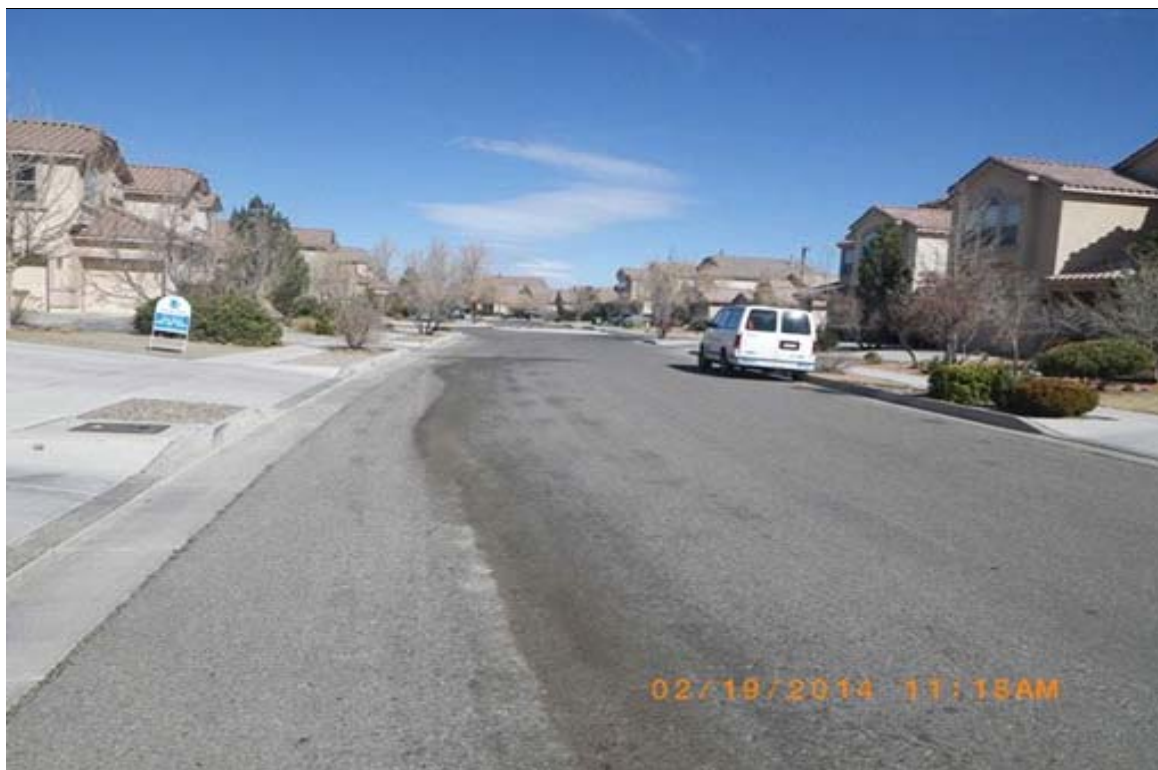
Address	10427 CANTACIELO NW				
Event ID	392	REPORTING SOURCE	311	Complaint Date	2/19/2014
CUSTOMER	JENNIFER PEREZ		311CASE ID	12139891	e-mail
CUSTOMER Ph#	702-5533	SharePointLink: http://sharepoint.cabq.gov/dmd/storm/STORMWATER%20POLLUTION			
Description:	OIL SPILLED IN MIDDLE OF THE STREET				
Suspected Facility	STREET		Type of Complaint	OIL	
Inspection Date	2/19/2014	Number of Field Visits	1	Inspector	SK
Facility Contact	NA		Facility Ph. #	na	
FIELD OBSERVATION	I SAW A BIG DRIED OIL/HYDRAULIC FLUID SPOT AT 10423 AND 10427 CANTACIELO NW, IT WAS COMPLETELY DRIED AND IT DID NOT NEED TO TAKE FURTHER ACTION.				
INITIAL ACTION	NO ACTION NEEDED

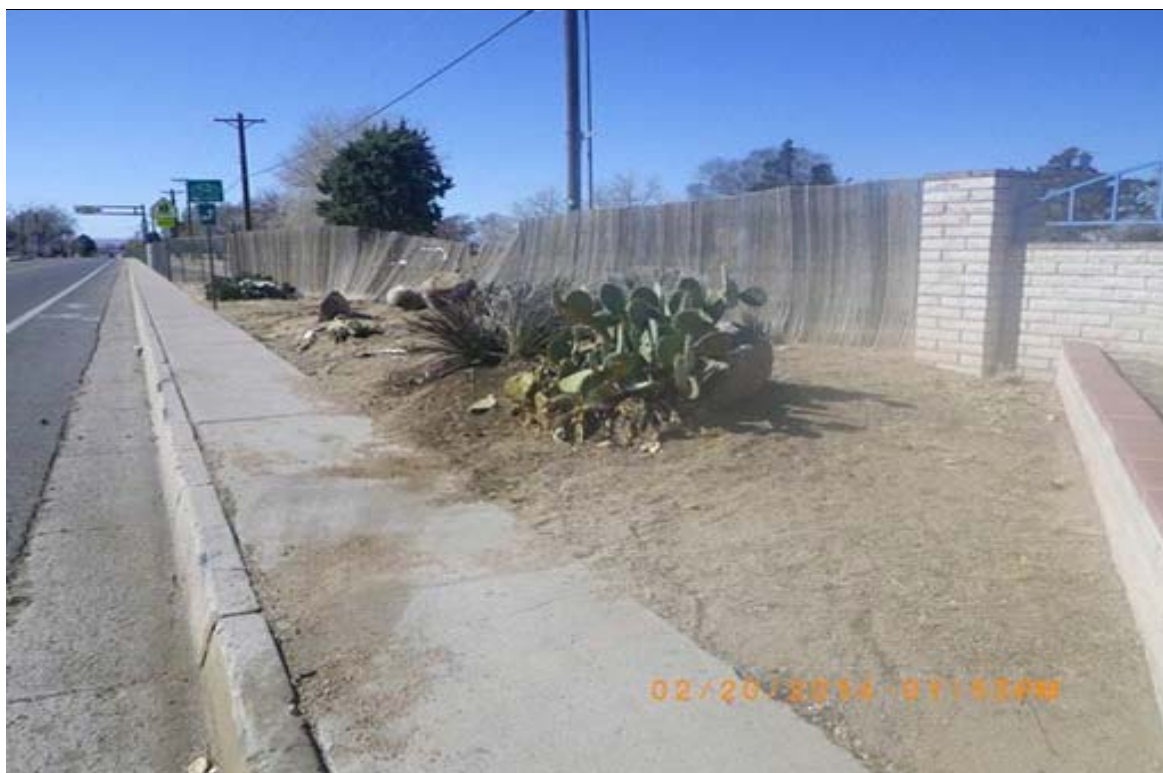
Address	LOS ALTOS PARK AT COPPER AND ERBBE				
Event ID	393	REPORTING SOURCE	PH CALL	Complaint Date	2/20/2014
CUSTOMER	DAVID SALAS	311CASE ID	E-MAL	e-mail	na
CUSTOMER Ph#	768-5347	SharePointLink: http://sharepoint.cabq.gov/dmd/storm/STORMWATER%20POLLUTION			
Description:	THERE WAS A VEHICLE ACCIDENT (CAR RAN OVER THE FENCE INTO CITY PROPERTY) THAT OCCURRED NEAR THE LOS ALTOS GOLF COURSE WHICH CAUSED MOTOR OIL TO BE SPILLED ON CITY PROPERTY.HOW TO HANDLE THE SPILL.				
Suspected Facility	CITY PARK	Type of Complaint	OIL		
Inspection Date	2/20/2014	Number of Field Visits	1	Inspector	SK
Facility Contact	NA	Facility Ph. #	na		
FIELD OBSERVATION	THERE WAS A MINOR OIL SPILL ON THE SAND				
INITIAL ACTION	KATHEY ASKED THE PARK MANAGER TO REMOVE THE OILED SAND

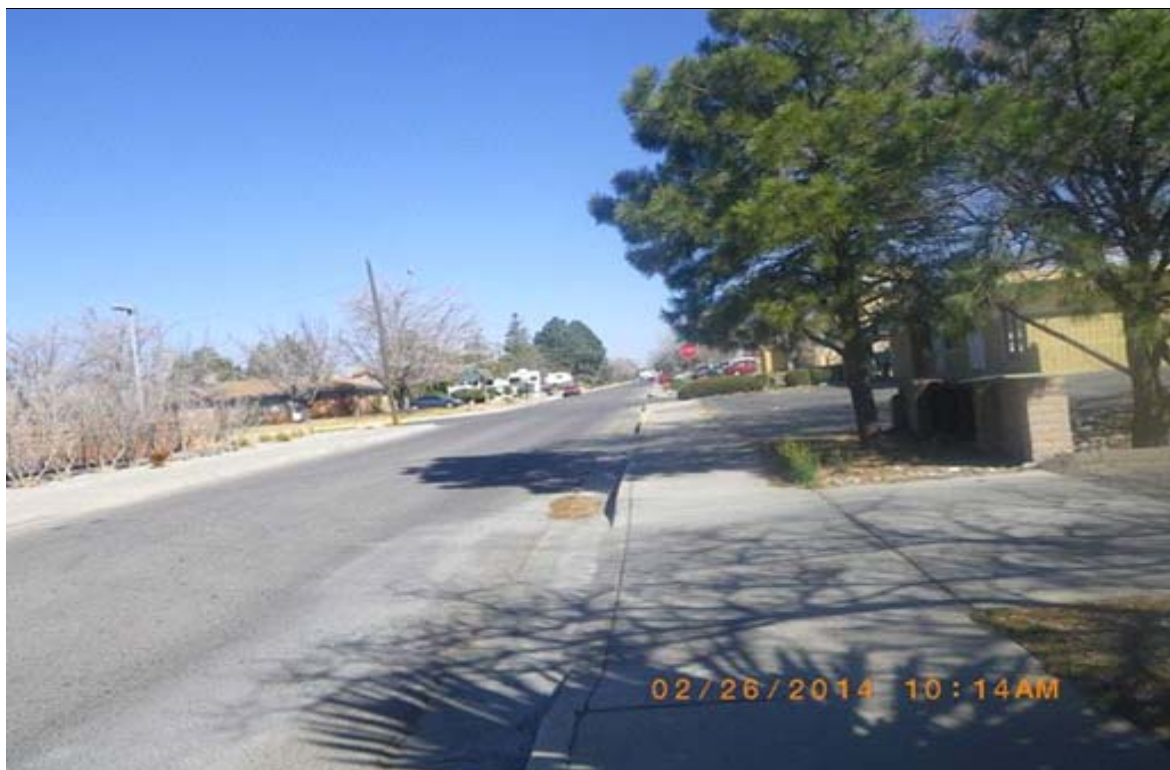
Address	2620 TENNESSEE NE		
Event ID	391	REPORTING SOURCE	311
		Complaint Date	2/24/2014
CUSTOMER	RON RUSSELL	311CASE ID	12187057
		e-mail	
CUSTOMER Ph#	489-3968	SharePointLink: http://sharepoint.cabq.gov/dmd/storm/STORMWATER%20POLLUTION	
Description:	PAINTERS OF A BUILDING ALLOWED PAINTS TO RUN INTO GUTTER.		
Suspected Facility	RESIDENT	Type of Complaint	PAINT
Inspection Date	2/26/2014	Number of Field Visits	1
		Inspector	
Facility Contact	RESIDENT	Facility Ph. #	na
FIELD OBSERVATION	I SAW A BIG DRY PAINT RESIDUE AT THIS LOCATION		
INITIAL ACTION	NO BODY WAS HOME, I DISTRIBUTED POLLUTION PREVENTION BROCHURES AT THIS NEIGHBORHOOD

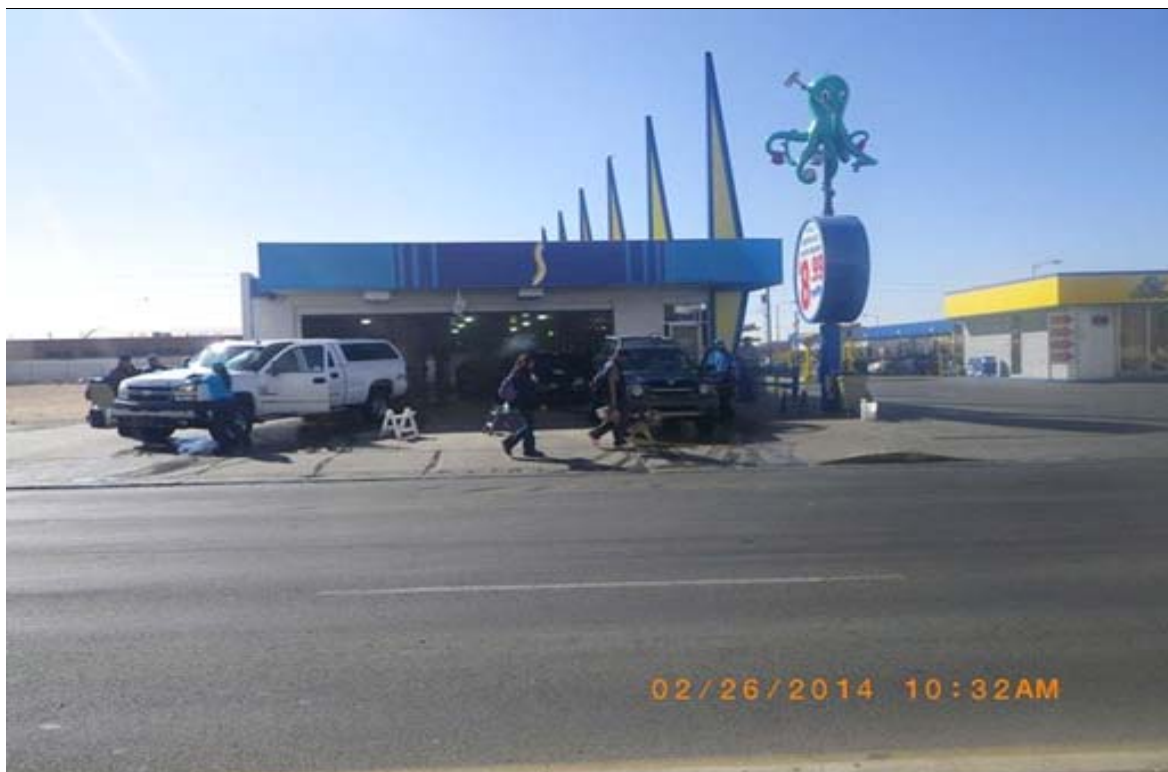
Address	5308 CENTRAL SE-				
Event ID	394	REPORTING SOURCE	Complaint Date		2/24/2014
CUSTOMER	BRANDY CABIC	311CASE ID	12182961	e-mail	
CUSTOMER Ph#	203-3315	SharePointLink: http://sharepoint.cabq.gov/dmd/storm/STORMWATER%20POLLUTION			
Description:	COOLANTS AND ANTIFREEZE IS DRAINING FROM THE BUSINESS OUT INTO THE STREET				
Suspected Facility	OCTOPUS CAR WASH	Type of Complaint		COLORD LIQUID	
Inspection Date	2/26/2014	Number of Field Visits	1	Inspector	SK
Facility Contact	MANAGER LUIS RAMIREZ	Facility Ph. #	265-1507		
FIELD OBSERVATION	THE GREEN LIQUID DRIPPING FROM THE WASHED CARS IS NOT COOLANT, IT IS A DYE ADDED TO THE CARWASH WATER STREAM JETS, IT IS ENVIRONMENTALLY SAFE.				
INITIAL ACTION	I ASKED THE MANAGER TO TRY TO KEEP THE DRAINING WATER TO THE GUTTER IS MINIMUM AS POSSIBLE. I GAVE HIM SOME OF POLLUTION PREVENTION BROCHURES FOR HIS EMPLOYEE.

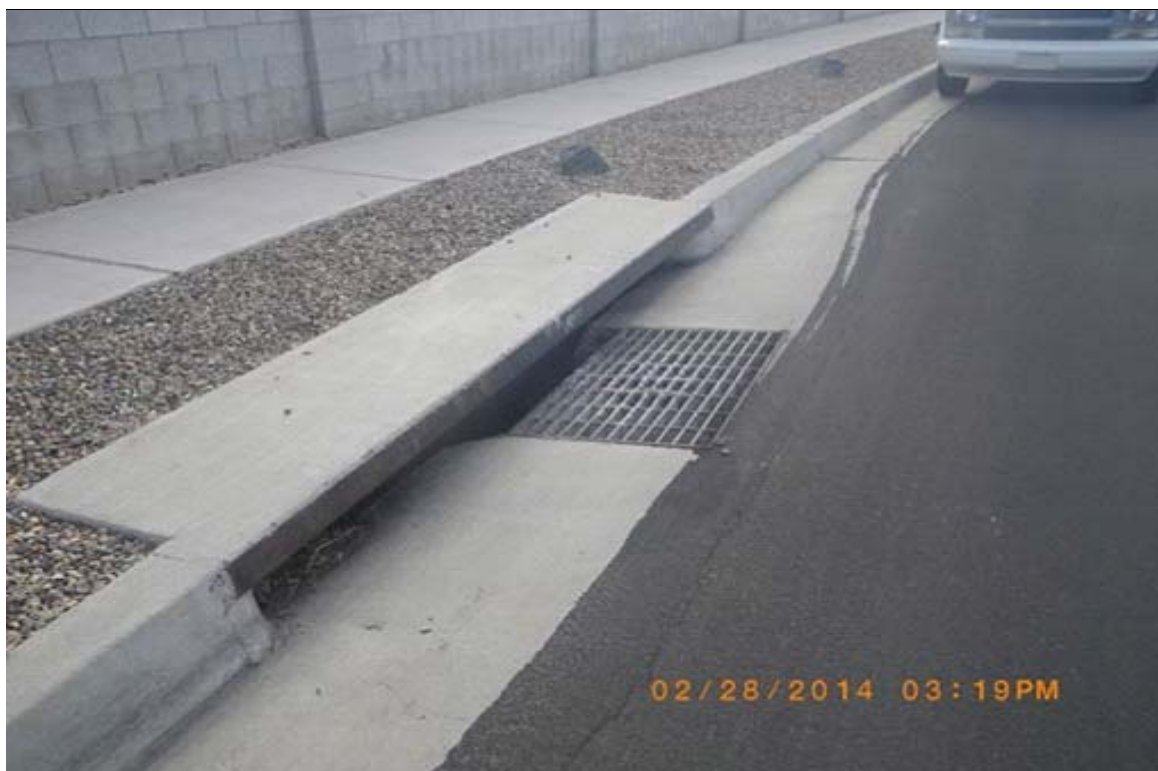
Address	<div>10554 VISTA BELLA PL NW</div>				
Event ID	<div>396</div>	REPORTING SOURCE	Complaint Date		<div>2/28/2014</div>
CUSTOMER	<div>DAVID MUELLER</div>	311CASE ID	<div>12182390</div>	e-mail	<div>NA</div>
CUSTOMER Ph#	<div>898-1991</div>	SharePointLink: http://sharepoint.cabq.gov/dmd/storm/STORMWATER%20POLLUTION			
Description:	<div>THERE WAS A VAN THAT DUMPED SOME ITEMS IN THE INLET STORM DRAIN AT THIS LOCATION. A WHITE VAN THAT SAYS UPHOLSTERY AND CARPET CLEANING 417-9530 THAT IS DUMPING LIQUIDS INTO STORM SEWER.THIS VAN DUMPED LAS 2 TIMES.</div>				
Suspected Facility	<div>CARPET CLEANING CO</div>	Type of Complaint		<div>CARPET CLEANING</div>	
Inspection Date	<div>2/28/2014</div>	Number of Field Visits	<div>1</div>	Inspector	<div>SK</div>
Facility Contact	<div>MANAGER</div>	Facility Ph. #	<div>417-9530</div>		
FIELD OBSERVATION	<div>I VISIT THE SITE ON 2-28-2014 AND I DID NOT SEE ANY KIND OF DERBIES ON THE STORM INLET GRATES.I ALSO SPOKE TO THE CALLER.</div>

INITIAL ACTION	<div>I SPOKE TO THE MANAGER OF THIS CARPET CLEANING CO REGARDING THIS INCIDENT, HE TOLD ME THAT THEY JUST DUMPED CLEAN WATER TO EMPTY THEIR TANK. I ALSO DISTRIBUTED POLLUTION PREVENTION BROCHURES AT THIS NEIGHBORHOOD</div>

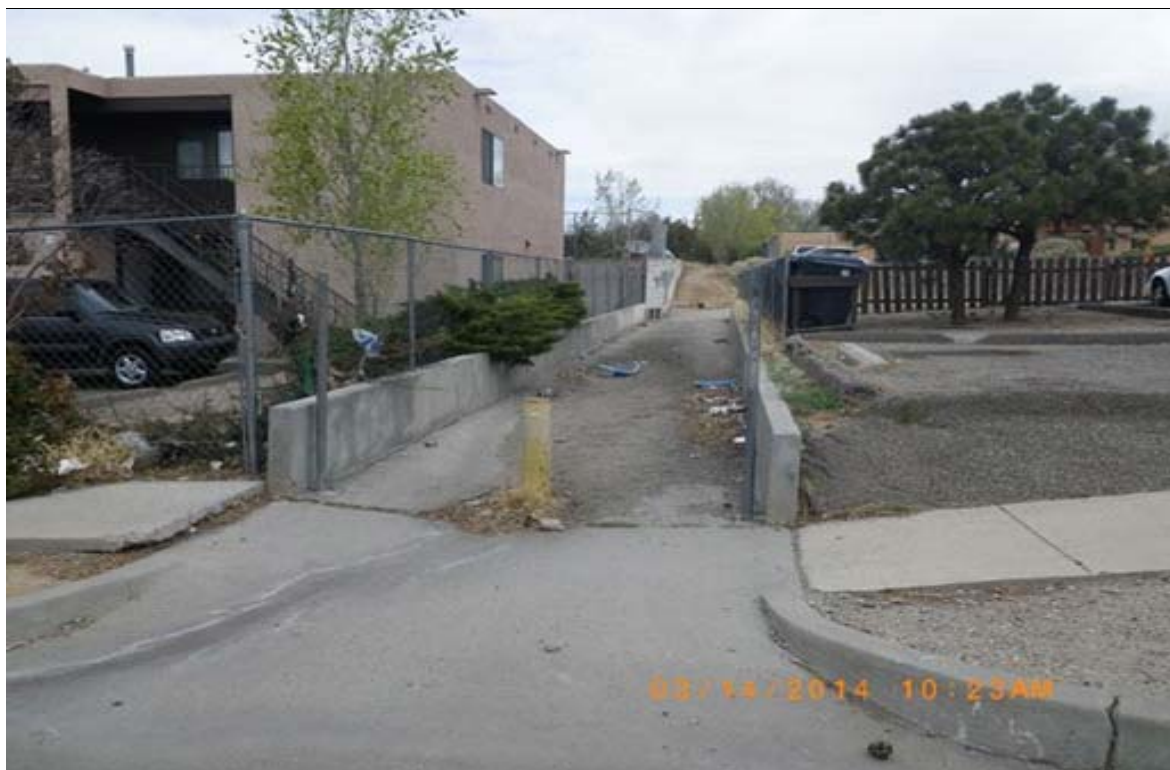
Address	13215 MOUNTAIN NE		
Event ID	397	REPORTING SOURCE	Complaint Date 3/12/2014
CUSTOMER	LARRY HERRERA	311CASE ID 12244731	e-mail
CUSTOMER Ph#	980-2073	SharePointLink: http://sharepoint.cabq.gov/dmd/storm/STORMWATER%20POLLUTION	
Description:	HE WANTS TO KNOW WHO WOULD BE RESPONSIBLE TO CLEAN UP A DRAINAGE AREA BEHIND HIS HOUSE?		
Suspected Facility	DRAINAGE EASEMENT	Type of Complaint	SEDIMENT
Inspection Date	3/14/2014	Number of Field Visits	1
Inspector	SK		
Facility Contact	STREET MAINTENANCE	Facility Ph. #	
FIELD OBSERVATION	THIS IS A CITY DRAINAGE EASEMENT, I SAW A LOT OF SEDIMENTS AND TRASH IN THE EASEMENT		
INITIAL ACTION	ASKED ARROYO CLEANING CREW TO CLEN UP THIS CHANNEL.

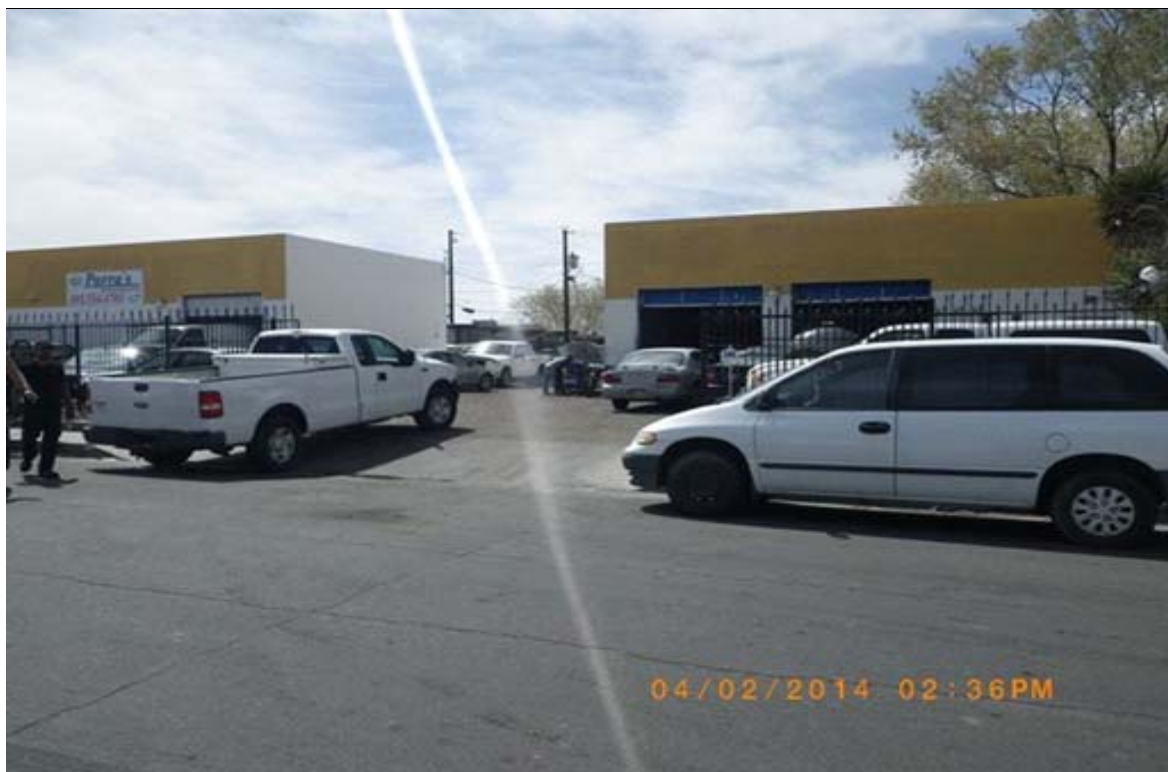
Address	<div>121 GENERAL STILWELL NE</div>		
Event ID	<div>399</div>	REPORTING SOURCE	Complaint Date <div>3/27/2014</div>
CUSTOMER	<div>ENVI. HEALTH</div>	311CASE ID	<div>E-MAL</div> e-mail <div></div>
CUSTOMER Ph#	<div>768-2658</div>	SharePointLink: http://sharepoint.cabq.gov/dmd/storm/STORMWATER%20POLLUTION	
Description:	<div>OIL AND FLUID SPILL ON THE STREET</div>		
Suspected Facility	<div>AUTO SHOP</div>	Type of Complaint	<div>OIL & ANTIFREEZE</div>
Inspection Date	<div>4/2/2014</div>	Number of Field Visits	<div>1</div> Inspector <div>SK</div>
Facility Contact	<div>MANAGER</div>	Facility Ph. #	<div></div>
FIELD OBSERVATION	<div>I SAW SEVERAL OIL SPOTS AROUND THIS AREA</div>		
INITIAL ACTION	<div>I ASKED THE MANAGER TO CLEAN UP THE OIL SPOTS AND STOP DUMPING OIL TO THE STREET. ALSO, I GIVE HIM SOME BROCHURES</div>

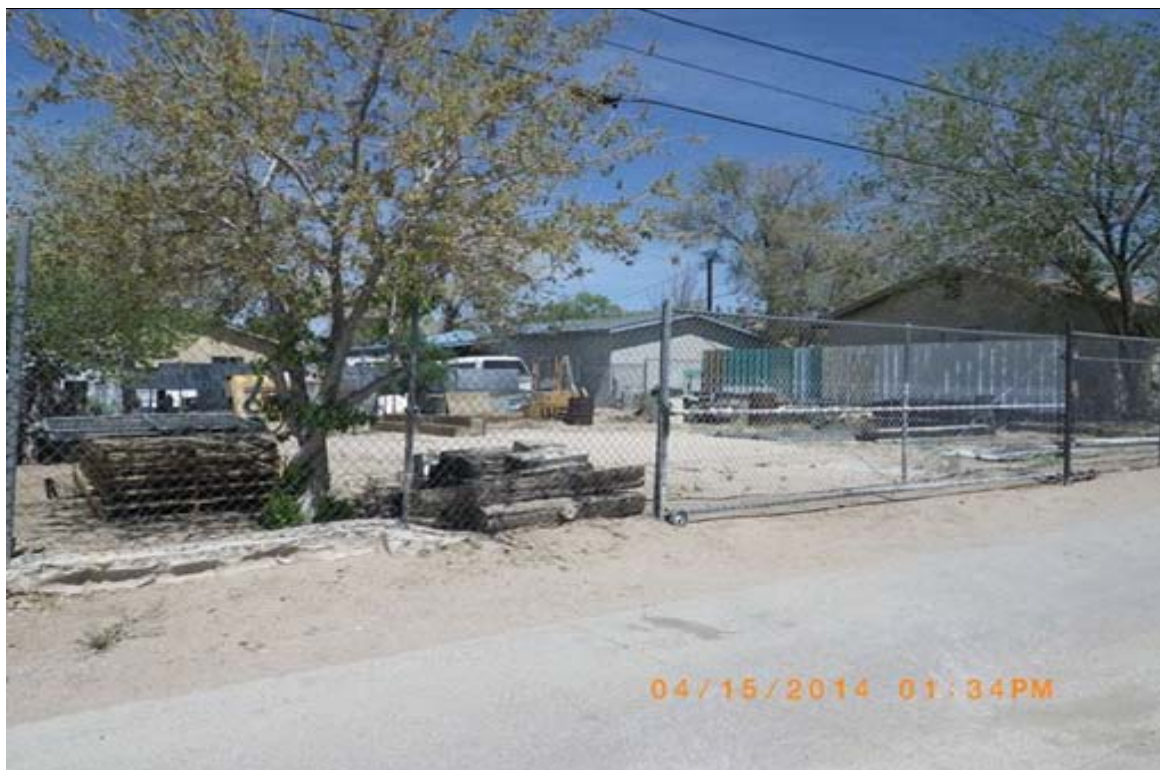
Address	507 MARTINEZ DR NE		
Event ID	400	REPORTING SOURCE	Complaint Date 4/14/2014
CUSTOMER	JESUS APODACA	311CASE ID 12348825	e-mail na
CUSTOMER Ph#	250-5697	SharePointLink: http://sharepoint.cabq.gov/dmd/storm/STORMWATER%20POLLUTION	
Description:	SEWAGE LEAKING FROM THE FRONT YARD OF THIS PROPERTY AND LEAKING INTO THE STREET		
Suspected Facility	HOME	Type of Complaint	SEWAGE
Inspection Date	4/15/2014	Number of Field Visits	1 Inspector SK
Facility Contact	NA	Facility Ph. #	na
FIELD OBSERVATION	NO SEWER OVERFLOW FOUND, IT HAS BEEN FIXED		
INITIAL ACTION	NO ACTION REQUIRED

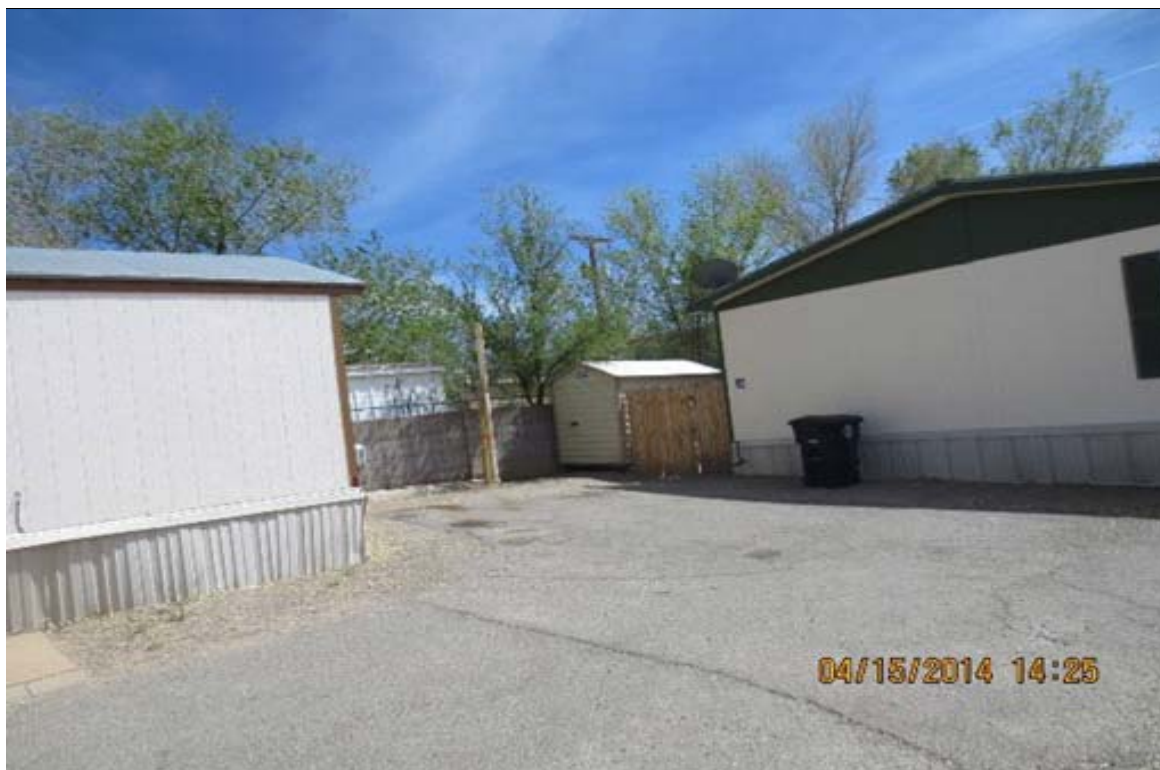
Address	10804 CHOCHITI SE NO.27		
Event ID	401	REPORTING SOURCE	Complaint Date 4/15/2014
CUSTOMER	ANONYMOUS	311CASE ID	12369158 e-mail
CUSTOMER Ph#	na	SharePointLink: http://sharepoint.cabq.gov/dmd/storm/STORMWATER%20POLLUTION	
Description:	SEMI TRAILER LEAKING OIL ON THE STREET		
Suspected Facility	TRAILER	Type of Complaint	OIL
Inspection Date	4/15/2014	Number of Field Visits	1 Inspector SK
Facility Contact	RESIDENT	Facility Ph. #	na
FIELD OBSERVATION	I SAW SOME OIL SPOTS		
INITIAL ACTION	I SPOKE TO THE RESIDENT AND DISTRIBUTED P2 BROCHURES

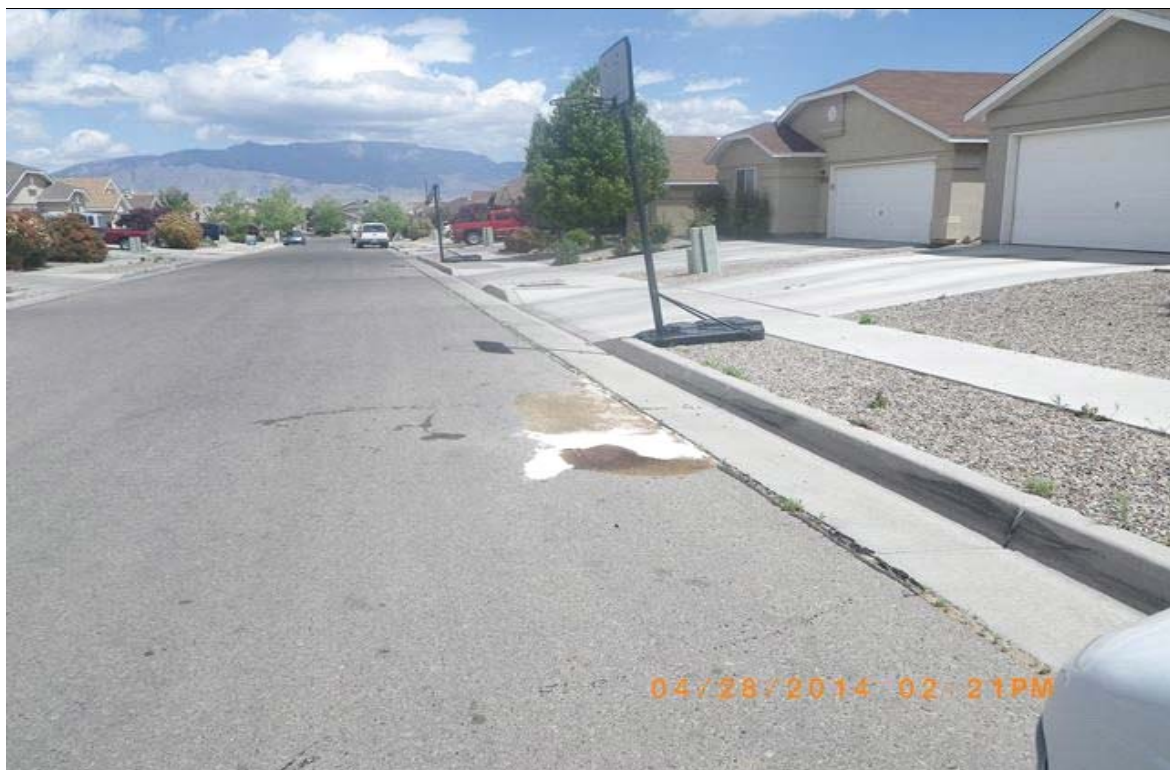
Address	5600 CROWNRIDGE NW				
Event ID	405	REPORTING SOURCE	311	Complaint Date	4/24/2014
CUSTOMER	ANONYMOUS		311CASE ID	12402220	e-mail
CUSTOMER Ph#		SharePointLink: http://sharepoint.cabq.gov/dmd/storm/STORMWATER%20POLLUTION			
Description:	OIL IS RUNNING DOWN THE STREET				
Suspected Facility	HOME		Type of Complaint	OIL	
Inspection Date	4/28/2014	Number of Field Visits	1	Inspector	SK
Facility Contact	RESIDENT		Facility Ph. #		
FIELD OBSERVATION	THE VEHICLE HAS BEEN REMOVED AND THE OIL WAS COVERED WITH ABSORBENT,				
INITIAL ACTION	I ADDED SOME MORE ABSORBENT TO COMPLETE THE REMOVAL OF THE OIL.THE ABSORBENT WILL BE SWEEPED NEXT STREET SWEEPING DAY.I ALSO DISTRIBUTED POLLUTION PREVENTION BROCHURES AT THIS NEIGHBORHOOD

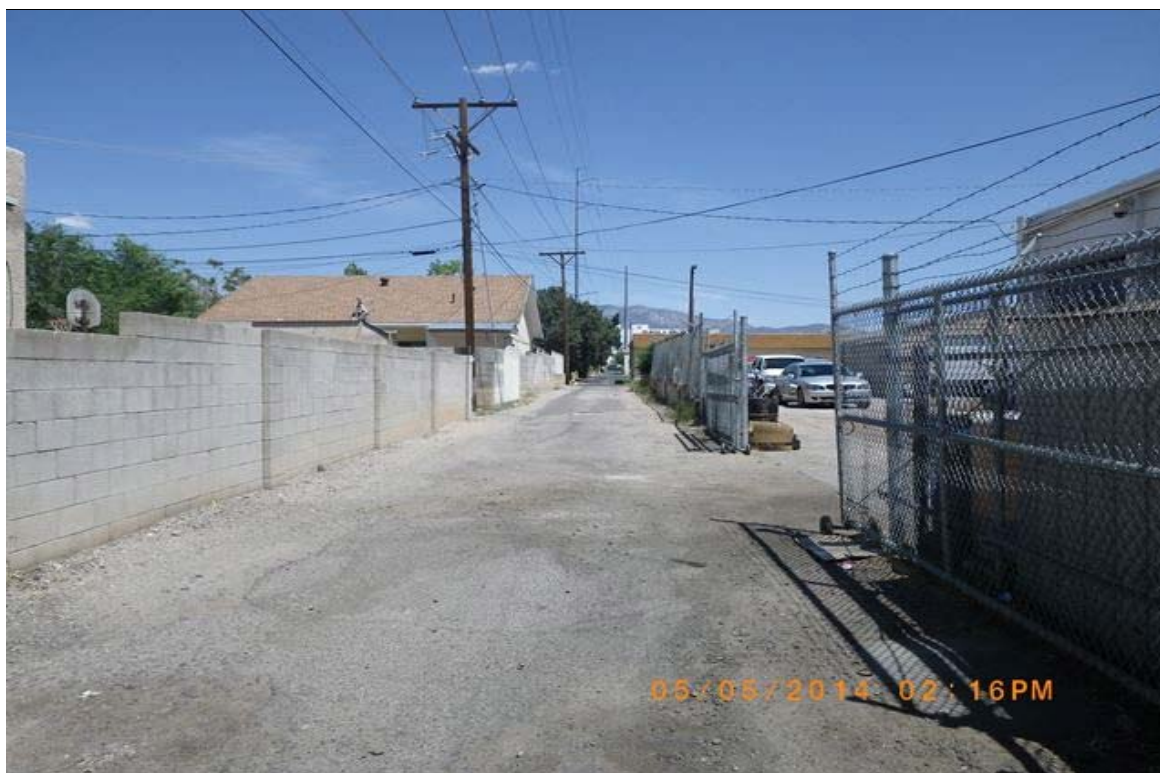
Address	4913 MENAUL NE ZIA AUTO		
Event ID	402	REPORTING SOURCE	Complaint Date 4/25/2014
CUSTOMER	ANONYMOUS	311CASE ID 12360561	e-mail
CUSTOMER Ph#		SharePointLink: http://sharepoint.cabq.gov/dmd/storm/STORMWATER%20POLLUTION	
Description:	THIS BUSINESS IS WASHING CARS AND THEREIS ALWAYS STANDING WATER BEHIND SHOP IN THE ALLEY.CITIZEN SMELL A CHEMICAL SMELL ONCE AND IS WONDER IF CHEMICAL AS PASSING WITH THE WATER OFF THEIR PROPERTY.		
Suspected Facility	ZIA AUTO	Type of Complaint	CAR WASHING
Inspection Date	5/5/2014	Number of Field Visits	1
Facility Contact	MANAGER	Inspector	SK
Facility Ph. #			
FIELD OBSERVATION	THERE WAS OILY DRY RESIDUE IN THE ALLEY COMING FROM BACK OF THE SHOP.		
INITIAL ACTION	I SPOKE TO THE MANAGER OF ZIA AUTO BUSINESS REGARDING THE DIRTY WASH WATER COMING OUT FROM THEIR AREA INTO THE ALLEY. HE TOLD ME THAT HE WILL MAKE SURE THAT THE WASH WATER WILL NOT LEAVE HIS YARD TO THE ALLEY. I GAVE HIM SOME POLLUTION PREVENTION BROCHURE

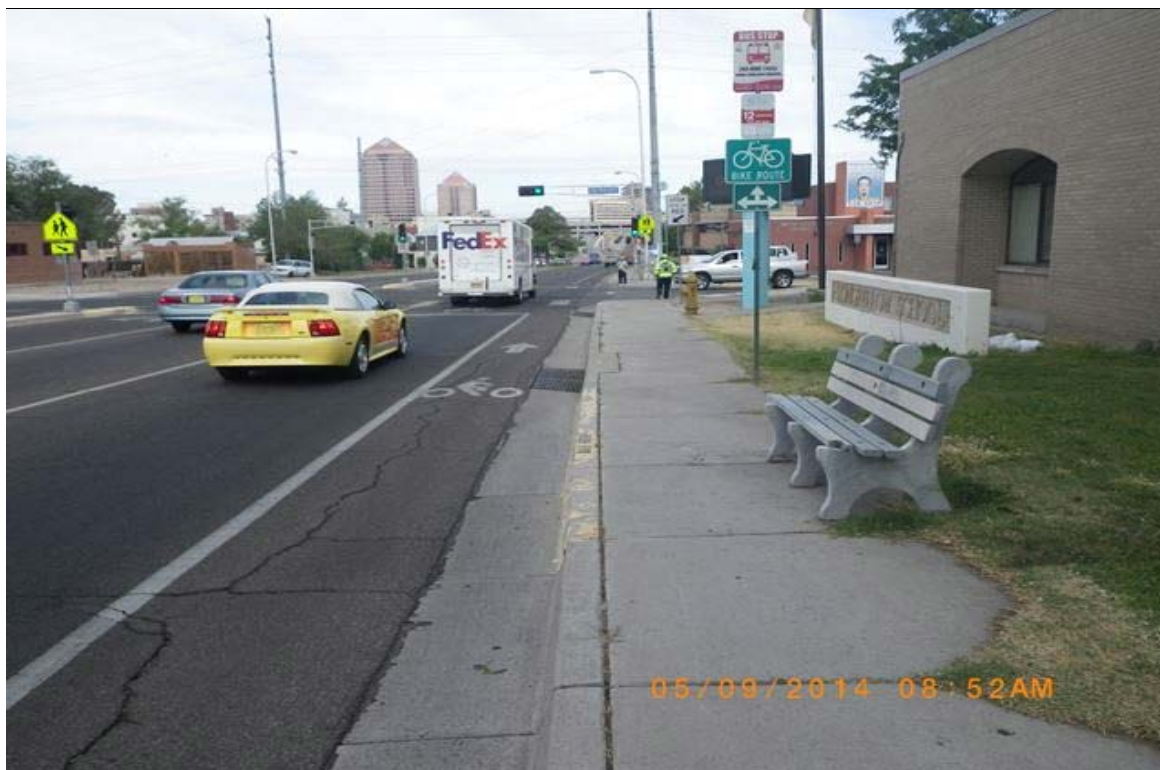
Address	MARTIN LUTHER KING AT BROADWAY TO I-25				
Event ID	403	REPORTING SOURCE	Complaint Date		5/8/2014
CUSTOMER	MELISSA LOZOYA	311CASE ID	PH CALL	e-mail	
CUSTOMER Ph#		SharePointLink: http://sharepoint.cabq.gov/dmd/storm/STORMWATER%20POLLUTION			
Description:	WHITE SUBSTANCE FLOWING DOWN THE STREET				
Suspected Facility		Type of Complaint		PAINT	
Inspection Date	5/9/2014	Number of Field Visits	1	Inspector	SK
Facility Contact		Facility Ph. #			
FIELD OBSERVATION	I WALKED ALONG THIS STREET FROM BROADWAY TO I-25 AND I COULD NOT SEE ANY WHITE SUBSTANCE, PROBABLY THE RAIN LAST NIGHT WASHED OFF ALL THE WHITE SUBSTANCE.				
INITIAL ACTION	NO ACTION WAS NECESSARY

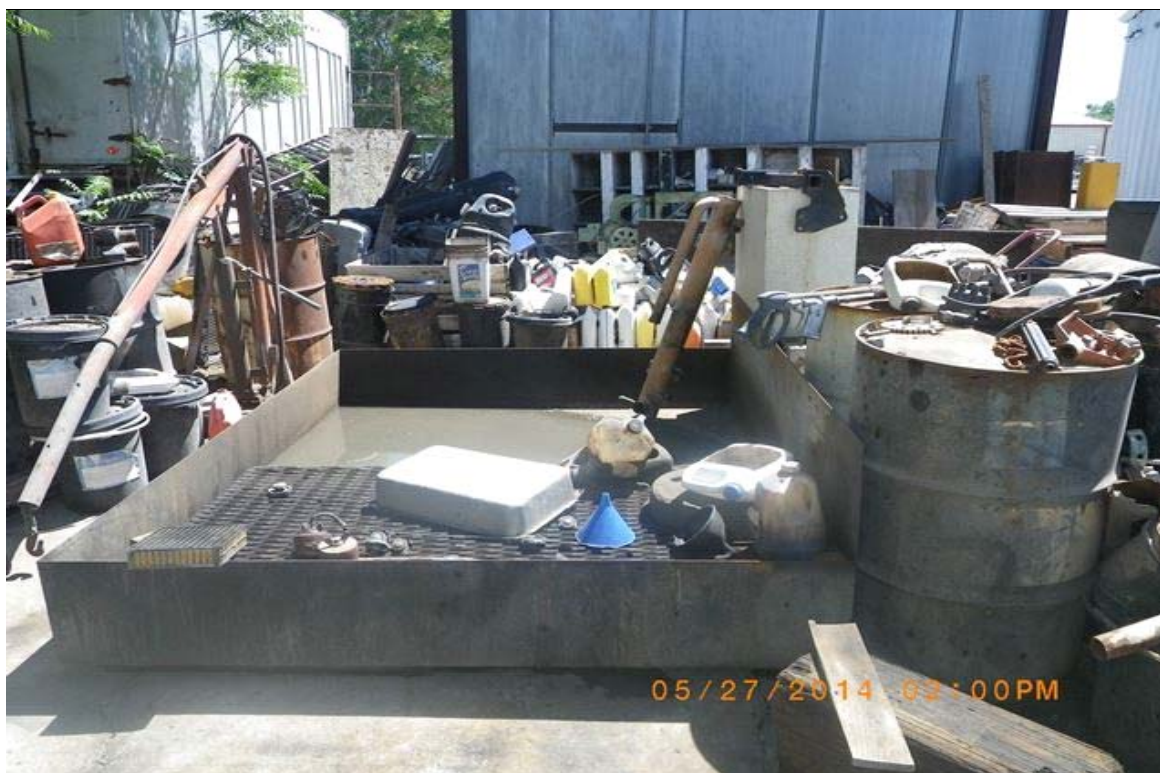
Address	5150 A-1 EDITH NE		
Event ID	408	REPORTING SOURCE	Complaint Date 5/21/2014
CUSTOMER	ANONYMOUS	311CASE ID 12499582	e-mail
CUSTOMER Ph#		SharePointLink: http://sharepoint.cabq.gov/dmd/storm/STORMWATER%20POLLUTION	
Description:	CITIZEN SAID THE RADIATOR SHOP AT INCIDENT ADDRESS IS THROW ACIDS,GASOLINE, AND OTHER CHEMICALS DOWN THE DRAIN. ALSO, THERE ARE IN AREAS IN SHOP WITH CONTAINERS OF OPEN CHEMICALS. CITIZEN REQUESTED THAT SHOP BE INSPECTED BY CITY.		
Suspected Facility	JB RADIATOR	Type of Complaint	HAZARDOUS MATERIAL
Inspection Date	5/27/2014	Number of Field Visits	1
Inspector	SK		
Facility Contact	MANAGER	Facility Ph. #	344-1458
FIELD OBSERVATION	I INSPECTED THIS SHOP ON 5/27/2014 AND I DID NOT SEE ANY HAZARDOUS WASTE DUMP AROUND THIS AREA. I SPOKE TO THE MANAGER OF THE SHOP AND HE DENIED DUMPING ANY HAZARDOUS WASTE TO THE STREET OR TO THE STORM INLETS, HE SHOWED ME THE WASHING AND STORAGE TANKS

INITIAL ACTION	I LEFT SOME POLLUTION PREVENTION BROCHURES AT THIS SHOP

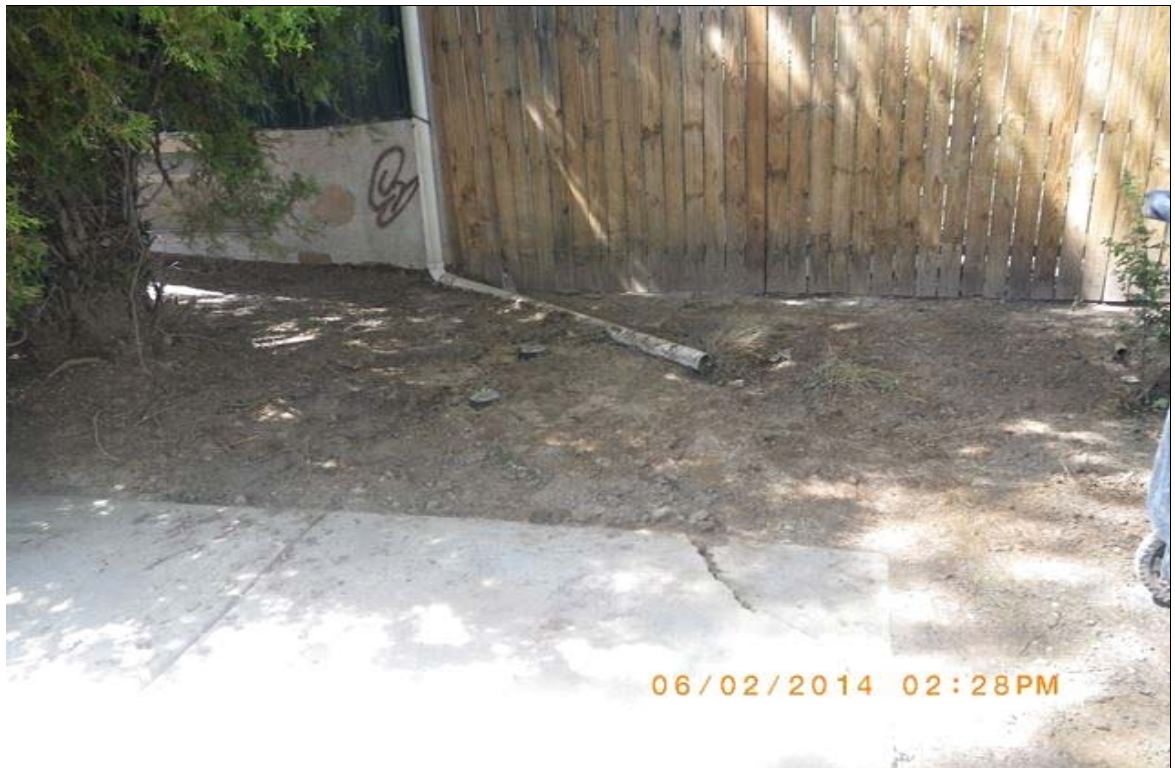
I SPOKE TO THE MANAGER OF THE RESTAURANT ON 6/2/2014 AND HE TOLD ME THAT THEIR SEWER LINE WAS PLUGGED UP CAUSING OVERFLOW THROUGH THE INSPECTION VALVES. THEY FIX THE PROBLEM AND THERE WAS NO OVERFLOW. I GAVE HIM SOME POLLUTION PREVENTION BROCHURES.

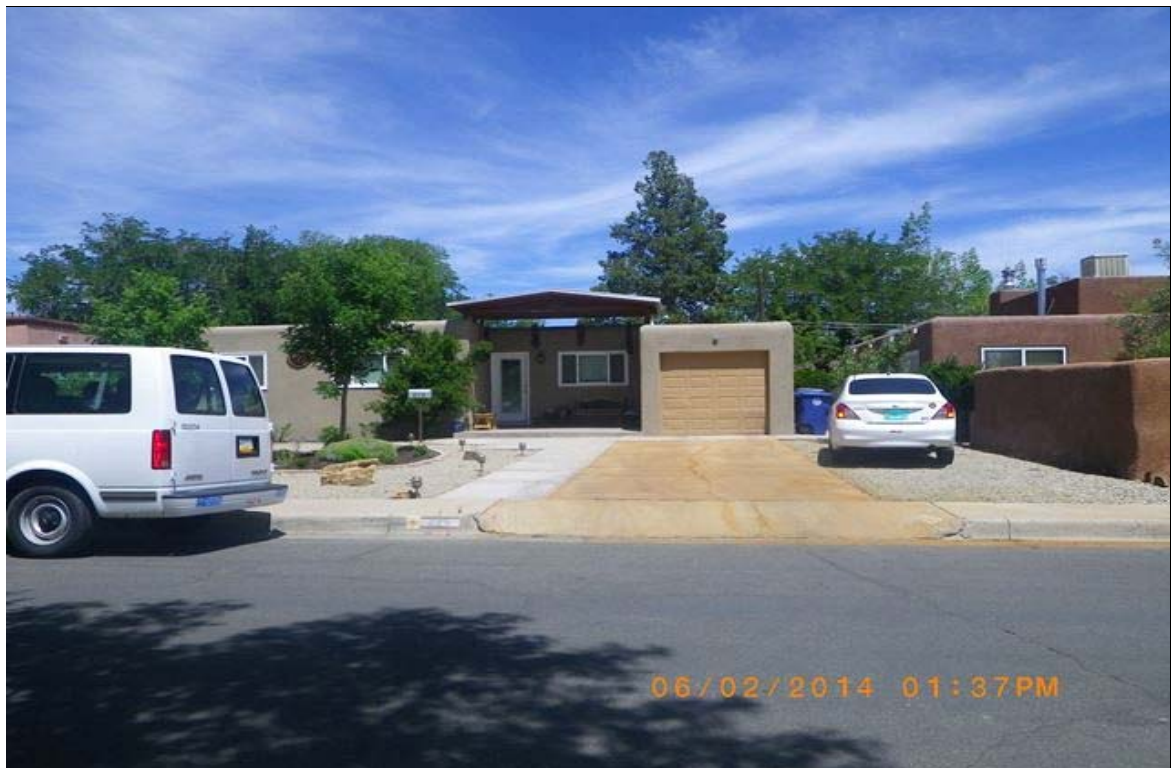
"FROM PROPERTY TO STORM DRAIN GOING SOUTH"
SOMEONE HAS POURED SOMETHING DOWN DRAIN FROM ONE HOUSE, STAINED LENGTH OF STREET, SMALL
AMOUNT MAY HAVE MADE IT TO DRAIN.COMING FROM ADDRESS, DRIED, VERY VISIBLE FROM STAIN, BRIGHT
RUST COLOR.

I SPOKE TO THE HOME OWNER ON 6/2/2014 AND HE TOLD ME THAT HE ACID RUSTIC STAINED HIS CONCRETE
DRIVEWAY USING AN ENVIRONMENTALLY SAFE ACID STAIN. THE RUSTIC COLOR ALONG THE GUTTER WAS
THE RESULT OF WASHING ACCESS STAIN ON THE DRIVEWAY.

I DISTRIBUTED POLLUTION PREVENTION BROCHURES AT THIS NEIGHBORHOOD.

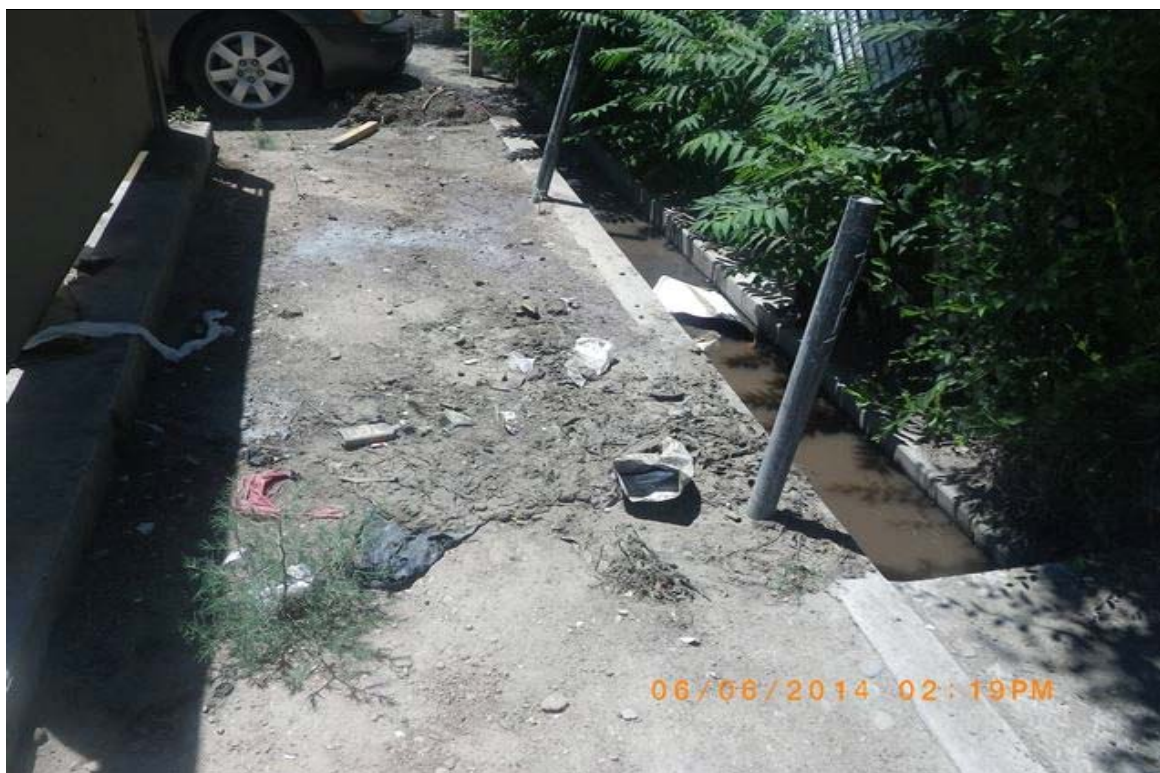
Address	1909 4TH ST NW		
Event ID	411	REPORTING SOURCE	Complaint Date 6/2/2014
CUSTOMER	CATHERINE MEXAL	311CASE ID	E-MAIL e-mail cmexal@gmail.com
CUSTOMER Ph#		SharePointLink: http://sharepoint.cabq.gov/dmd/storm/STORMWATER%20POLLUTION	
Description:	THIS CAR-DETAILING BUSINESS ROUTES ITS NASTY WASTE WATER INTO THE STREET. IT HAS SO MUCH BLACK ROAD SLUDGE IN IT THAT THEY'VE ACTUALLY HAD TO DIG A CHANNEL THROUGH THE SLUDGE. THE STREET IS NEVER DRY.		
Suspected Facility	SOUTHWEST IMPORT SUPPLY	Type of Complaint	CAR WASHING
Inspection Date	6/6/2014	Number of Field Visits	1 Inspector SK
Facility Contact	MANAGER	Facility Ph. #	
FIELD OBSERVATION	I SAW THE DIRTY WATER IS COMING OUT OF THIS BUSINESS AND PUDDLES IN THE GUTTER ALONG THE 4TH ST		
INITIAL ACTION	I SPOKE TO THE MANAGER AND ASKED HIM TO STOP WASHING CARS IN THE SHOP, HE AGREED TO DO SO. I GAVE HIM AND THE OTHER BUSINESSES AT THIS LOCATION SOME POLLUTION PREVENTION BROCHURES
