Locations of the Public Calls in 2014

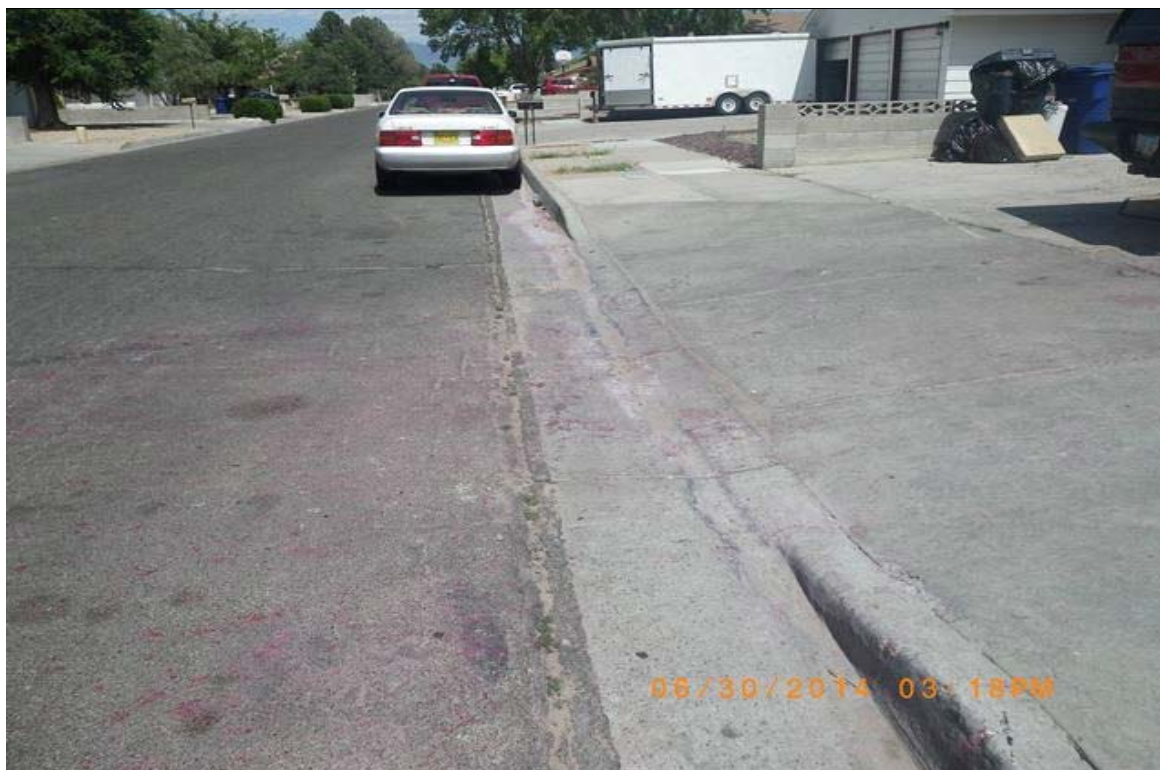
Address	6132 FLOR DE MAYO PL NW				
Event ID	413	REPORTING SOURCE	Complaint Date		6/30/2014
CUSTOMER	TIM WAGNER	311CASE ID	E-MAIL AND PH	e-mail	
CUSTOMER Ph#	349-9805	SharePointLink: http://sharepoint.cabq.gov/dmd/storm/STORMWATER%20POLLUTION			
Description:	PAINT AND AUTOMOTIVE FLUIDS FROM THIS ADDRESS				
Suspected Facility	HOME	Type of Complaint		PAINT	
Inspection Date	6/30/2014	Number of Field Visits	1	Inspector	SK
Facility Contact	RESIDENT	Facility Ph. #			
FIELD OBSERVATION	THERE WAS RED PAINT RESIDUE ALONG THE GUTTER COMING FROM THIS ADDRESS				
INITIAL ACTION	I SPOKE TO THE RESIDENT AND HE TOLD ME THAT IT WAS AN ACCIDENT THAT THEY SPILL A BUCKET OF PAINT. I DISTRIBUTED POLLUTION PREVENTION BROCHURES AT THIS NEIGHBORHOOD.

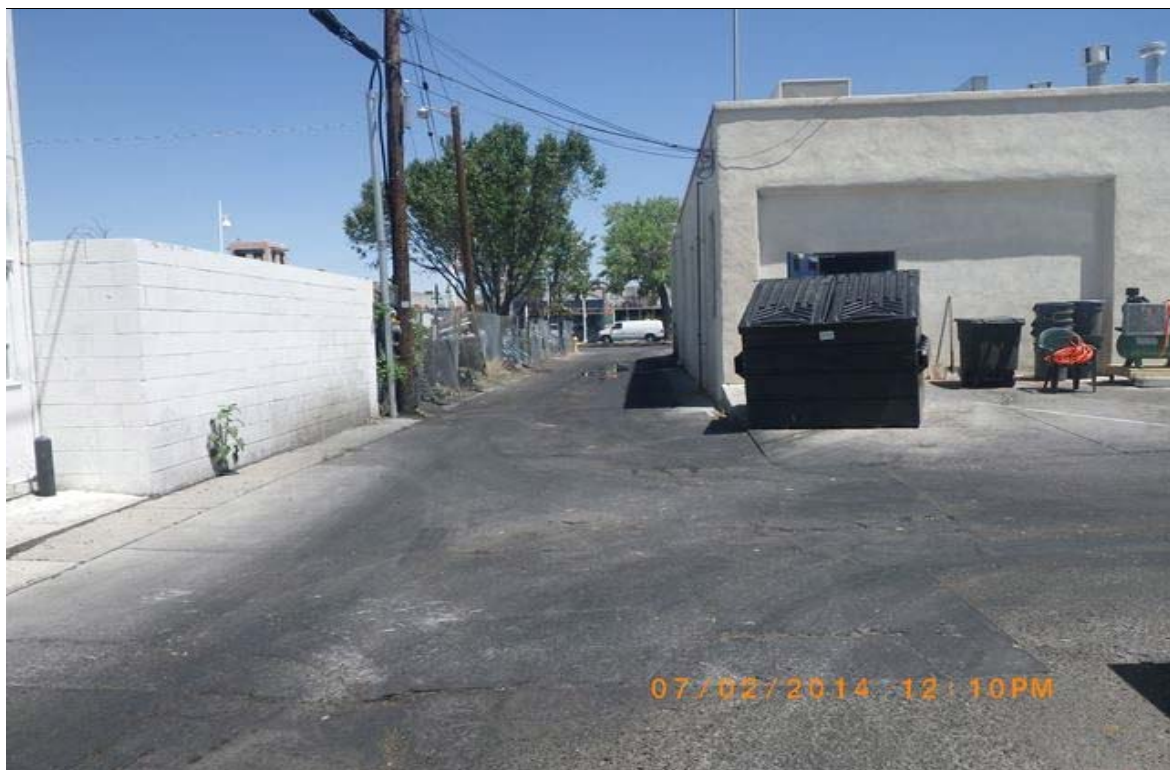
Address	109 WELLESLEY SE		
Event ID	414	REPORTING SOURCE	Complaint Date 7/1/2014
CUSTOMER	SALLY FULTON	311CASE ID 12538423	e-mail
CUSTOMER Ph#	255-6533	SharePointLink: http://sharepoint.cabq.gov/dmd/storm/STORMWATER%20POLLUTION	
Description:	WASHING WATER FROM BEER RESTURANT SMELLS BAD		
Suspected Facility	RESTURANT	Type of Complaint	GREY WATER
Inspection Date	7/2/2014	Number of Field Visits 1	Inspector SK
Facility Contact	MANAGER	Facility Ph. #	
FIELD OBSERVATION	THE ALLEY IS PAVED AND IT IS IN BAD CONDITION. THE FLOOR WASHING WATER FROM THE RESTURENT SMELLS BAD AND PONDS IN THE ALLEY.		
INITIAL ACTION	I ASKED THE RESTURANT NOT TO DUMP THEIR WASHING WATER IN TO THE ALLEY.

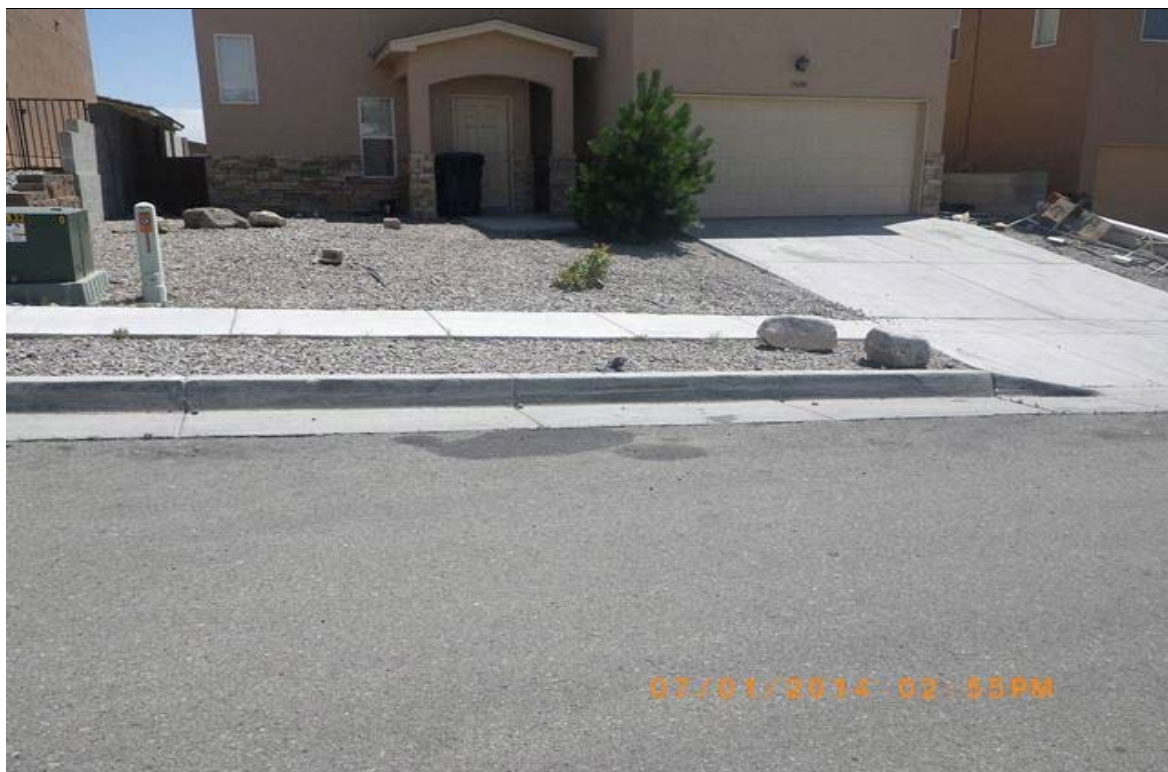
Address	13608 COVERED WAGON SE		
Event ID	415	REPORTING SOURCE	Complaint Date 7/1/2014
CUSTOMER	MIKE JOLLEY	311CASE ID	12586000 e-mail
CUSTOMER Ph#	991-0784	SharePointLink: http://sharepoint.cabq.gov/dmd/storm/STORMWATER%20POLLUTION	
Description:	OIL SPOTS ON THE STREET		
Suspected Facility	HOME	Type of Complaint	OIL
Inspection Date	7/1/2014	Number of Field Visits	1 Inspector SK
Facility Contact	RESIDENT	Facility Ph. #	
FIELD OBSERVATION	THERE WERE SEVERAL DRIED OIL SPOTS AT THIS LOCATION.RESIDENT WAS NOT HOMEAT THE TIME OF THE VISIT.		
INITIAL ACTION	DISTRIBUTED POLLUTION PREVENTION BROCHURES AT THIS NEIGHBORHOOD

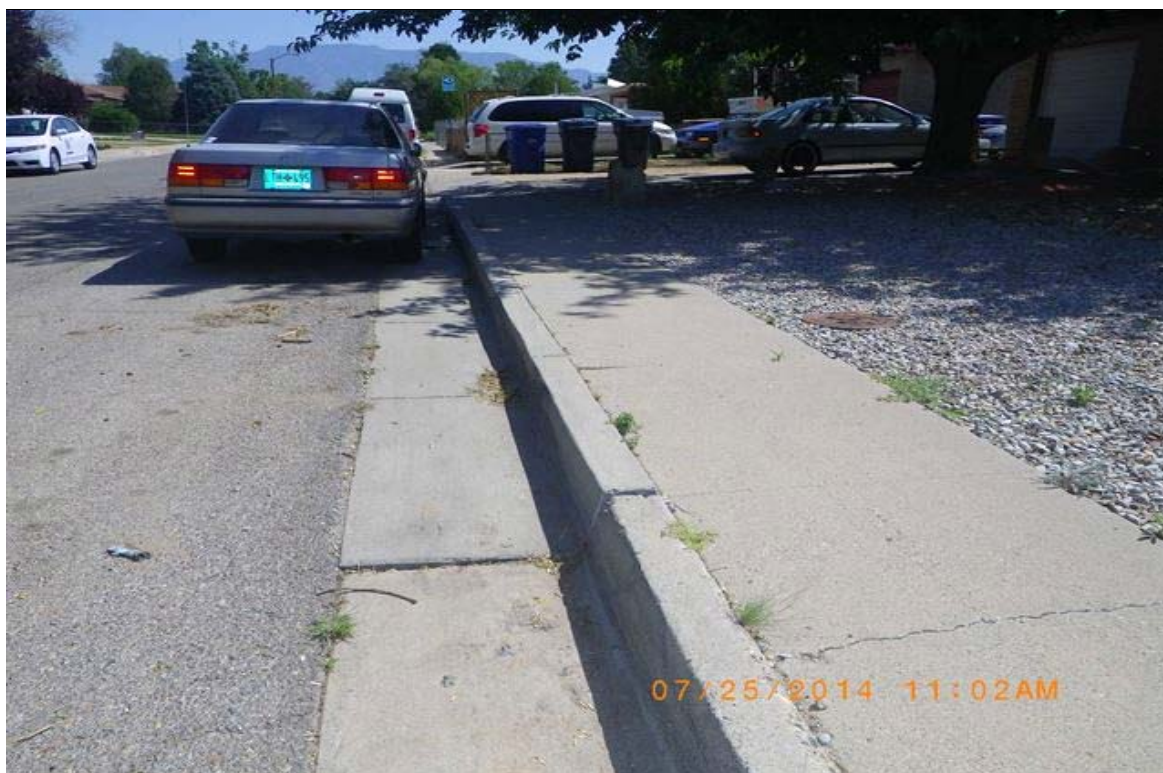
Address	1102 GRETTA NE		
Event ID	422	REPORTING SOURCE	Complaint Date 7/21/2014
CUSTOMER	ANONYMOUS	311CASE ID 12743053	e-mail
CUSTOMER Ph#		SharePointLink: http://sharepoint.cabq.gov/dmd/storm/STORMWATER%20POLLUTION	
Description:	CITIZEN SEES OWNER OF ADDRESS USING A WATER HOSE TO DRAIN POOL WATER INTO STREET AND SMELLS VERY BAD. CITIZEN NEEDS TO BE ADDRESSED ON THE PROPER WAY TO DRAIN POOL WATER AND MAINTAIN POOL WATER.		
Suspected Facility	HOME	Type of Complaint	SWIMMING POOL
Inspection Date	7/25/2014	Number of Field Visits	1
Facility Contact	RESIDENT	Inspector	SK
Facility Ph. #			
FIELD OBSERVATION	I SPOKE TO THE RESIDENT REGARDING THIS INCIDENT, HE TOLD ME THAT HE DRAINED HIS SWIMMING POOL TO THE FRONT AND BACK YARDS AND VERY SMALL PORTION WENT TO THE STREET BY ACCIDENT. I TOLD HIM THAT HE CAN USE THE SANITARY LINE TO EMPTY HIS SWIMMING POOL.		
INITIAL ACTION	I DISTRIBUTED POLLUTION PREVENTION BROCHURES AT THIS NEIGHBORHOOD.

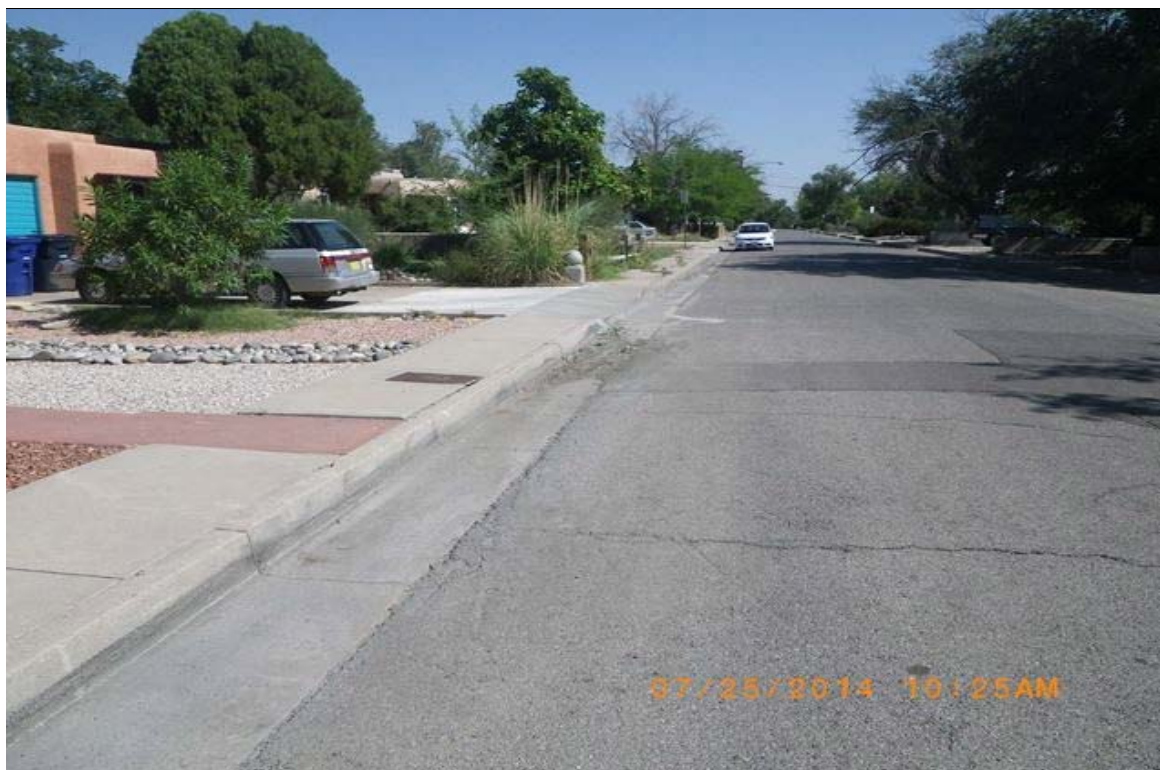
Address	1229 COLUMBIA NE		
Event ID	420	REPORTING SOURCE	Complaint Date 7/23/2014
CUSTOMER	ILENE MURPHY	311CASE ID 12751967	e-mail
CUSTOMER Ph#	266-2136	SharePointLink: http://sharepoint.cabq.gov/dmd/storm/STORMWATER%20POLLUTION	
Description:	PLASTIC GREY COLOR DUMPED INTO STORM DRAIN AT ADDRESS		
Suspected Facility	HOME	Type of Complaint	HAZARDOUS MATERIAL
Inspection Date	7/25/2014	Number of Field Visits	1 Inspector SK
Facility Contact	RESIDENT	Facility Ph. #	
FIELD OBSERVATION	THE SOURCE OF DISCHARGE WAS DRAINING THE TURBID WATER FROM A SMALL FISH POND AT 1229. THERE IS NO HARM EFFECTS TO THE ENVIRONMENT FROM THIS DISCHARGE AND CLEANING THE DRY RESIDUE WAS NOT NECESSARY.		
INITIAL ACTION	I DISTRIBUTED POLLUTION PREVENTION BROCHURES AT THIS NEIGHBORHOOD.

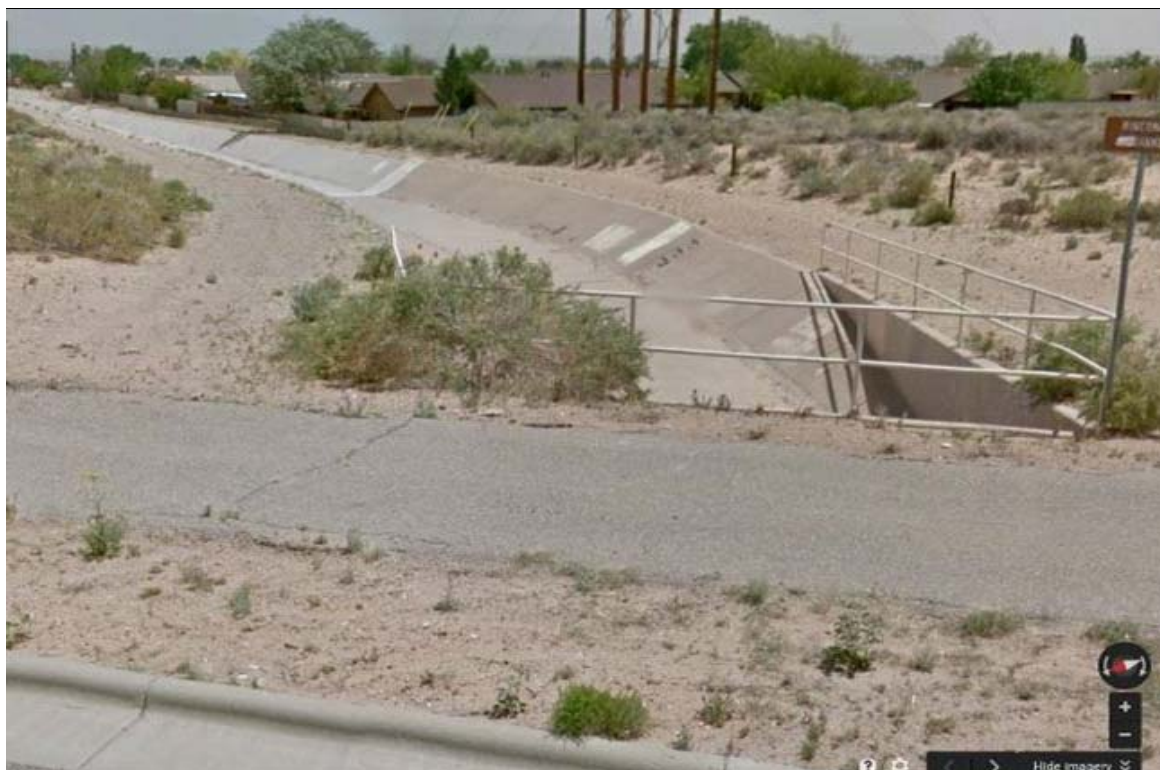
Address	SAINT JOSEPH AND UNSER NW		
Event ID	421	REPORTING SOURCE	Complaint Date 7/23/2014
CUSTOMER	LEON LOVATO	311CASE ID 12710357	e-mail
CUSTOMER Ph#	980-9958	SharePointLink: http://sharepoint.cabq.gov/dmd/storm/STORMWATER%20POLLUTION	
Description:	DUMPING LIQUID SOLUTION INTO ARROYO		
Suspected Facility	LIGHT CONNECTION FIBER SOLUTIONS	Type of Complaint	COLORD LIQUID
Inspection Date	7/23/2014	Number of Field Visits	1
Inspector			
Facility Contact	MANAGER	Facility Ph. #	
FIELD OBSERVATION	NO SITE VISIT		
INITIAL ACTION	I SPOKE TO THE MANAGER OF THIS COMPANY REGARDING THE INCIDENT, HE TOLD ME THAT THEY WENT TO THE DUMPING SITE AND CLEANED UP THE DISPOSED MUD AND HE TERMINATED THAT EMPLOYEE WHO DUMPED.

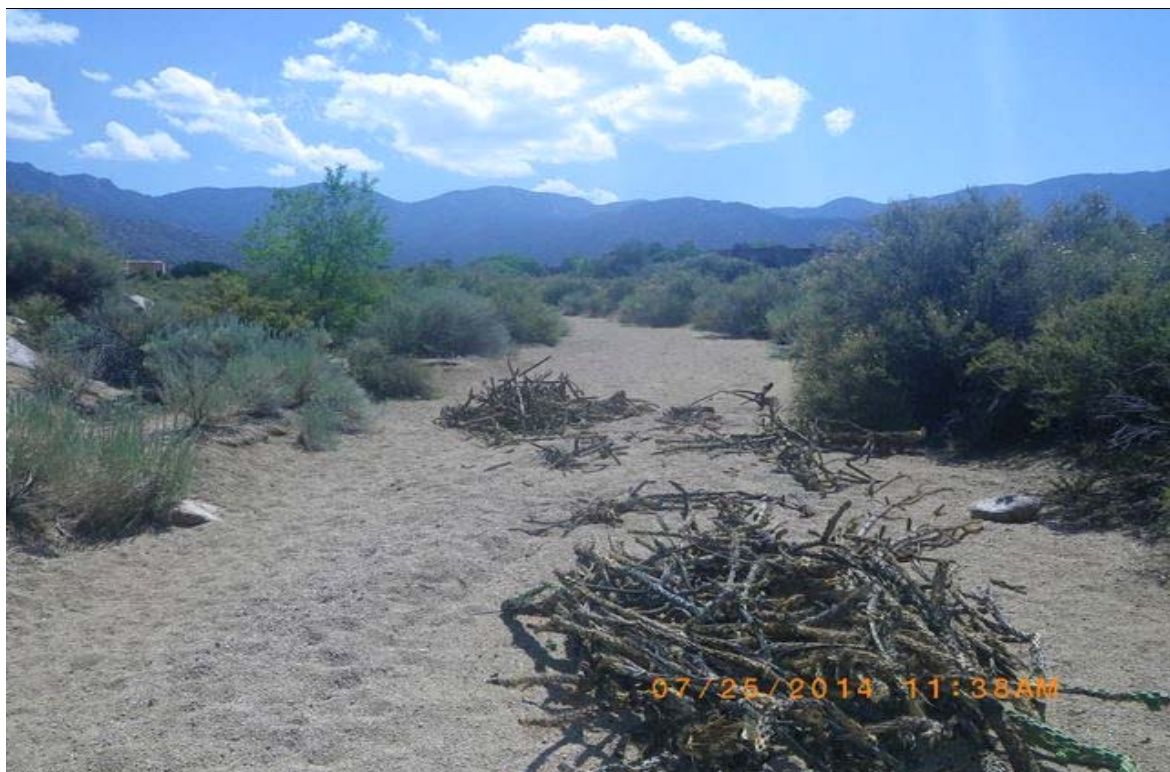
Address	BOBCAT BETWEEN DEER AND MORNING GLORY NE		
Event ID	419	REPORTING SOURCE	Complaint Date 7/24/2014
CUSTOMER	CHRISTINE MARSHALL	311CASE ID WEB	e-mail
CUSTOMER Ph#	344-1345	SharePointLink: http://sharepoint.cabq.gov/dmd/storm/STORMWATER%20POLLUTION	
Description:	DUMPING CACTUS INTO ARROYO		
Suspected Facility	OPEN SPACE PARK	Type of Complaint	TRASH
Inspection Date	7/24/2014	Number of Field Visits 1	Inspector SK
Facility Contact	NA	Facility Ph. #	
FIELD OBSERVATION	2 TRUCK LOAD OF CACTUS DUMPED INSIDE OPEN SPACE, THIS AREA BELONG TO THE COUNTY		
INITIAL ACTION	I ASKED THE CALLER TO CONTACT THE OPEN SPACE AT THE COUNTY

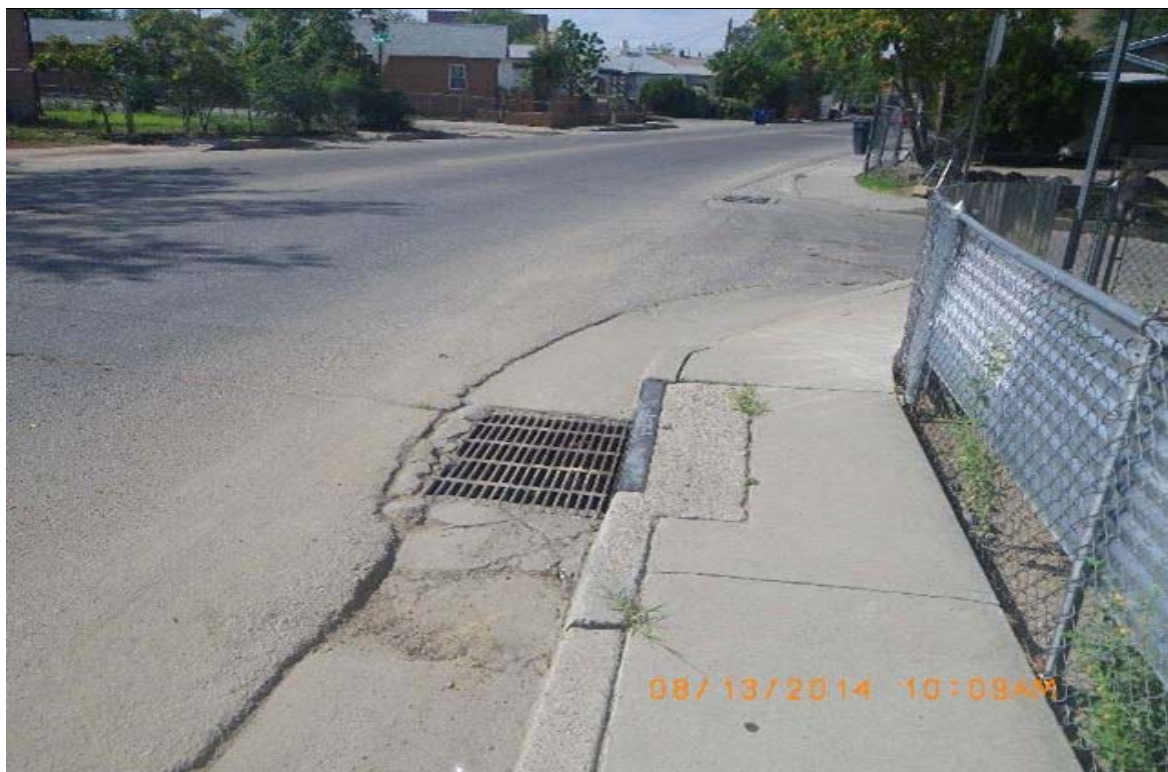
Address	MARBLE BETWEEN EDITH AND FRANCISCAN		
Event ID	424	REPORTING SOURCE	Complaint Date 8/11/2014
CUSTOMER	DIANE DOLAN	311CASE ID	E-MAIL ddolan@cabq.gov
CUSTOMER Ph#	768-3186	SharePointLink: http://sharepoint.cabq.gov/dmd/storm/STORMWATER%20POLLUTION	
Description:	STRONG CHEMICAL ODOR		
Suspected Facility	INLET	Type of Complaint	FOUL ODOR
Inspection Date	8/13/2014	Number of Field Visits	1
Facility Contact	NA	Inspector	SK
	Facility Ph. #	na	
FIELD OBSERVATION	THE INLET AT THE CORNER OF MARBLE AND EDITH HAD A BAD ODOR		
INITIAL ACTION	I ASKED THE SORM CLEANING CREW TO CLEAN UP THIS INLET

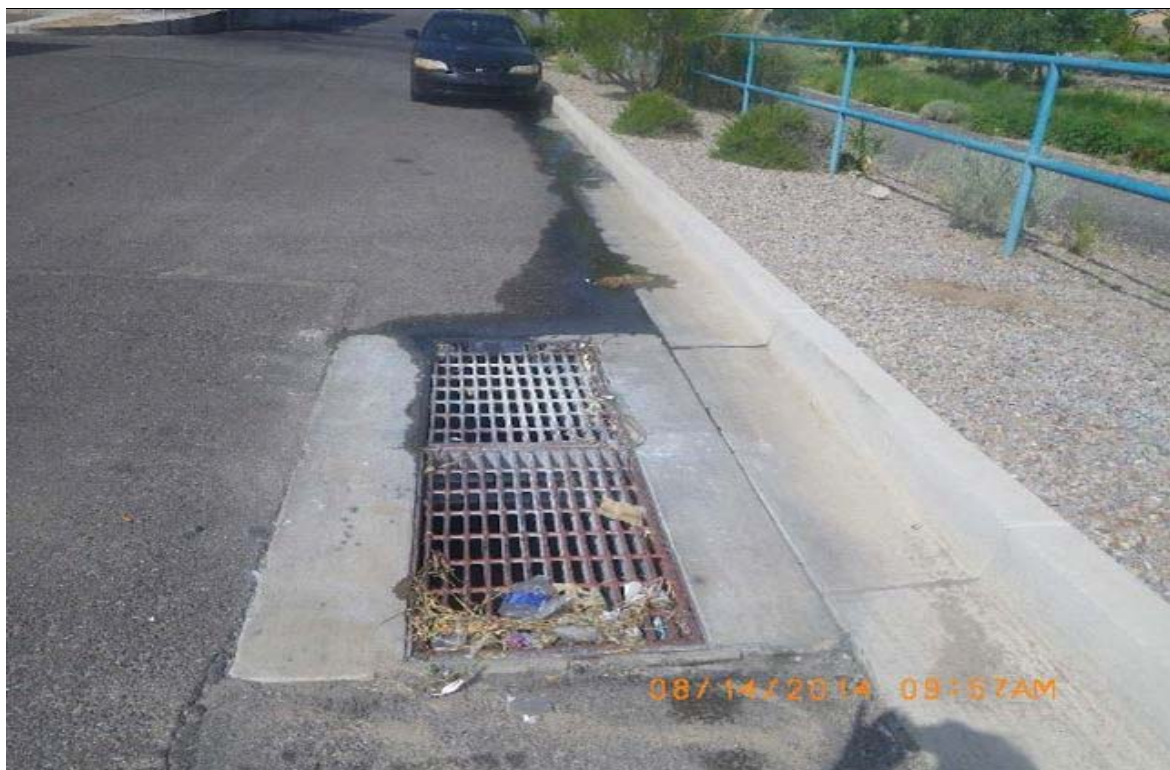
Address	6521 PARADISE NW		
Event ID	425	REPORTING SOURCE	Complaint Date 8/13/2014
CUSTOMER	JEFF WILLIS	311CASE ID	E-MAIL e-mail
CUSTOMER Ph#	878-0517	SharePointLink: http://sharepoint.cabq.gov/dmd/storm/STORMWATER%20POLLUTION	
Description:	DUMPING PAINT IN TO THE ARROYO		
Suspected Facility	DESERT RIDGE DENTAL	Type of Complaint	PAINT
Inspection Date	8/14/2014	Number of Field Visits	1 Inspector SK
Facility Contact	CONTRACTOR (TRINTY)	Facility Ph. #	
FIELD OBSERVATION	THERE WAS SOME WHITE PAINT ON THE GRATE AND NEAR THE OUTFALL TO THE ARROYO AT THIS LOCATION.A CONTRACTOR WAS DOING REMODELING WARK AT THIS ADDRESS.		
INITIAL ACTION	I ASKED THE CONTRACTOR TO STOP DUMPING ANY PAINT INTO THE STORM DRAIN AND THE ARROYO AND TO CLEAN UP THE AREA.I ALSO GAVE HIM SOME POLLUTION PREVENTION BROCHURES.

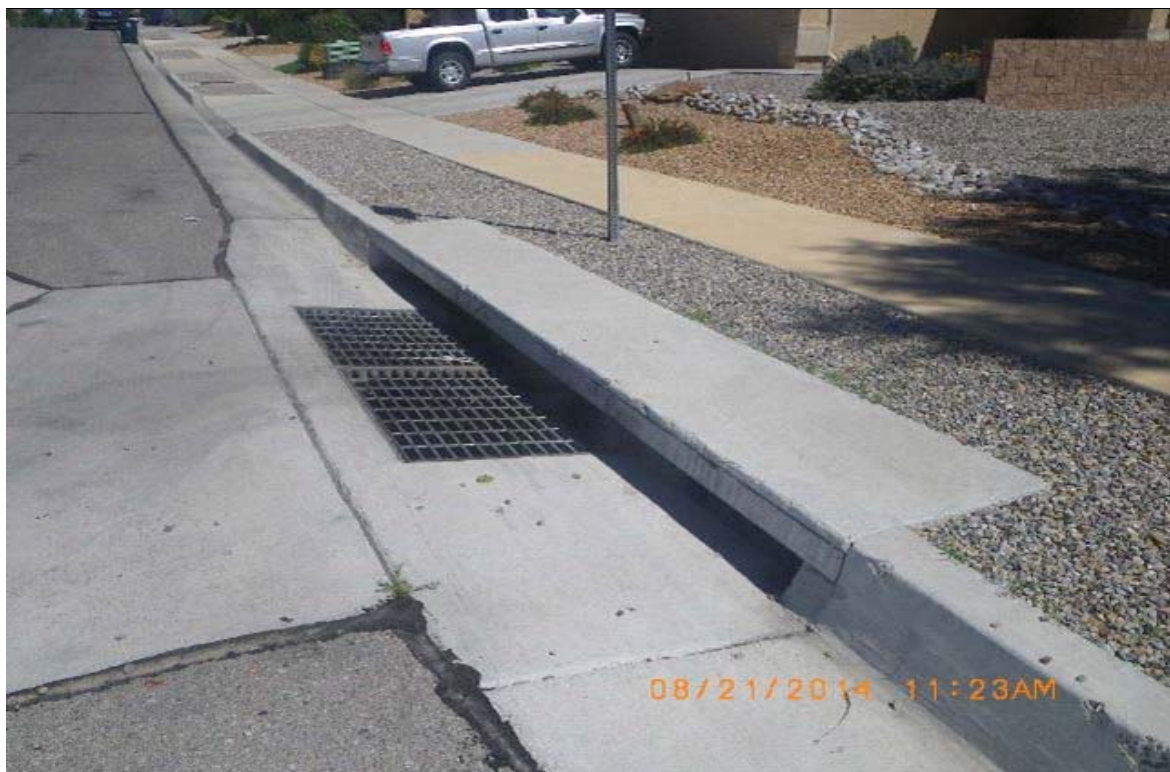
Address	9200 CARSON MESA NW		
Event ID	426	REPORTING SOURCE	Complaint Date 8/19/2014
CUSTOMER	JOHN MEDINA	311CASE ID 12845461	e-mail
CUSTOMER Ph#	899-4613	SharePointLink: http://sharepoint.cabq.gov/dmd/storm/STORMWATER%20POLLUTION	
Description:	DUMPING ANTIFREEZE INTO STORM DRAIN		
Suspected Facility	HOME	Type of Complaint	OIL & ANTIFREEZE
Inspection Date	8/21/2014	Number of Field Visits 1	Inspector SK
Facility Contact	NA	Facility Ph. #	
FIELD OBSERVATION	THERE WAS NO 9200 HOUSE NUMBER, PROBABLY WAS 9400.I DID NOT SEE ANY LIQUID AROUND THIS INLET.		
INITIAL ACTION	I DISTRIBUTED POLLUTION PREVENTION BROCHURES AT THIS NEIGHBORHOOD.

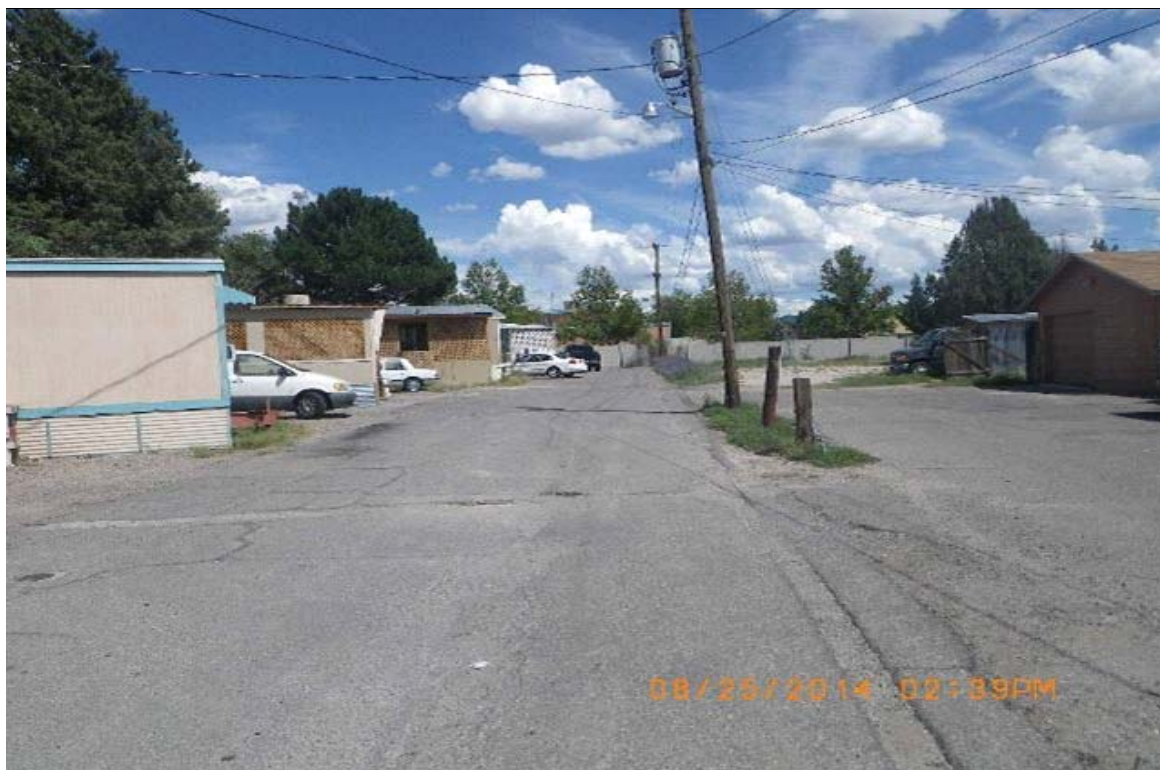
Address	530 UTAH SPACE 56		
Event ID	427	REPORTING SOURCE	Complaint Date 8/20/2014
CUSTOMER	ANONYMOUS	311CASE ID	WEB e-mail na
CUSTOMER Ph#	na	SharePointLink: http://sharepoint.cabq.gov/dmd/storm/STORMWATER%20POLLUTION	
Description:	DUMPING LAUNDRY WASHWATER TO THE STREET		
Suspected Facility	MOBILE HOME	Type of Complaint	LAUNDRY CLEANING
Inspection Date	8/25/2014	Number of Field Visits	1 Inspector SK
Facility Contact	RESIDENT	Facility Ph. #	
FIELD OBSERVATION	THE AREA WAS DRY AND THERE WAS NO EVIDENCE OF DUMPING ANY THING TO THE STREET. THE RESIDENT DENIED HAVING LUNDRY MACHINE		
INITIAL ACTION	I DISTRIBUTED POLLUTION PREVENTION BROCHURES AT THIS PARK.

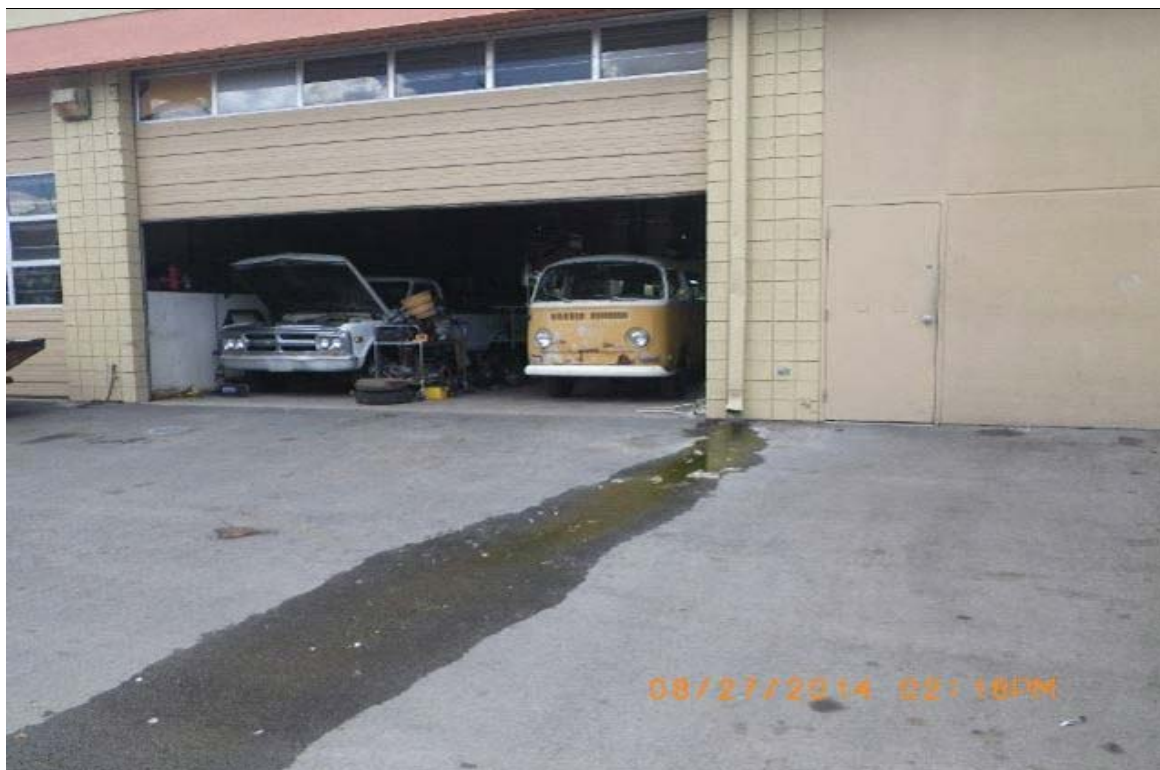
Address	10300 MENAUL NE SUIT 8-9			
Event ID	428	REPORTING SOURCE	Complaint Date	8/25/2014
CUSTOMER	AARON COFFMAN	311CASE ID	PH CALL TO EHD	e-mail
CUSTOMER Ph#	222-9503	SharePointLink: http://sharepoint.cabq.gov/dmd/storm/STORMWATER%20POLLUTION		
Description:	AUTOMOTIVE FACILITY AT THIS ADDRESS MAY BE DUMPING ANTIFREEZE			
Suspected Facility	AUTO SHOP	Type of Complaint	ANTIFREEZE	
Inspection Date	8/27/2014	Number of Field Visits	1	Inspector SK
Facility Contact	MANAGER	Facility Ph. #		
FIELD OBSERVATION	I SPOKE TO THE MANAGER OF THIS AUTO SHOP REGARDING DISPOSAL OF ANTIFREEZE TO THE STREET, HE DENIED IT AND SHOWED ME THAT THEY HAVE TANKS FOR STORAGE AND DISPOSAL OF HAZARDS MATERIAL.			
INITIAL ACTION	I DISTRIBUTED POLLUTION PREVENTION BROCHURES AT THIS PLAZA

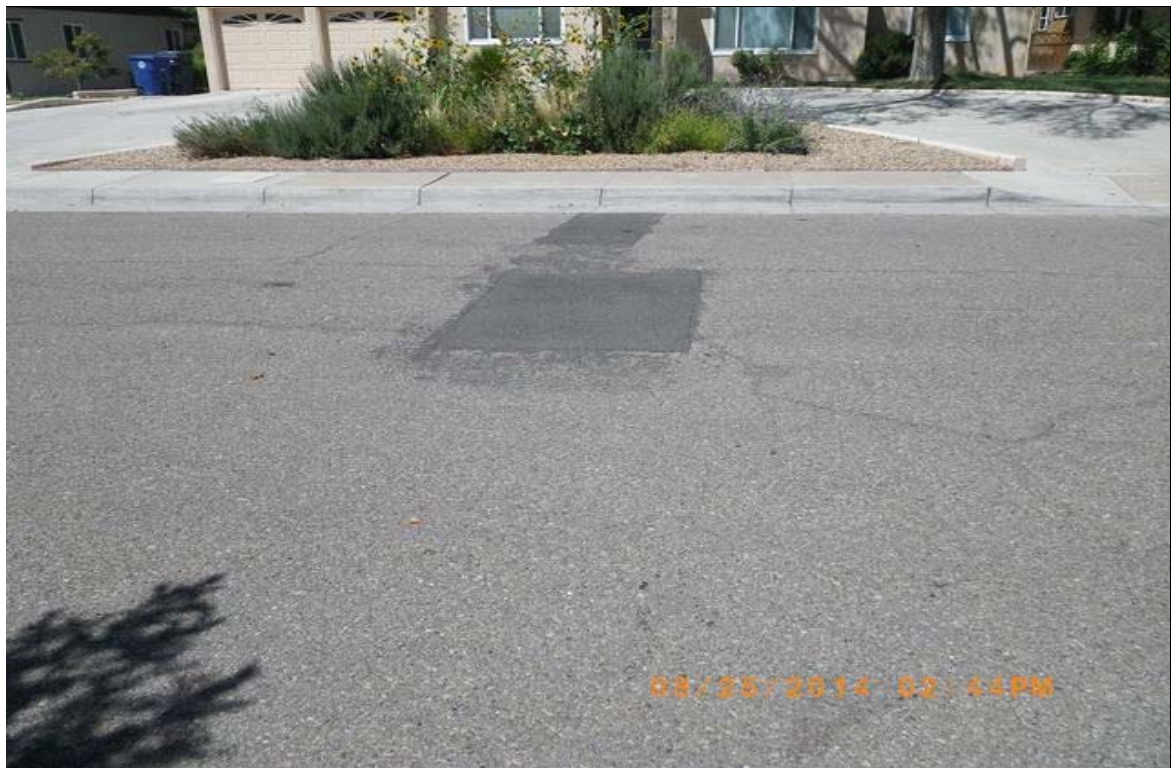
4427 AVENIDA MANANA NE

AFTER THE WALKTHROUGH FOR NEAR HEIGHT FLOOD CONTROL, CPN 549891, RAY SMITH (SOUDER, MILLER & ASSO.) MENTIONED THAT THEY HAD TELEVISED THE STORM DRAIN ALONG AVENIDA MANANA AND FOUND SIGNS OF RAW SEWAGE BETWEEN WASHINGTON AND AVENIDA LA RESOLANA.

THE RESIDENT TOLD ME THAT HE FIXED HIS COLLAPSED SANITARY LINE AROUND 4/19/2013.

TV-INSPECTION OF THIS LINE IS PENDING.

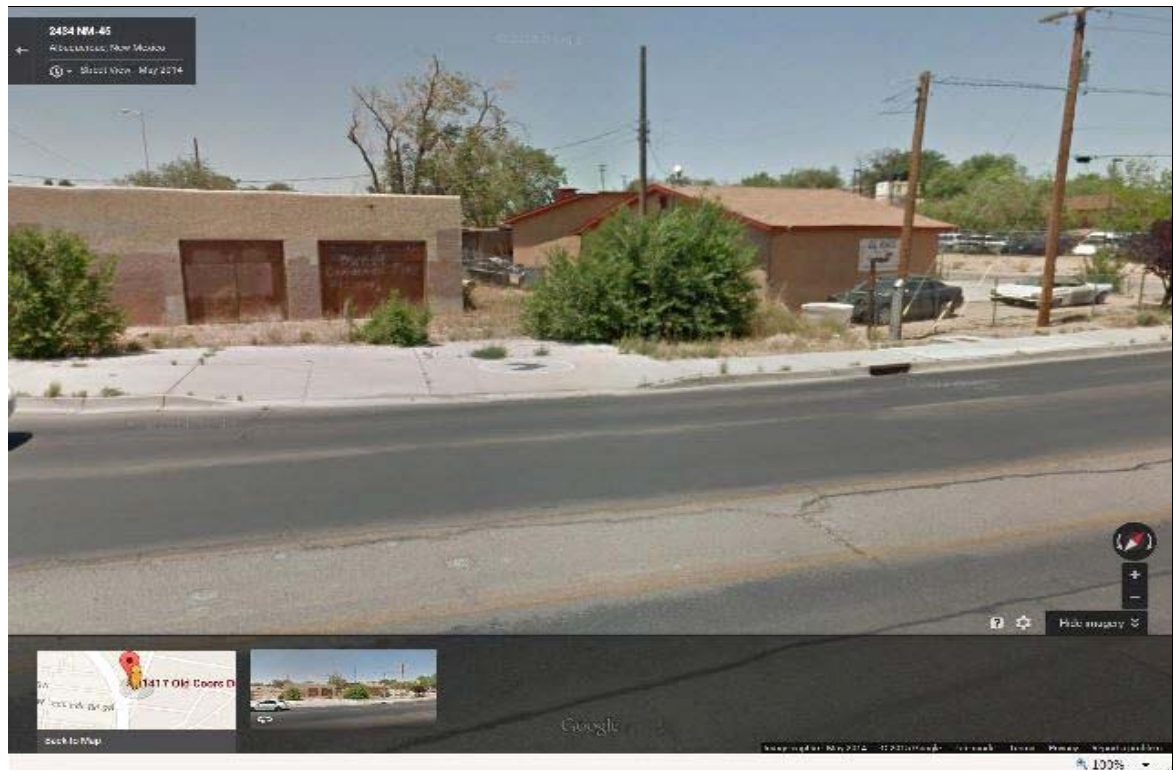
1417 OLD COORS SW

CONCERNED CITIZEN WOULD LIKE THIS BUILDING REMOVED, ALSO THERE IS OVERGROWN VEGETATION (WEEDS/TREES) UP TO STREET BLOCKING CITIZENS BUSINESS SIGNS. FINALLY, THERE IS A LARGE OIL BARREL LEAKING ONTO PROPERTY.

NO VISIT, OUT OF CITY LIMIT

THE CALLER OWNS THE HOME AT THIS OUTSIDE CITY LIMIT ADDRESS.HE NEEDS TO CALL THE COUNTY.

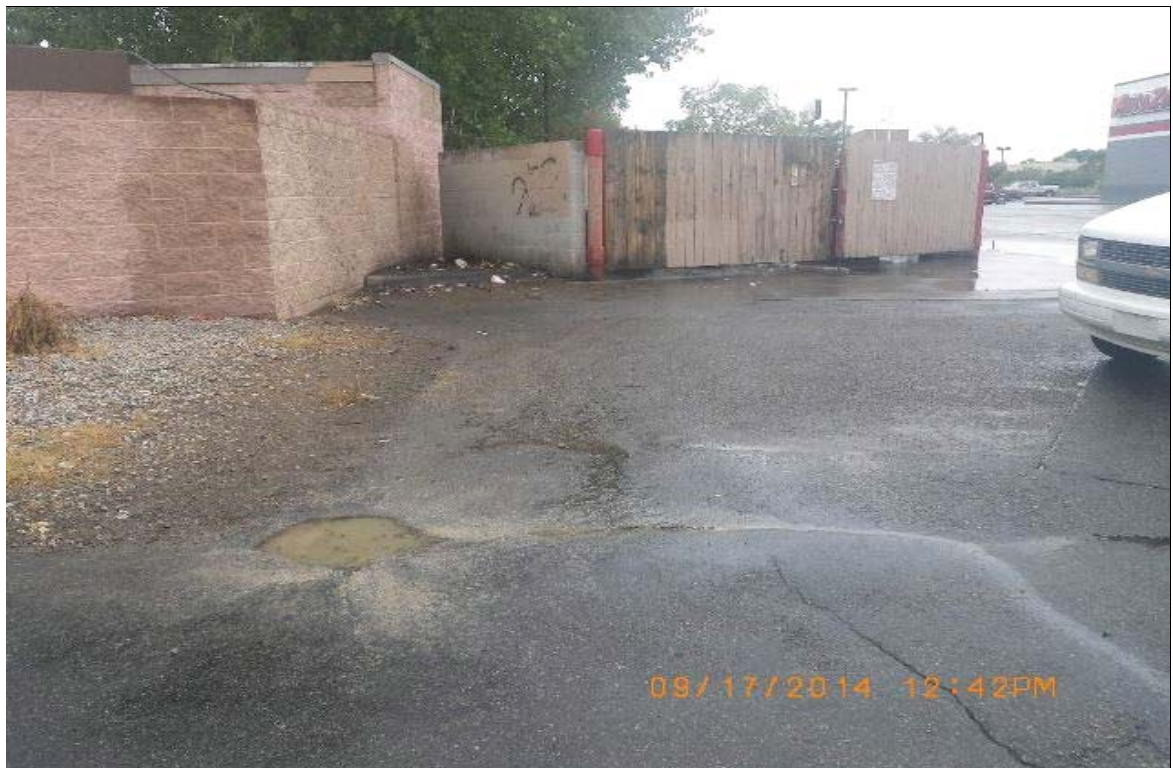
BRIDGE AND 4TH ST SW

MOTOR OIL HAS BEEN SPILLED IN MCDONALDS PARKING LOT GOING INTO STORM DRAIN

AUTOZONE MANAGER TOLD ME THAT SOMEONE LEFT USED MOTOR OIL NEAR THE DUMPSTER AND SHE DID TAKE CARE OF THE SPILLED OIL.THE OIL SPOTS WERE COVERED WITH ABSORBENT.

I LEFT POLLUTION PREVENTION BROCHURES WITH THE AUTOZONE AND MCDONNELL'S MANAGERS.

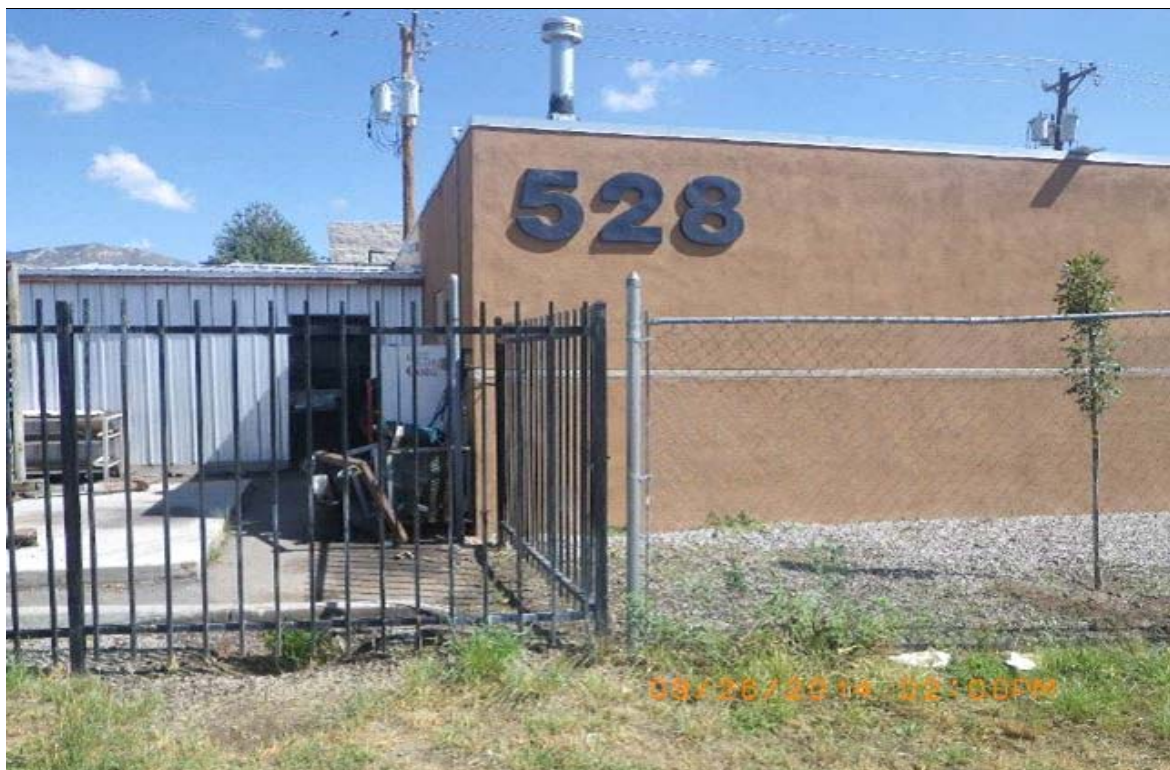
Address	528 JUAN TABO NE		
Event ID	431	REPORTING SOURCE	Complaint Date 9/17/2014
CUSTOMER	ERIC MUNN	311CASE ID	E-MAIL e-mail holybarbarian@yahoo.com
CUSTOMER Ph#	688-2914	SharePointLink: http://sharepoint.cabq.gov/dmd/storm/STORMWATER%20POLLUTION	
Description:	CONSIDERING THE NATURE OF THIS BUSINESS, I WOULD LIKE YOU TO PROPOSE A BMP SUITED FOR THIS SITE.		
Suspected Facility	BUSINESS	Type of Complaint	OIL
Inspection Date	9/25/2014	Number of Field Visits	1 Inspector SK
Facility Contact	MANAGER	Facility Ph. #	
FIELD OBSERVATION	I SAW A FEW SMALL OIL SPOTS AT THE BACK OF THE BUILDING. THE OWNER CLAIMS THAT HE IS USING THIS PLACE TO STORE ANTIQYE CARS AND HE HAS NO OIL PROBLEMS.		
INITIAL ACTION	I LEFT P2 BROCHOURS AT THIS BUSINESSAND ASKED THEM TO KEEP THE PLACE CLEAN.

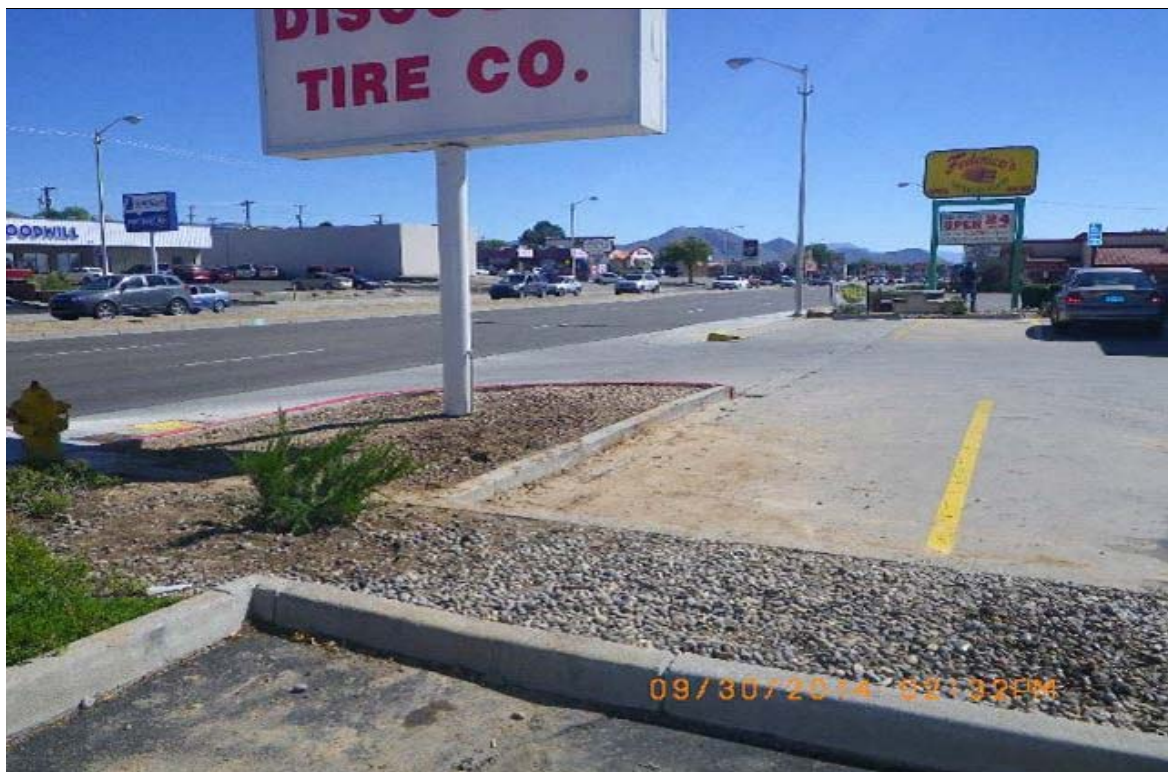
Address	MIDAS AT 1129 JUAN TABO NE		
Event ID	432	REPORTING SOURCE	Complaint Date 9/29/2014
CUSTOMER	DANIEL GONZALES	311CASE ID	13012578, 13012947 e-mail
CUSTOMER Ph#	917-650-0135	SharePointLink: http://sharepoint.cabq.gov/dmd/storm/STORMWATER%20POLLUTION	
Description:	MIDAS IS POURING USED OIL NITO STORM DRAIN		
Suspected Facility	MIDAS AUTO	Type of Complaint	OIL
Inspection Date	9/30/2014	Number of Field Visits	1 Inspector SK
Facility Contact	MANAGER	Facility Ph. #	
FIELD OBSERVATION	THE MANAGER EXPLAINED TO ME THAT THERE WAS SOMEONE DRILLING NEAR THE INLET YESTERDAY TO INSTALL A SIGN NEXT TO HIS BUSINESS AND NONE OF HIS EMPLOYEE EVER DUMPED ANY OIL TO THE INLET.I DID NOT SEE ANY OIL AT THE INLET.		
INITIAL ACTION	I LEFT SOME P2 BROCHURES WITH THE MANAGER FOR HIS EMPLOYEES TO READ.

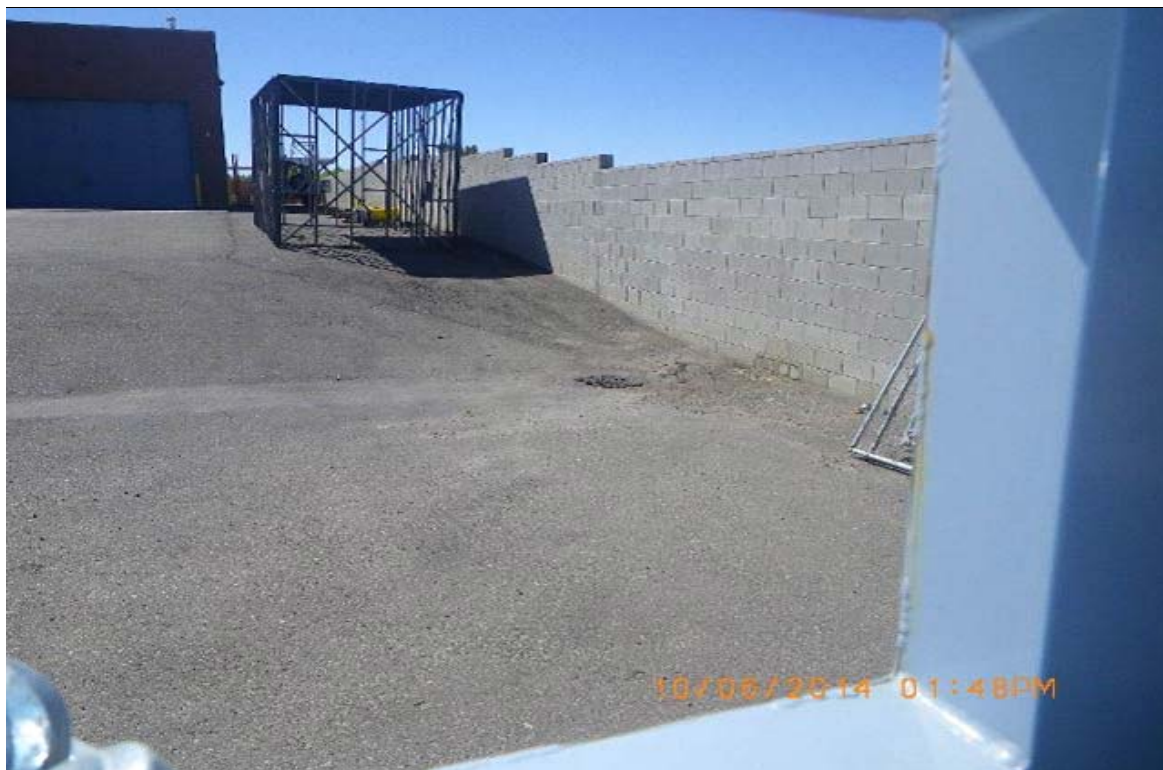
Address	5809 JEFFERSON ST NE		
Event ID	433	REPORTING SOURCE	Complaint Date 10/2/2014
CUSTOMER	LEROY CORDOVA	311CASE ID WEB	e-mail leeleeinabq@yahoo.com
CUSTOMER Ph#	873-1542	SharePointLink: http://sharepoint.cabq.gov/dmd/storm/STORMWATER%20POLLUTION	
Description:	COOLENT AND SOLVENT LIQUIDS. ONGOING DUMPING MONTHLY FOR YEARS IN BACK DRAIN OF ENCLOSED YARD (NORTH SIDE).		
Suspected Facility	BACKERWORKS MANUFACTURING	Type of Complaint	HAZARDOUS MATERIAL
Inspection Date	10/6/2014	Number of Field Visits	1 Inspector SK
Facility Contact	MANAGER	Facility Ph. #	342-2943
FIELD OBSERVATION	I DID NOT SEE ANY EVIDENCE OF DUMPING TO THE STORM INLET		
INITIAL ACTION	THIS COMPANY HAS MSGP, I GAVE THE MANAGER POLLUTION PREVENTION BROCHURES.

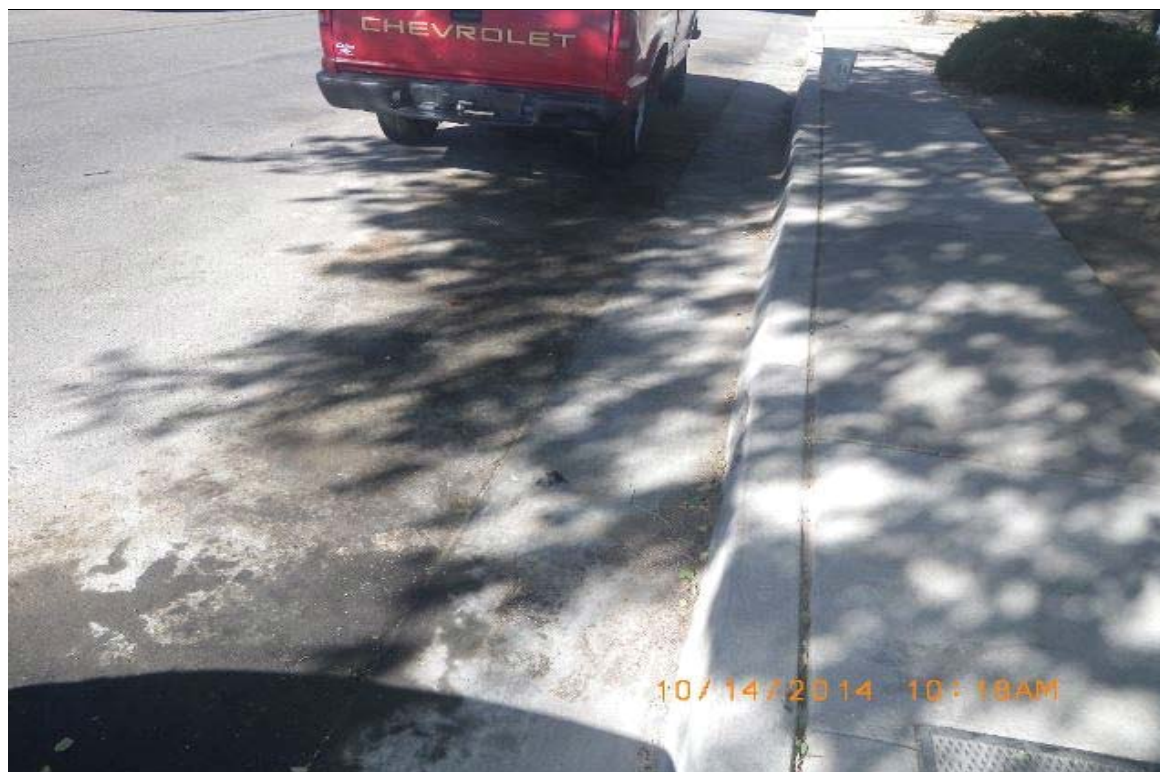
Address	4323 MESA GRANDE PL SE		
Event ID	443	REPORTING SOURCE	Complaint Date 10/10/2014
CUSTOMER	ABQ NEIGHBOR	311CASE ID 13055312	e-mail
CUSTOMER Ph#		SharePointLink: http://sharepoint.cabq.gov/dmd/storm/STORMWATER%20POLLUTION	
Description:	USED VEHICLE REPAIR BUSINESS ON STREET IN FRONT OF HOUSE. OIL, ANTIFREEZE ON STREET HTTP://SEECLICKFIX.COM/ISSUES/1316235		
Suspected Facility	HOME	Type of Complaint	OIL & ANTIFREEZE
Inspection Date	10/14/2014	Number of Field Visits	1 Inspector SK
Facility Contact	RESIDENT	Facility Ph. #	
FIELD OBSERVATION	THE RESIDENT TOLD ME THAT SHE HAD TRANSMISSION PROBLEM WITH HER CAR AND SOMEONE FROM THE CITY CAME BY AND CLEANED UP THE SPILLED OILS.I NOTICED THAT THE AREA HAS BEEN CLEANED UP.		
INITIAL ACTION	NO ACTION WAS NECESSARY. I LEFT POLLUTION PREVENTION BROCHURES AT THIS NEIGHBORHOOD.

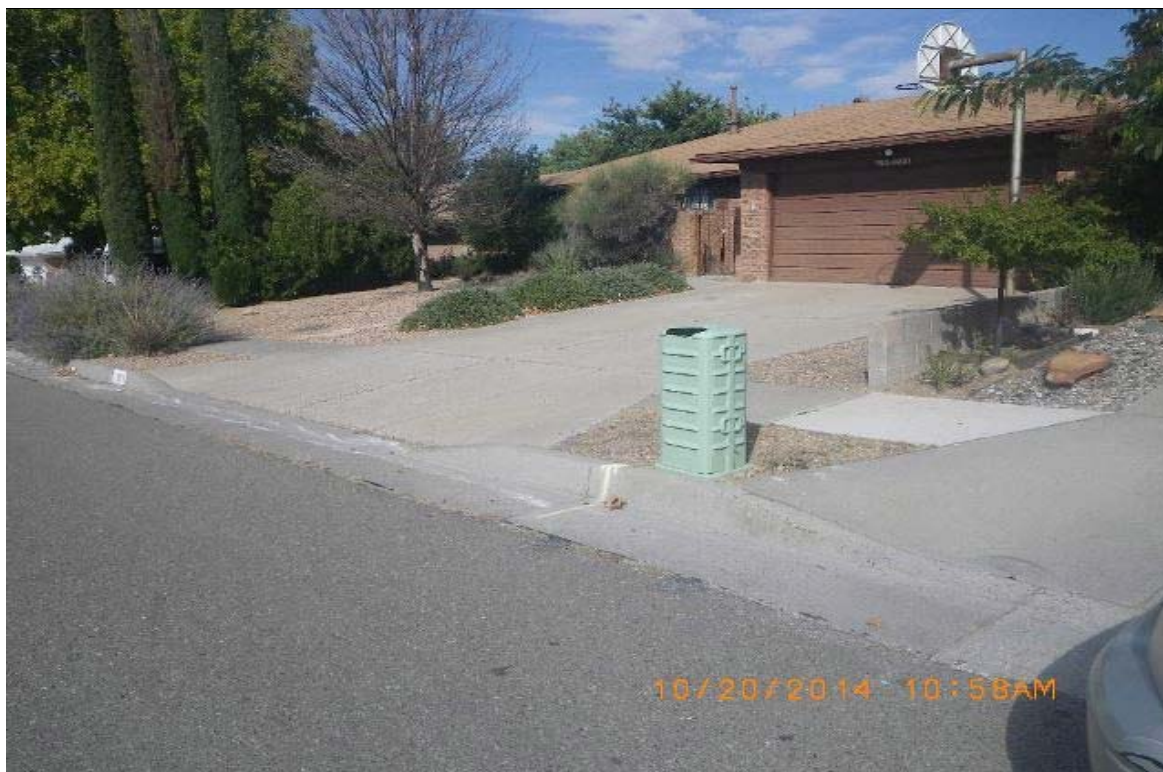
Address	9521 AVENIDA DEL OSO NE		
Event ID	434	REPORTING SOURCE	Complaint Date 10/15/2014
CUSTOMER	ALAN HILL	311CASE ID 13070365	e-mail
CUSTOMER Ph#	962-2385	SharePointLink: http://sharepoint.cabq.gov/dmd/storm/STORMWATER%20POLLUTION	
Description:	OWNERS OF PROPERTY DUMPING PAINT IN GUTTER AND ENDS UP IN SEWER		
Suspected Facility	HOME	Type of Complaint	SEDIMENT
Inspection Date	10/20/2014	Number of Field Visits 1	Inspector SK
Facility Contact	RESIDENT	Facility Ph. #	
FIELD OBSERVATION	THE SOURCE WAS FROM 9521 AVENIDA DEL OSO NE, THE WHITE RESIDUE ALONG THE GUTTER WAS THE WASHED LIME RESIDUE ON THE SWIMMING POOL FILTER, THE RESIDENT THOUGHT IT WAS OKAY TO WASH THE FILTER ON THE STREET.		
INITIAL ACTION	I ASKED HIM TO STOP DOING THIS IN THE FUTURE AND I DISTRIBUTED POLLUTION PREVENTION BROCHURES AT THIS NEIGHBORHOOD.

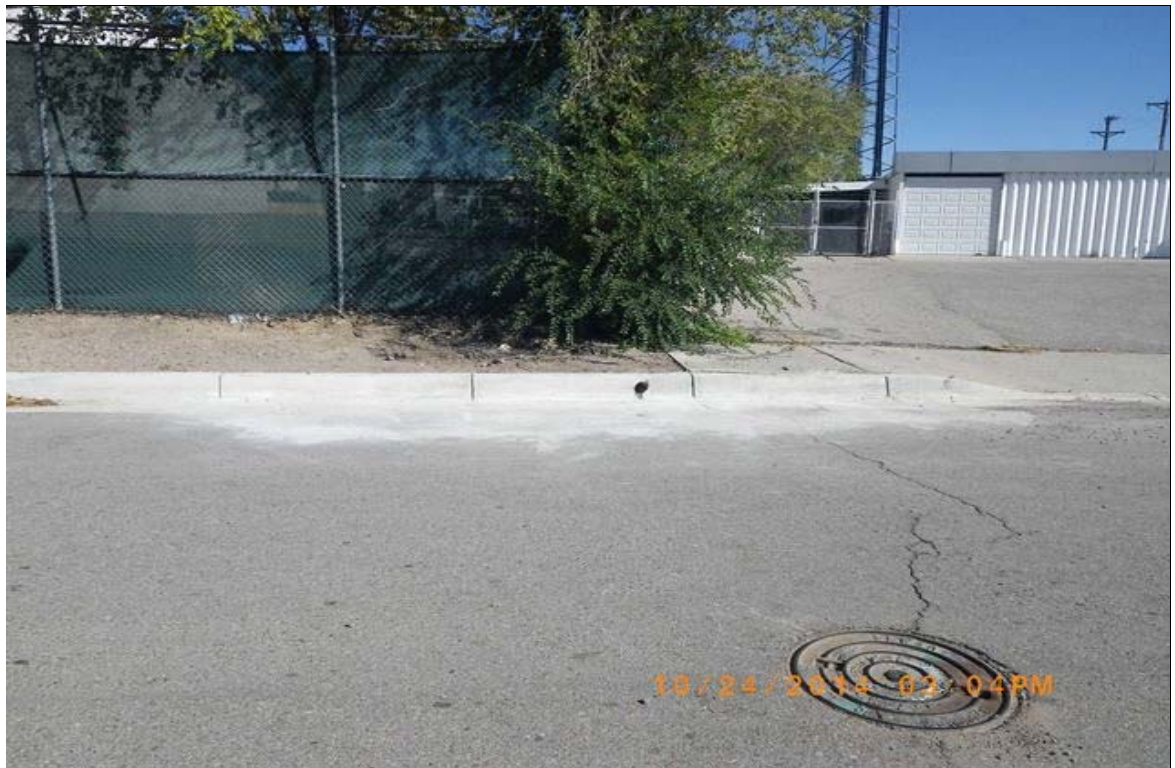
REDBURN TIRE CO. AT 2645 BAYLOR SE

ONE OF OUR CREWS NOTICED THIS STORMWATER DISCHARGE. THE ADDRESS IS 2645 BAYLOR DR SE. THOUGHT YOU WOULD WANT TO KNOW.SEE THE ATTACHED PICTURES.

THE MANAGER TOLD ME THAT ONE OF HIS EMPLOYEES WASHED AN EMPTY 55 GALLON CONTAINER (OF WATER BASED TIRE PAINT) AND IT DRAINED TO THE STREET.

THEY DID CLEANED UP THE AREA AND DISCIPLINED THE EMPLOYEE WHO DID THAT. THE MANAGER GAVE ME A COPY OF MSDS FOR THIS PRODUCT WHICH INDICATES IT IS SAFE.
