Locations of the Public Calls in 2014

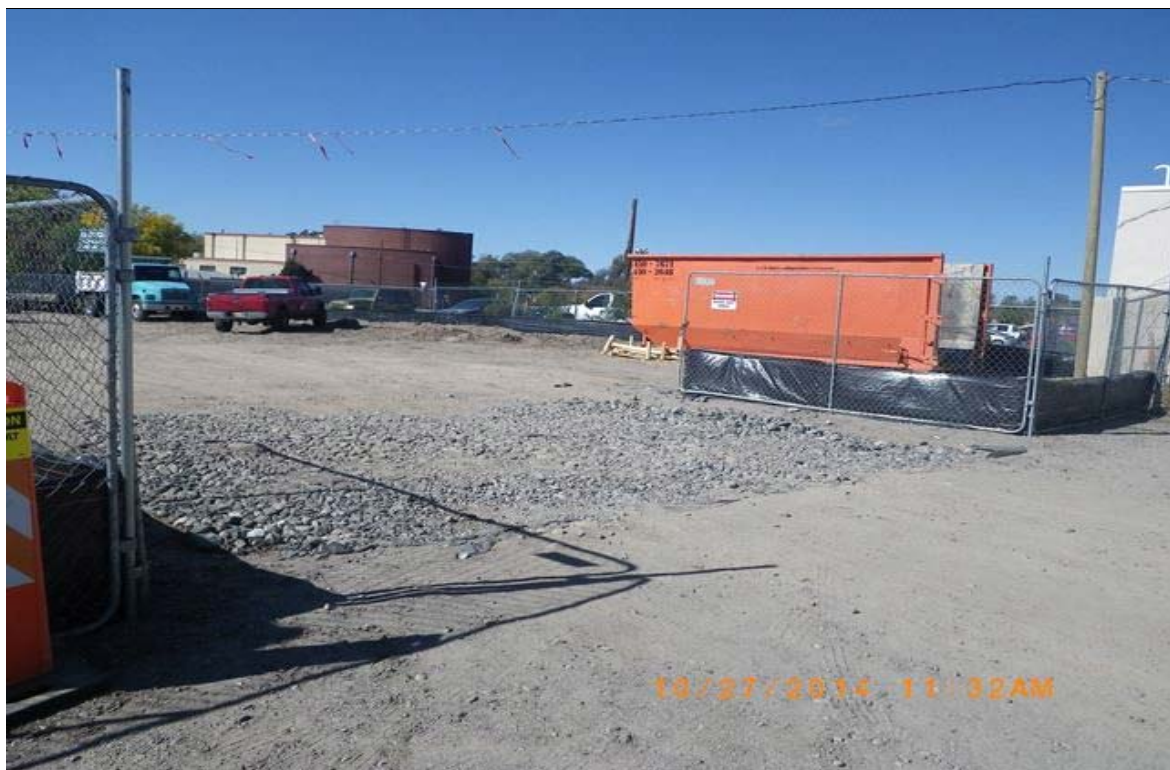
Address	224 SAN PASQUAL SW		
Event ID	436	REPORTING SOURCE	Complaint Date 10/24/2014
CUSTOMER	KEVIN DAGGETT	311CASE ID	E-MAIL kdaggett@cabq.gov
CUSTOMER Ph#	768-2778	SharePointLink: http://sharepoint.cabq.gov/dmd/storm/STORMWATER%20POLLUTION	
Description: DIRT IS BEING TRACKED AND A BICYCLIST ALMOST SLIPPED ON THE MUD.			
Suspected Facility	GARCIA'S KITCHEN CONSTRUCTION	Type of Complaint	CONSTRUCTION
Inspection Date	10/27/2014	Number of Field Visits	1 Inspector SK
Facility Contact	SUPERINTENDENT	Facility Ph. #	
FIELD OBSERVATION	THE TRACKED MUD WAS VISIBLE COMING FROM THIS SITE.		
INITIAL ACTION	THE SUPERINTENDENT ASKED THE WORKER TO SWEEP THE AREA AND IMPROVE THE BMP OF THE SITE ENTRANCE.

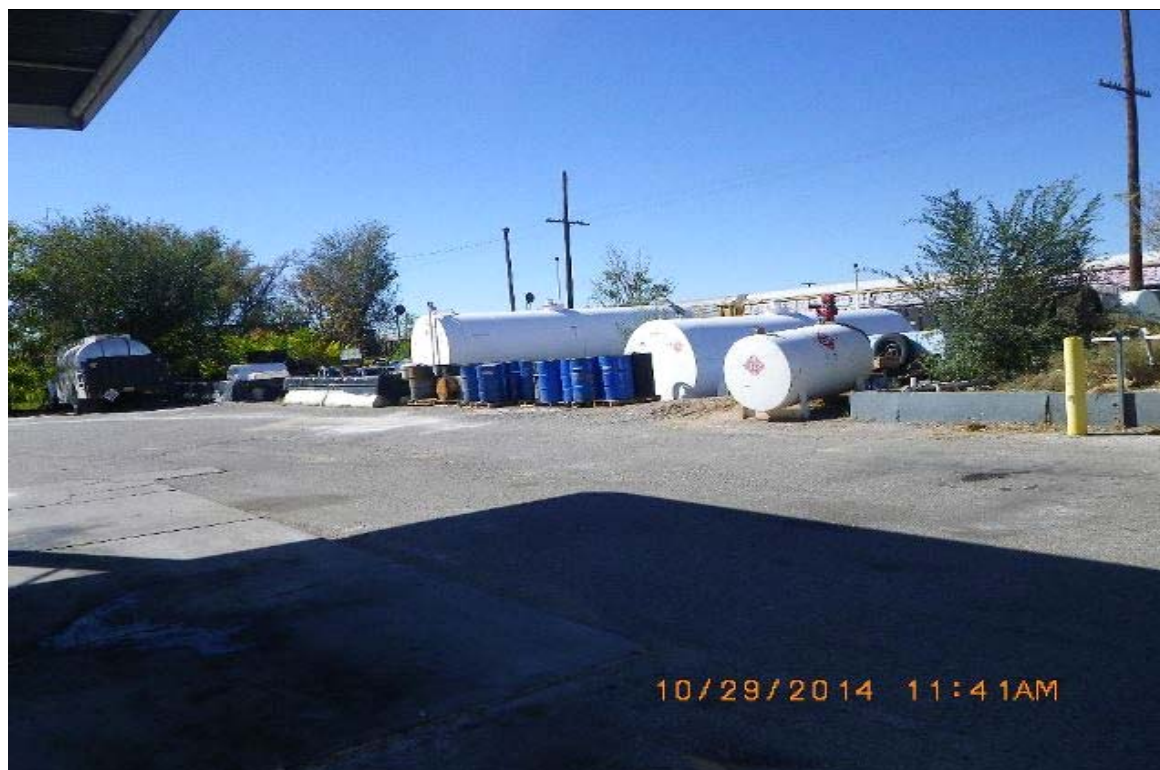
Address	101 ANDERSON SE		
Event ID	439	REPORTING SOURCE	Complaint Date 10/25/2014
CUSTOMER	STEVEN ABEYTA	311CASE ID 13110481	e-mail
CUSTOMER Ph#	244-9395	SharePointLink: http://sharepoint.cabq.gov/dmd/storm/STORMWATER%20POLLUTION	
Description:	CITIZEN REPORTING OIL OR FUEL SPILL AT ADDRESS ADVISED AIR QUALITY WILL NOT GO OUT TO CLEAN. CITIZEN INSISTED IT BE REPORTED SINCE HE CAN SMELL IT.		
Suspected Facility	BIG BEAR PETROLEUM	Type of Complaint	OIL
Inspection Date	10/29/2014	Number of Field Visits	1 Inspector SK
Facility Contact	MANAGER	Facility Ph. #	250-3816
FIELD OBSERVATION	I SAW SEVERAL OIL SPOTS COVERED WITH ABSORBENT. THE MANAGER TOLD ME THAT A CUSTOMER SPILLED SOME USED OIL BY ACCIDENT AND THEY COVERED IT WITH ABSORBENT. ALSO HE SHOWED ME THEIR OPERATIONS & MAINTENANCE PLAN MANUAL.		
INITIAL ACTION	I GAVE THE MANAGER SEVERAL COPIES OF POLLUTION PREVENTION BROCHURES FOR HIS EMPLOYEES.

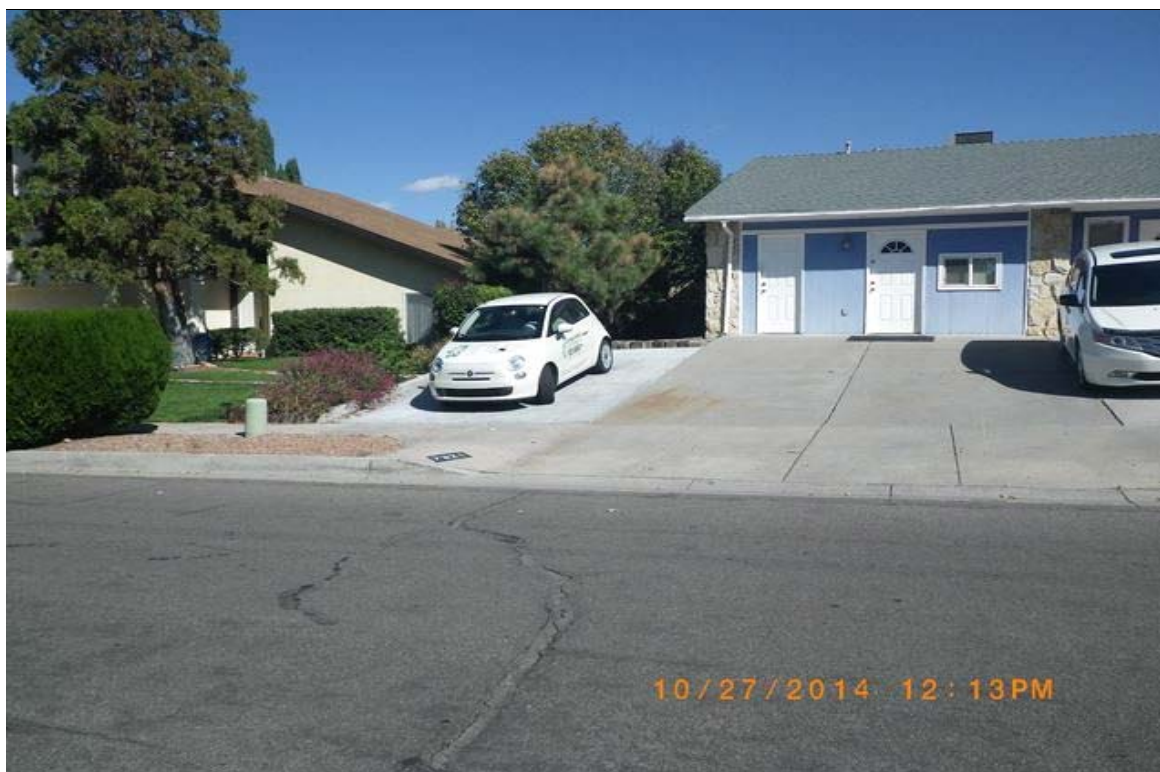
Address	7321 VIVIAN NE		
Event ID	438	REPORTING SOURCE	Complaint Date 10/27/2014
CUSTOMER	ROBERT KNOLLS	311CASE ID 13110168	e-mail
CUSTOMER Ph#	797-0422	SharePointLink: http://sharepoint.cabq.gov/dmd/storm/STORMWATER%20POLLUTION	
Description:	A1 CARPET CLEANING IS EMPTING THE WATER CONTAINING CHEMICALS FROM THEIR CARPET CLEANING BOX COMMERCIAL TRUCK ALONG THE CURB AREA. HE IS CONCERNED BECAUSE OF THE CHEMICALS.		
Suspected Facility	STREET	Type of Complaint	CARPET CLEANING
Inspection Date	10/27/2014	Number of Field Visits 1	Inspector SK
Facility Contact	RESIDENT	Facility Ph. #	
FIELD OBSERVATION	I SPOKE TO THE RESIDENT REGARDING THE INCIDENT AND SHE TOLD ME THAT THEY DUMPED CLEAN WATER TANK ONLY. THERE WERE NO STORM INLETS AT THIS AREA AND THE STREET (AND THE GUTTER) WAS CLEAN.		
INITIAL ACTION	I GIVE HER AND OTHER NEIGHBOR SOME POLLUTION PREVENTION BROCHURES.

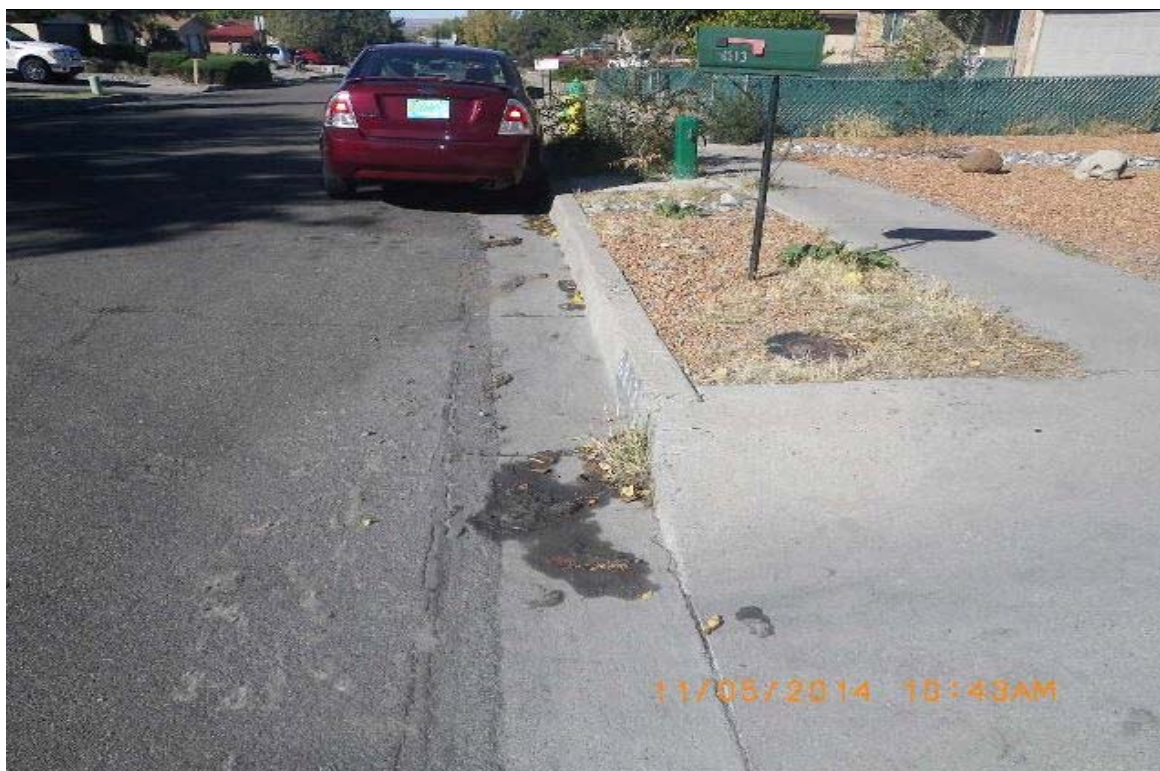
Address	6313 BELCHER NE		
Event ID	440	REPORTING SOURCE	Complaint Date 11/4/2014
CUSTOMER	MARY VILLANUEVA	311CASE ID 13146049	e-mail
CUSTOMER Ph#	507-5263	SharePointLink: http://sharepoint.cabq.gov/dmd/storm/STORMWATER%20POLLUTION	
Description:	CITIZEN SAID HER NEIGHBOR HAS A CARPET CLEANING BUSINESS AND AT NIGHT THEY DUMP ALL OF THE DIRTY WATER ON THE STREET AND IT RUNS DOWN AND INTO THE INLET GRATES CITIZEN WOULD LIKE TO KNOW IF THIS IS ILLEGAL.		
Suspected Facility		Type of Complaint	CARPET CLEANING
Inspection Date	11/5/2014	Number of Field Visits	1
Facility Contact		Inspector	SK
Facility Ph. #			
FIELD OBSERVATION	THERE WERE SOME INDICATIONS OF DUMPING CARPET CLEANING WASTE WATER IN FRONT OF THIS ADDRESS.		
INITIAL ACTION	I WENT TO THIS ADDRESS BUT NOBODY WAS HOME. I DISTRIBUTED POLLUTION PREVENTION BROCHURES AT THIS NEIGHBORHOOD

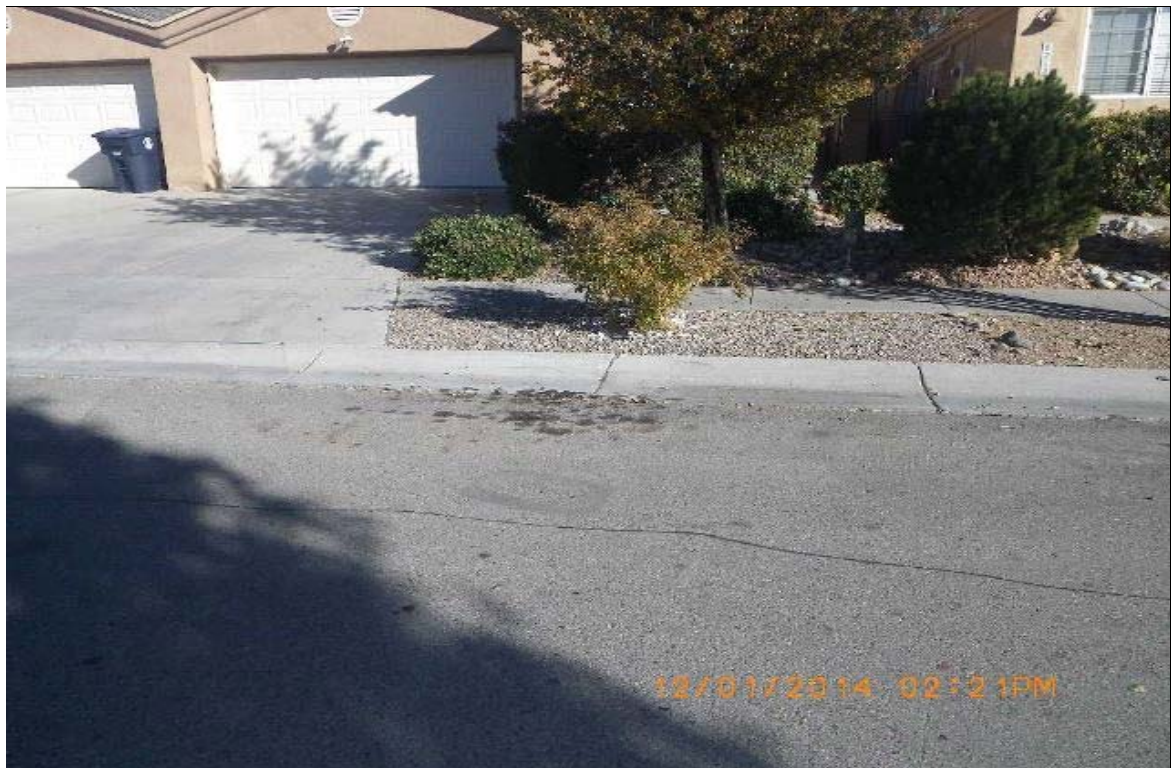
8212 CALLE AVION NE

Description: VEHICL LEAKING OIL

THERE WAS NO NEED THE DRIED OIL TO BE COVERED WITH ABSORBENT. I DISTRIBUTED POLLUTION PREVENTION BROCHURES AT THIS NEIGHBORHOOD.

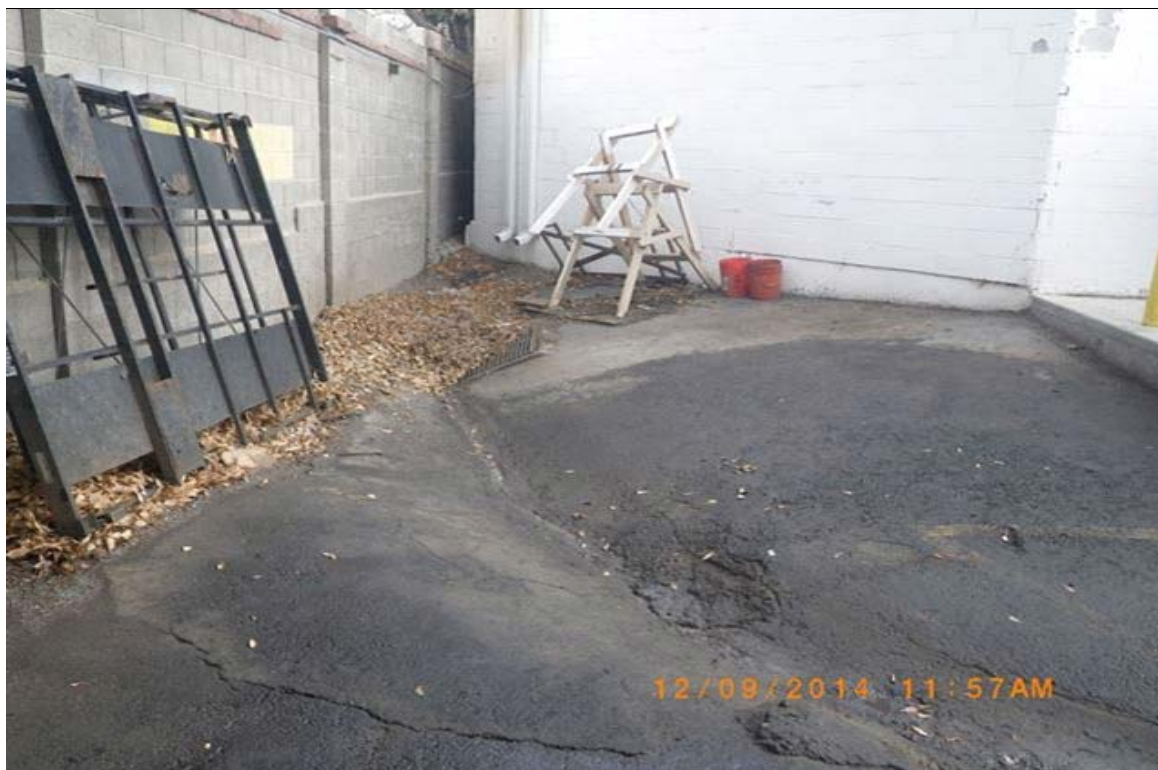
Address	5310 SAN MATEO NE-FRANK'S POWER EQ				
Event ID	445	REPORTING SOURCE	Complaint Date		12/8/2014
CUSTOMER	ANONYMOUS	311CASE ID	PH-CALL TO KF	e-mail	
CUSTOMER Ph#		SharePointLink: http://sharepoint.cabq.gov/dmd/storm/STORMWATER%20POLLUTION			
Description:	ENGINE WASH				
Suspected Facility	FRANK'S POWER EQUIPMENTS	Type of Complaint		OIL	
Inspection Date	12/9/2014	Number of Field Visits	1	Inspector	SK
Facility Contact	OWNER-MANAGER	Facility Ph. #	872-2535		
FIELD OBSERVATION	THEY HAVE AN AREA THAT THEY POWERWASH EQUIPMENT THAT DRAINS TO STORM DRAIN.THIS BUSINESS HAS A SHOP FOR SMALL ENGINE REPAIR.THEY ARE CALSSIFIED AS SIC CODE 526109 LAWN MOWERS, NOT REQUIRED TO HAVE INDUSTRIAL PERMIT.				
INITIAL ACTION	LEFT POLLUTION PREVENTION BROCHURES WITH THE MANAGER AND TOLD HIM THAT POWERWASHING ENIGNS AT THE STORM INLET IS NOT ACCEOTABLE.
