City of Albuquerque  
Facility Condition Assessment  
De Anza Motor Lodge

2014 REPORT

## 1.0 Executive Summary

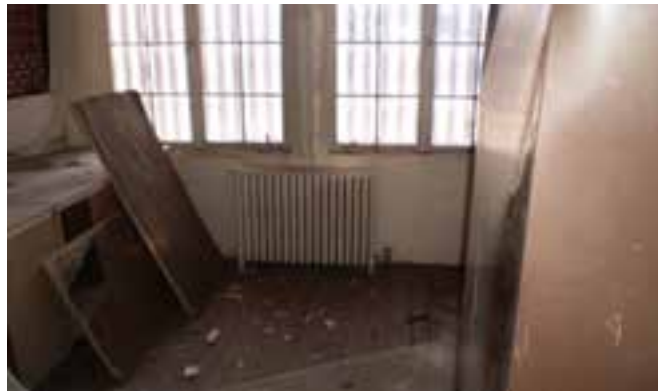
**Figure 2 - Typical Steam Radiator with Manual Control**

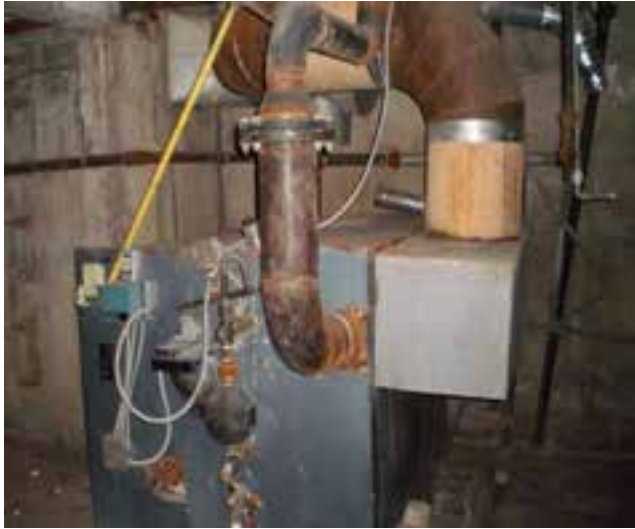
The current installed steam boiler is a replacement boiler that was installed in the early 1990's since the first entry on City of Albuquerque boiler inspection tag is dated December 16, 1992. The last City of Albuquerque Boiler inspection was dated August 5, 1993. Since there is no other entry inspection dates we can only assume that boiler system was no longer used or used without proper City of Albuquerque inspections. There is documentation that the building was at least partially occupied until 2003.

**Existing Steam Boiler**

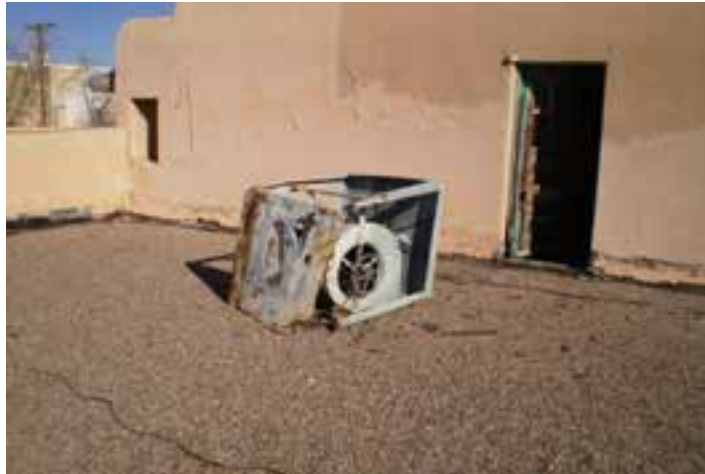
Abandoned Evaporative Cooler for Lobby

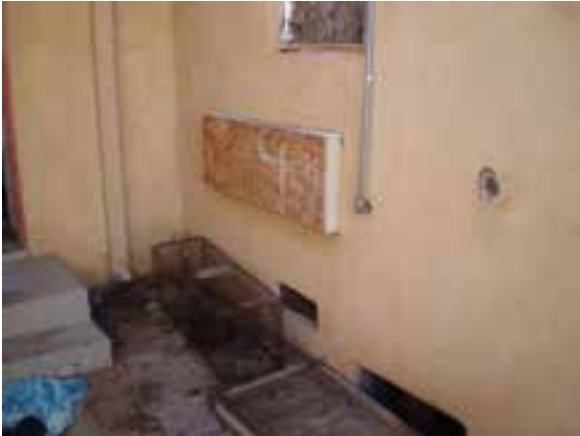
Removed PTAC units with Plywood Cover

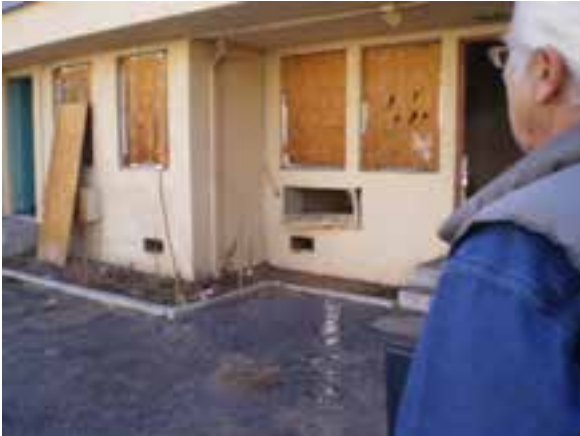
Removed PTAC units without Plywood Cover

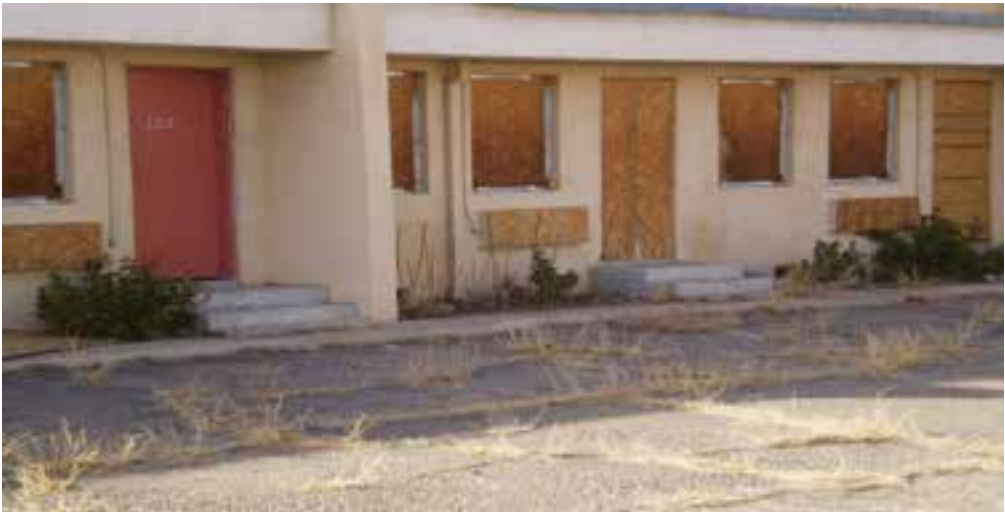
PTAC units with Plywood Cover

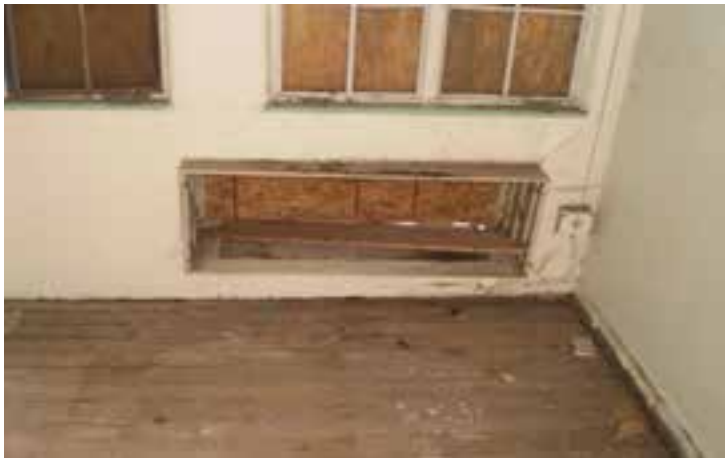
Typical Location of Removed PTAC

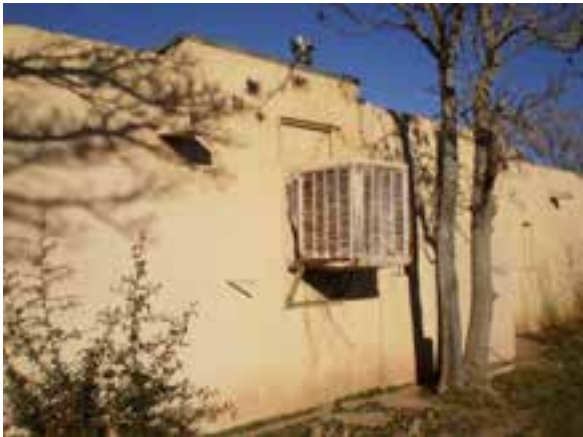
**Added Building 'A' Evaporative Cooler**

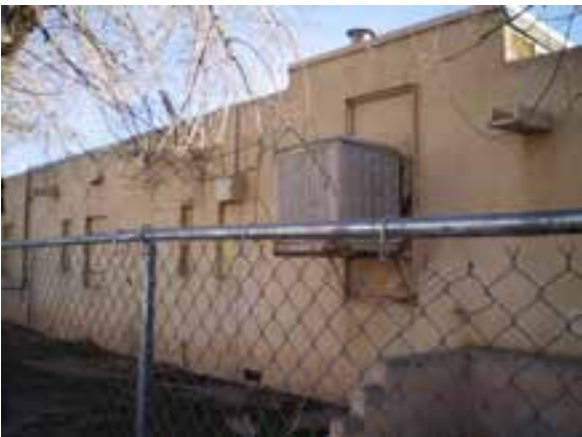
**Added Building 'G' Evaporative Cooler**

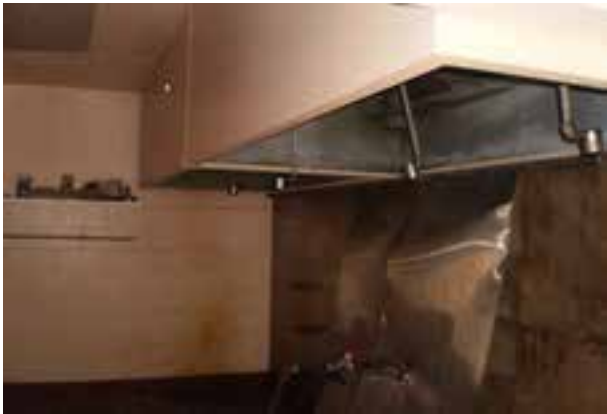
Room toilet and public toilets are not provided with a power exhaust fans. Operable windows are used in lieu of exhaust, which complied with code requirements at the time of construction. The mechanical room is provided a wall ventilation fan. The Kitchen area is provided with a range hood and associated exhaust system. A chemical fire protection system is provided for the range hood. The equipment is abandoned.

Kitchen Range Hood

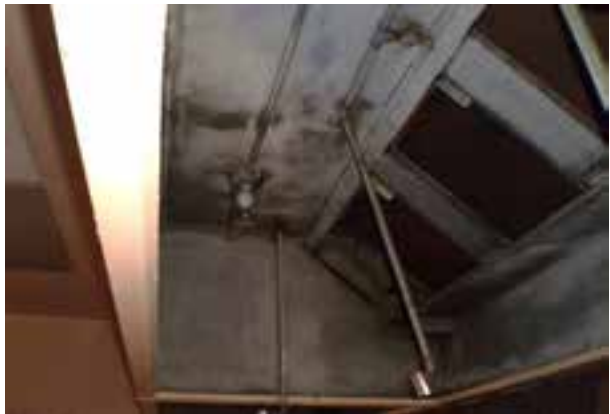
Kitchen Range Hood Fire Protection

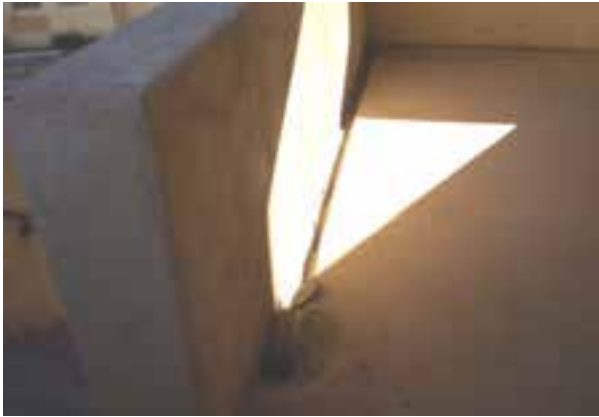
Scuppers and gutters are used for draining all roof areas. The landings of the two story building are provided with a grate cover and drain, one for each side. It appears that the drainage system on both sides of the stairs have been modified. A channel has been improvised against the wall to help with the area draining. This appears to be ineffective.

Eastside Landing Drainage

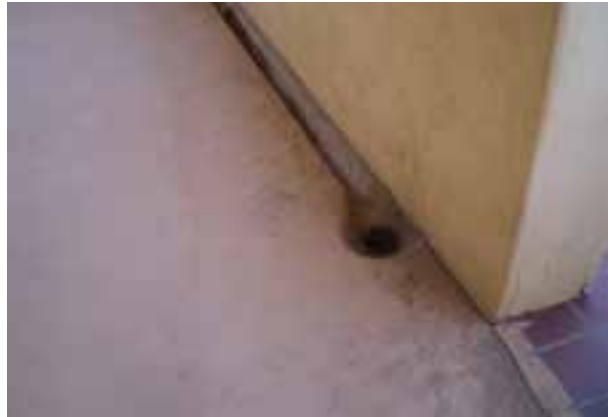
Westside Landing Drainage

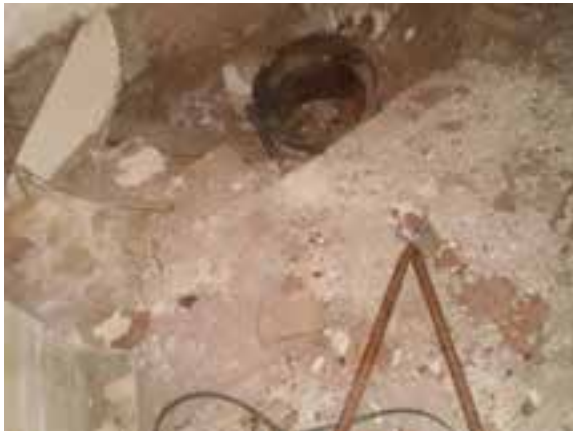
The facility is provided with a Laundry Room Facility. The two compartment sink has been removed from the sanitary system and an open trench drain remains.

Laundry Room Open Trench Drain

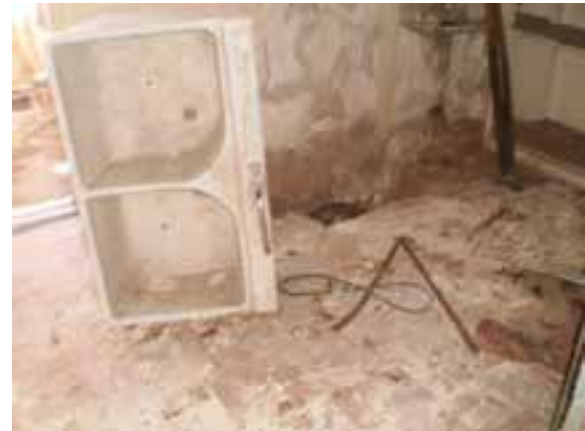
Abandoned Laundry Sink

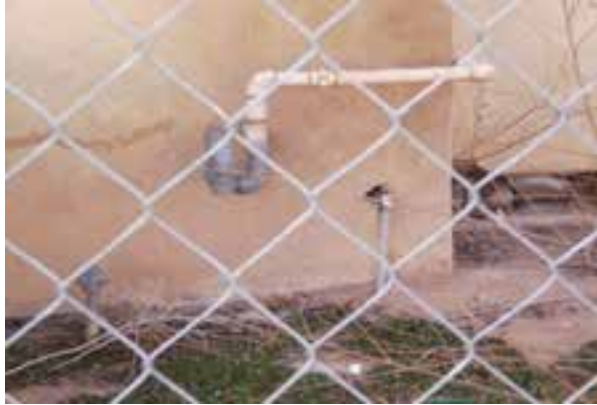
**Missing Kitchen Natural Gas Assembly**

10. If the existing restaurant in Building G is to remain a restaurant, the domestic hot water system needs to be upgraded to comply with current standards. A grease trap will be required.
11. The complete natural gas system needs to be replaced with a system that meets the final occupancy requirements of the facility.

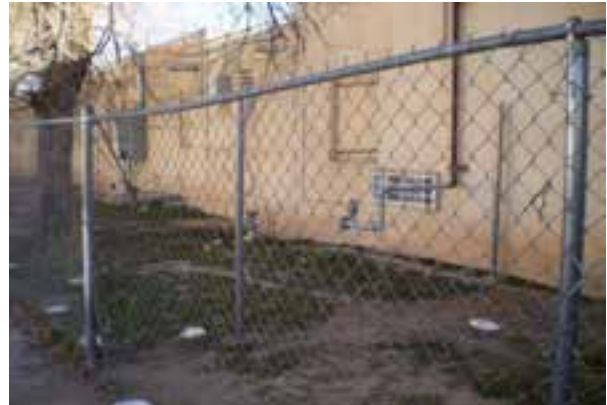
**Missing Building Natural Gas Assembly**

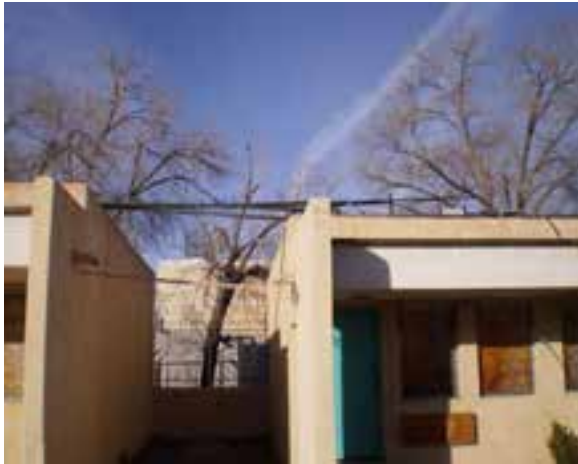
**Poorly Supported Natural Gas Piping Between Bldgs F & G**

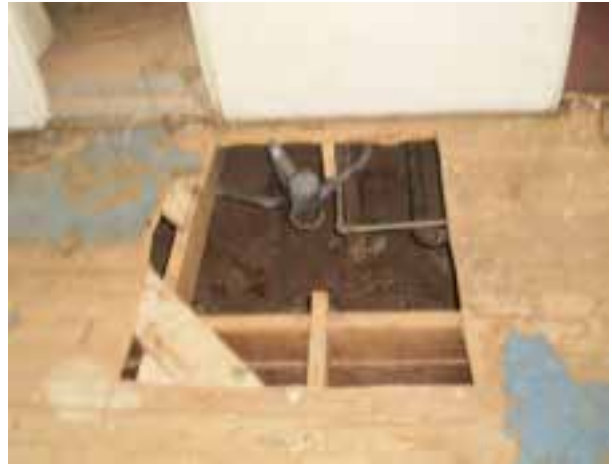
**Plumbing Piping Below Floor in Typical Room**

We did not find a backflow preventer for the main domestic water system or a grease trap for the Kitchen area. The water piping for the plumbing system is galvanized steel pipe. The piping appears in poor condition. Since the buildings were not heated there is a very good possibility that the piping is damaged due to freezing conditions. The heating system piping shows signs of corrosion.

The complete plumbing systems, including the domestic water distribution, domestic hot water, natural gas and sanitary should be replaced. The systems are in deplorable condition, typical of an abandoned building.

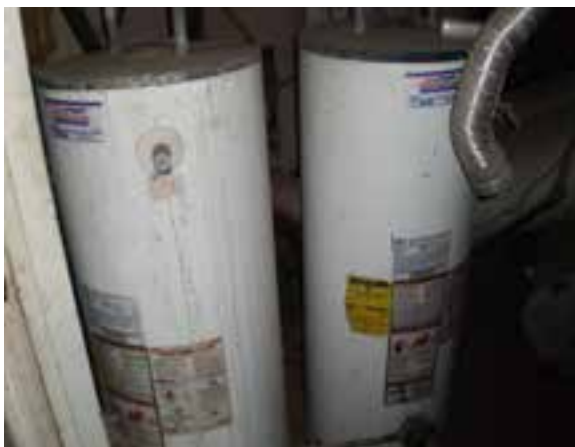
**Natural Gas Central Domestic Water Heaters**

4. Existing water heaters are not connected and not operational.
5. The domestic hot water re-circulation system does not exist.
6. The majority of the plumbing fixtures are either damage or missing. New plumbing fixtures will be required to meet the final configuration of the facility. Also new water fixture would be specified low flow for water conservation.

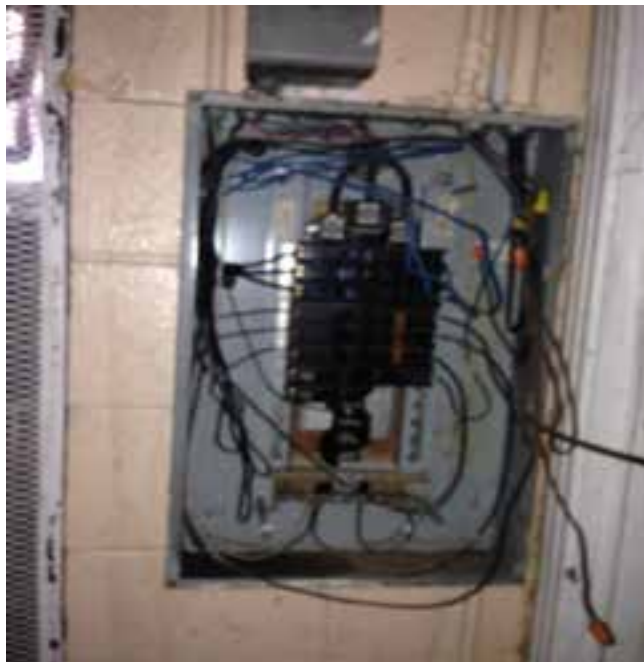
A. Left side first disconnect switch is routed to Sub-Panel "O" in the back office hallway (Bldg. E), shown below.

Sub-Panel Located In Hall Of Office Building "E"

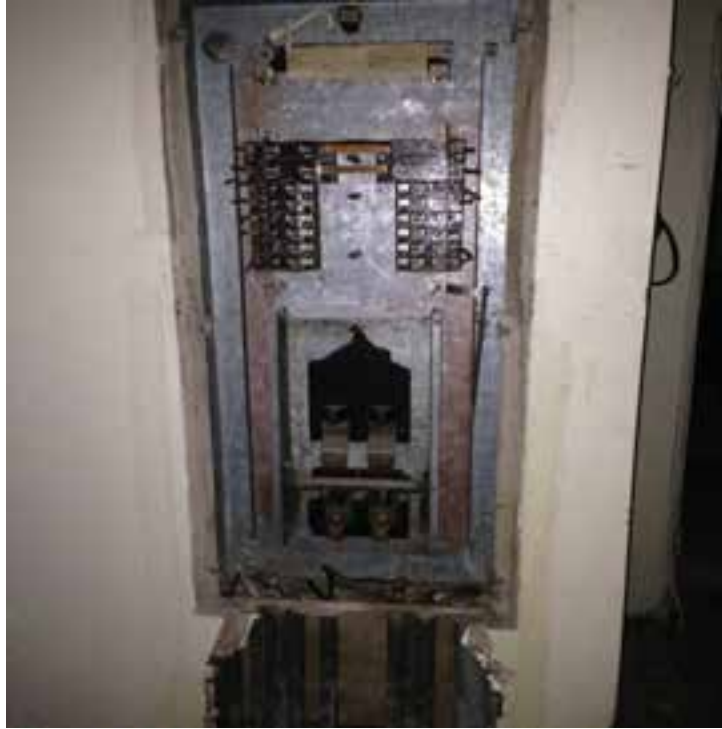
- B. Sub-Panel below is vintage 1938, abandoned in place in the back office North hallway wall, shown below.

Sub-Panel Located In Hall Of Office Building "E"

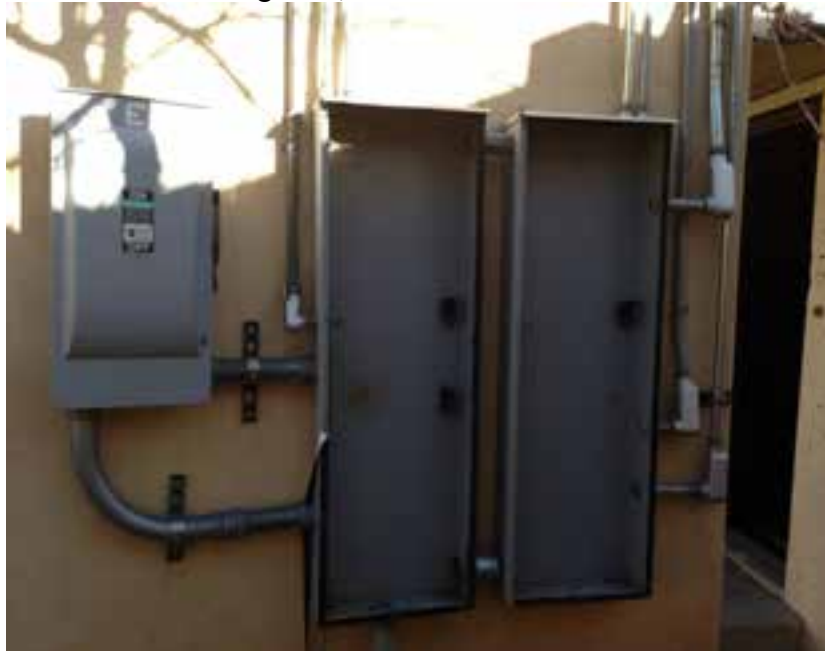
- C. Second disconnect switch is routed to a 240V, 200A disconnect switch to (2) Sub-Panels "E" (EAST) for Rms. 100-129 (Building's A & B) and the other routed to Panel in Building "C" mounted at south exterior wall of Bldg. "B", shown below.

Two Sub-Panels Located At South Exterior Wall Building "B"

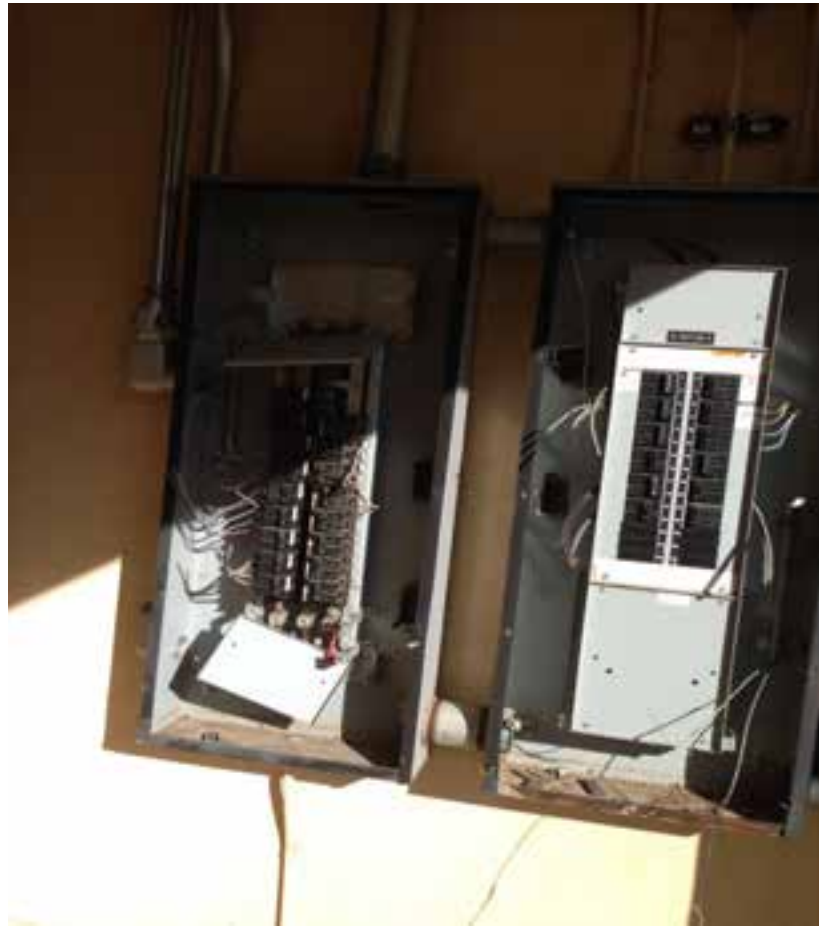
Two Section Sub-Panels Located At South Exterior Wall Building “G”

- E. Panel “W” (WEST) for Rms. 154-182 (Building’s F & G) each with 2.5” Conduit abandoned in place (Feeders are all removed from disconnects to Panels).

- F. There is not any branch circuit conductors from all panels feeding the respective areas in any of the branch circuit conduits from all the panels. The majority of the power distribution system equipment in the De Anza Motor Hotel is in extremely not in usable condition. Grouped Disconnect’s are located on the East side of the building “G” and are vintage 1983’s. All Dead front panel covers, bus, breakers, complete interiors, including wiring of panel boards have been removed or vandalized and are vintage 1983’s. Panels located in the office are load center type, vintage 1939’s, and there are numerous electrical code violations relative to grounding and clearance throughout all of the Buildings. All feeders from the disconnect switches to all the subpanels and branch circuits to all guest rooms have been vandalized at some point.

- 1.5.3 Power System: The electrical service entrance equipment is not in good working condition. All the feeders from the Service Entrance Distribution to the Sub-Panels and branch circuits have been removed or vandalized. There will be new receptacle circuits routed in conduit as required in all of the new guest rooms, offices and through-out the entire facility. Our recommendation, would be to install New Service Entrance Distribution for the calculated load and individual panels for each building “A”, “B”, “C”, “D”, “E”, “F” & “G” and extend branch circuits to the respective panels.

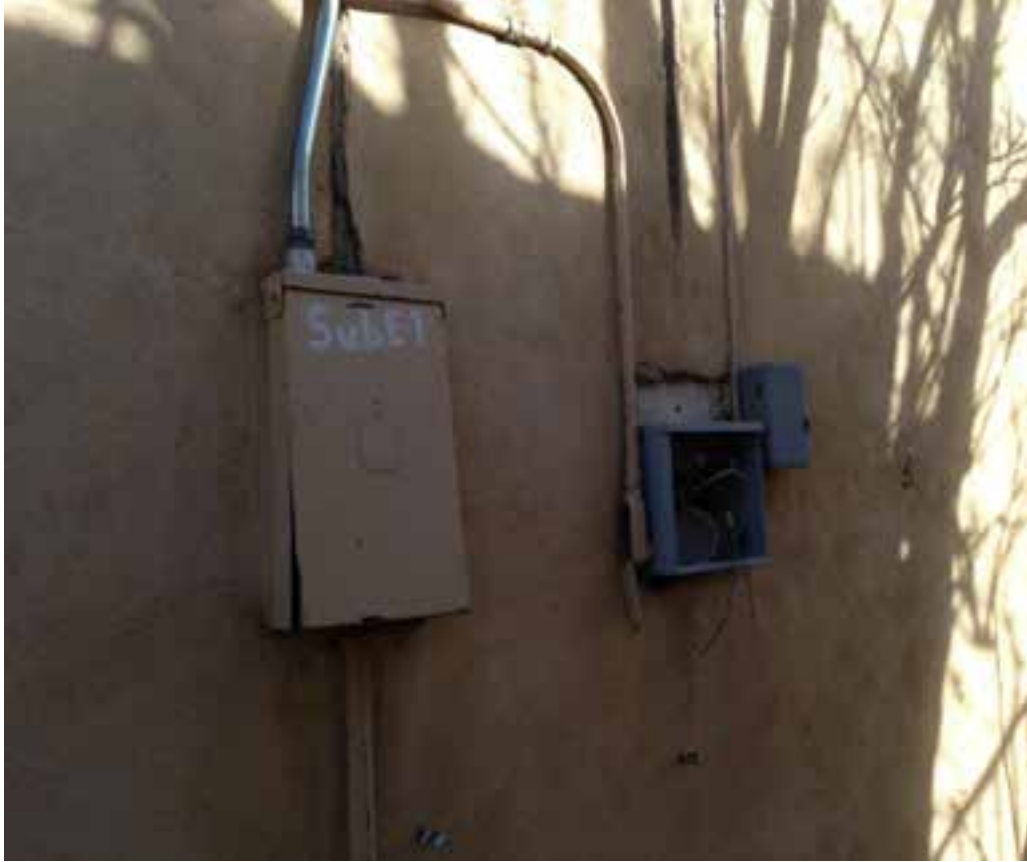
1.1.3 Sub-Panels: Vintage 1939 Sub-Panels “E1” have been used as a pull box when new Service was installed.

Building “B”– Sub Panel “E1” Mounted On The South Exterior Wall Of Bldg. “B”

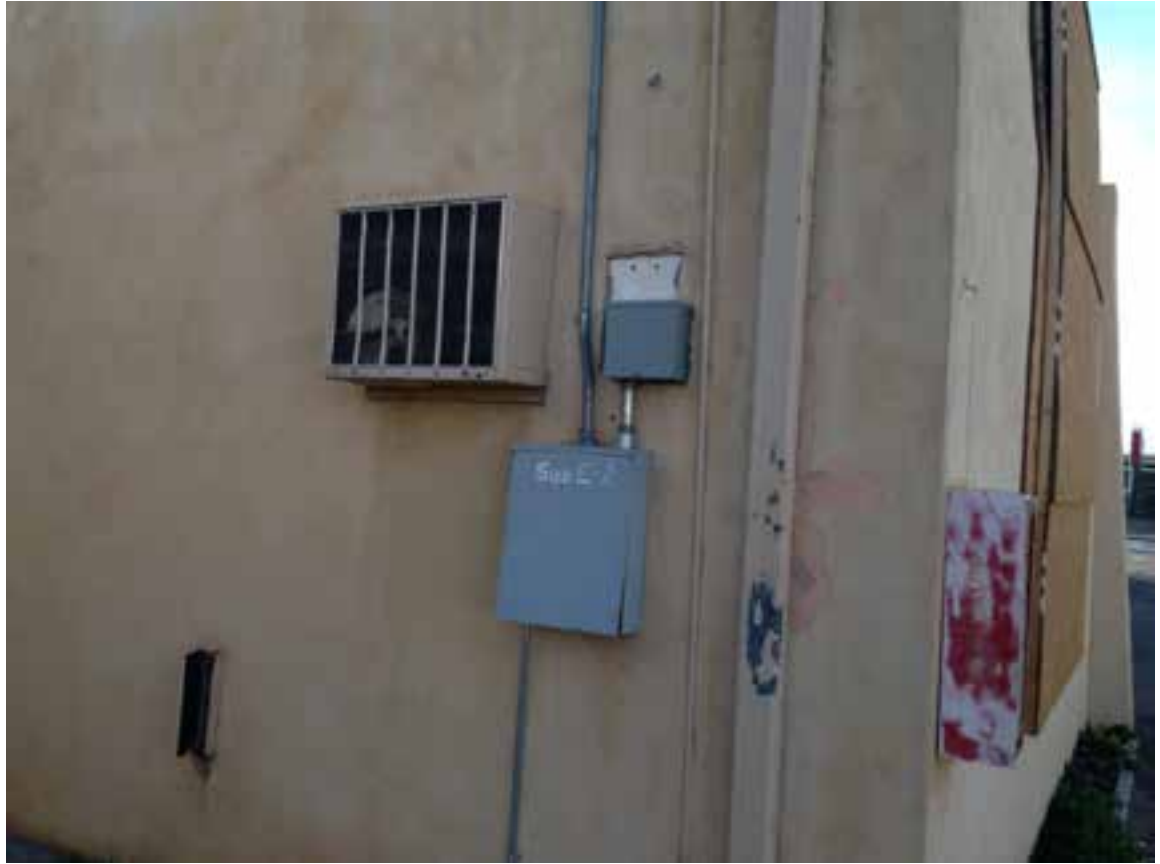
- 1.1.4 Sub-Panels: Vintage 1939 Sub-Panels “E2” have been used as a pull box when new Service was installed.

Building “B”– Sub Panel “E1” Mounted On The South Exterior Wall Of Bldg. “B”

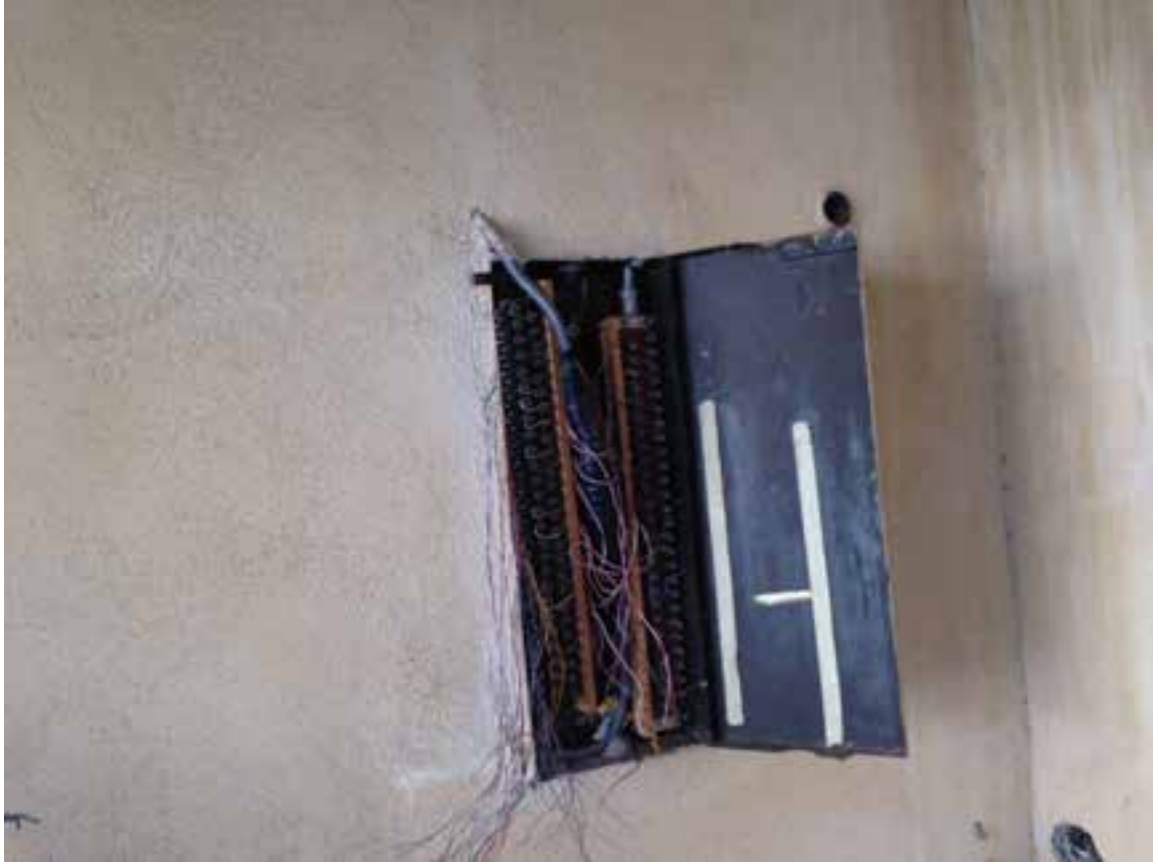
Telephone Terminal Cabinet At South Exterior Wall Of Bldg “B”

- 1.2 Telephone Terminal Cabinet Entrance: The Telephone extend to the guest rooms with two twisted pair telephone cable that is stapled to the wall and other building components. The telephone jacks are surface mounted to the walls and jacks and cable are not in usable condition.

- 1.5.5 Telephone System: The Telephone system is not in good working conditions, it is recommended to replace all telephone system for all the entire Facility. Install new plywood telephone terminal backboard, including ground bar with #6 ground to bonding to main grounding System, device back box & cover plates, RJ45 jacks and 4 #22 conductor twisted pair to terminal board.

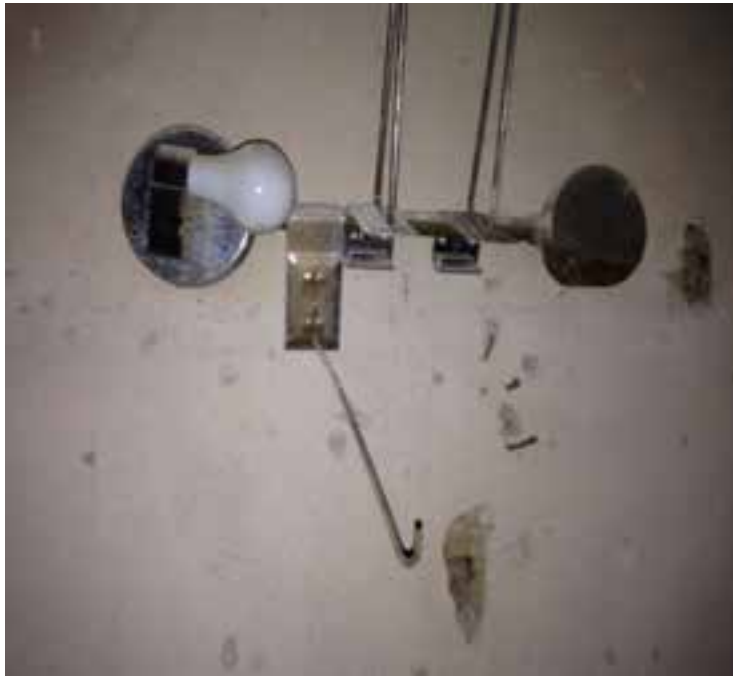
Guest Room Bathroom Incandescent Lighting Fixture and Exposed Conduit

- 1.5.1 Lighting System: There are numerous NEC violations regarding illegal use of wiring for the all, including exposed junction boxes, lighting with broken lenses, branch circuits wiring running exposed along open walls and ceilings without physical protection. There are no exit lights and/or emergency egress lighting through-out facility. The exterior lighting under the canopy consists of inexpensive period type light fixtures surface mounted to the bottom of the canopy with incandescent lamps. Lantern period type fixtures are bracket mounted to the exterior on the west & east side of the canopy and Guest room are old period. Large, Bulky Incandescent PAR lamp flood lights are located on the east and west side of the building “D” & “E” parapets, as well as east of Bldg. “F” & “G” and west on Building “A”, “B” are not in working conditions. There are several lights located in and through-out the facility, of which all has been vandalized and the glass cover’s are broken. Several pedestrian type fixtures with period type lantern luminaires are located at the office entry wires are exposed. All lighting in the entire premises is not in working condition. There is no green wire equipment grounding conductor in any of the branch circuits. It is recommended to provide an entire lighting system through-out the facility, including new lighting fixtures, occupancy sensor switches, toggle switches, dimmer switches, conduit, equipment grounding conductors and branch circuit wiring to comply with the latest addition of the National Electrical Code.

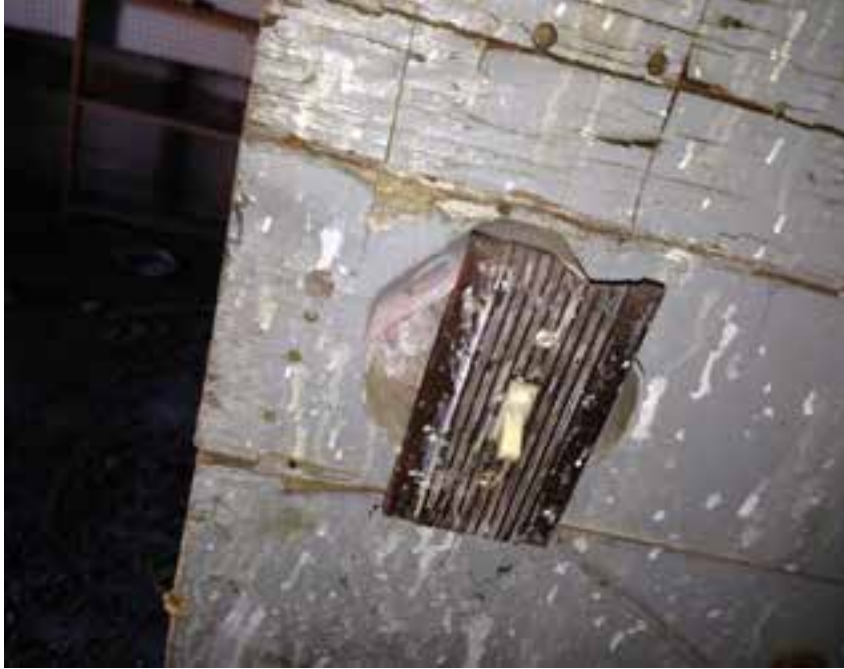
All Hotel Guest Rooms Lighting Controlled With Toggle Switch located at door entrance

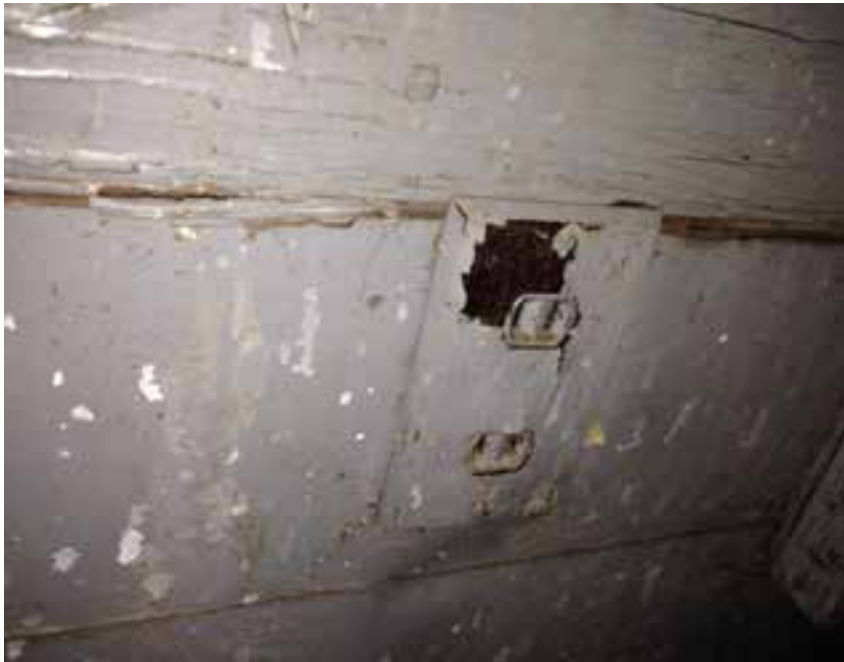
Non-Grounded Receptacle Through-out the Facility-Bldg's A, B, C, D, E, F & G

- 1.5.4 Branch Circuit Wiring: Even though it is not a code violation to have green wire equipment grounding conductors in the lighting and power branch circuits, it is recommended to replace all lighting and receptacle branch circuits and to provide green wire equipment grounds in all the conduits. It also recommended to replace all non-grounding type receptacles with grounding type receptacle through-out the entire Facility.

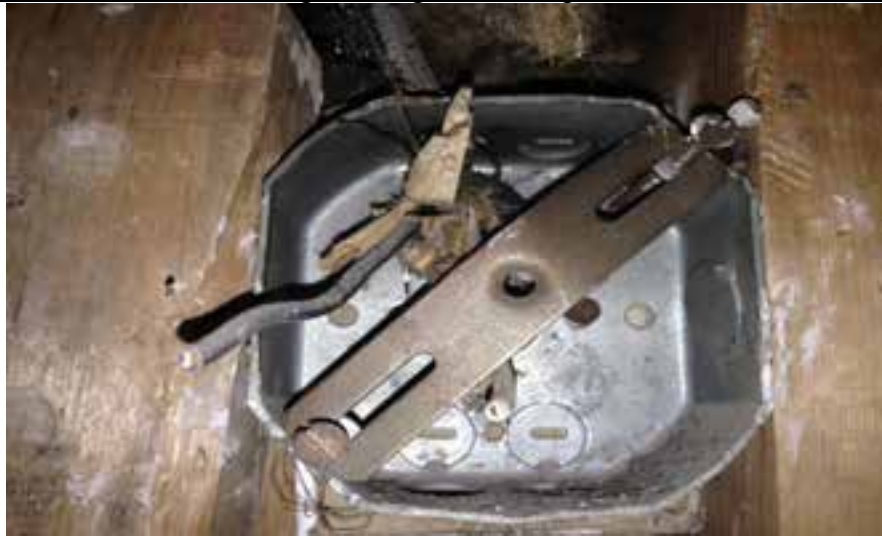
Guest Room Exposed Octagon Junction Box For Lighting At Majority Of Guest Rooms

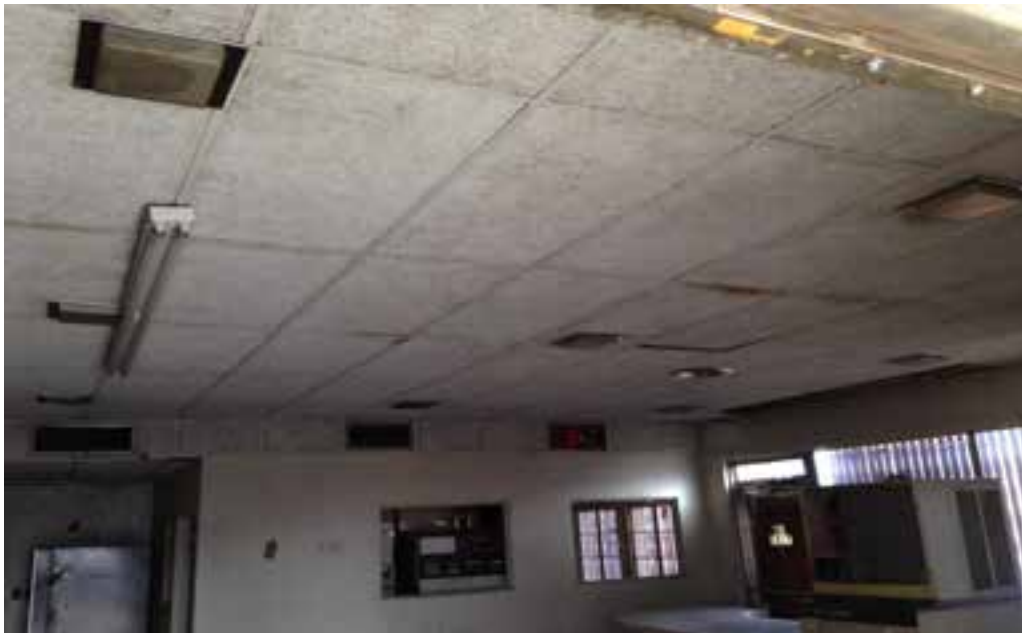
- 1.3.2 The fixtures in Building "E", consist of industrial fluorescent, wraparound fluorescent type, square recessed incandescent type and pendant type light fixtures that have been vandalized at some point in the office. There are multiple code violations including no exit lights and emergency lights for path of Egress. All the lighting, switches and conductors in all areas of the site are not energy efficient, in code violations and life safety code concerns.

Office Entrance Lobby Area

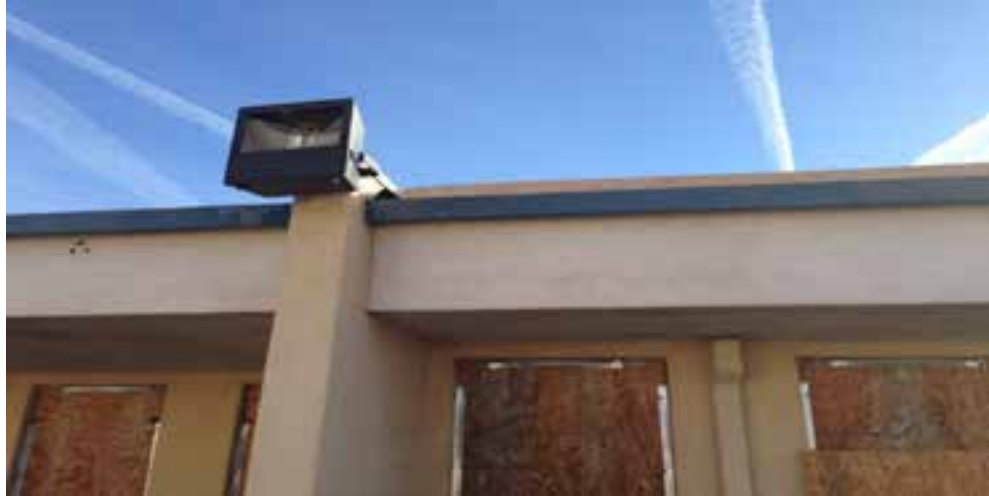
Exterior HID Surface Mount At Various Places On Site

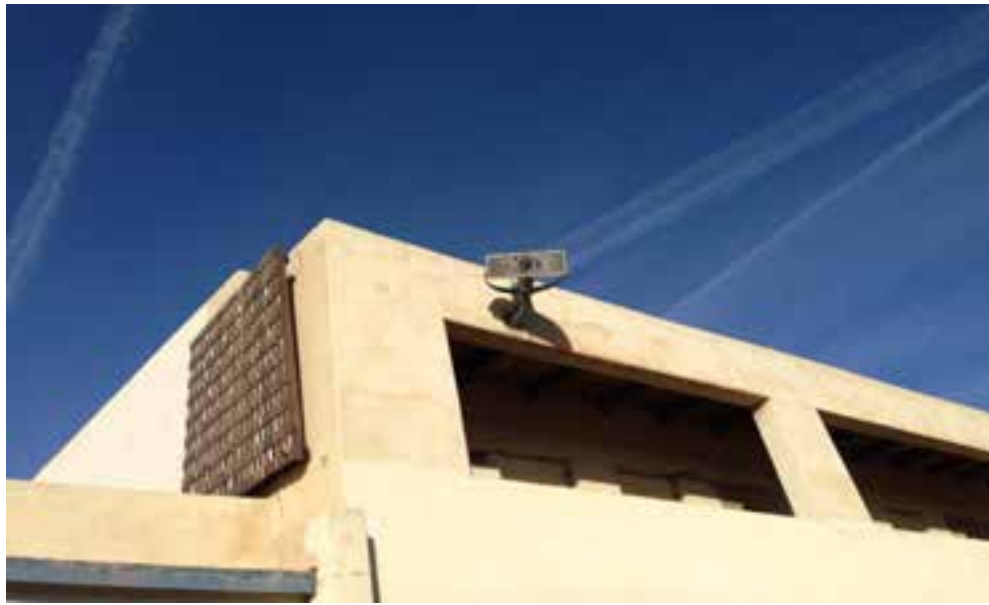
Exterior HID Wall Surface At Various Places On Site

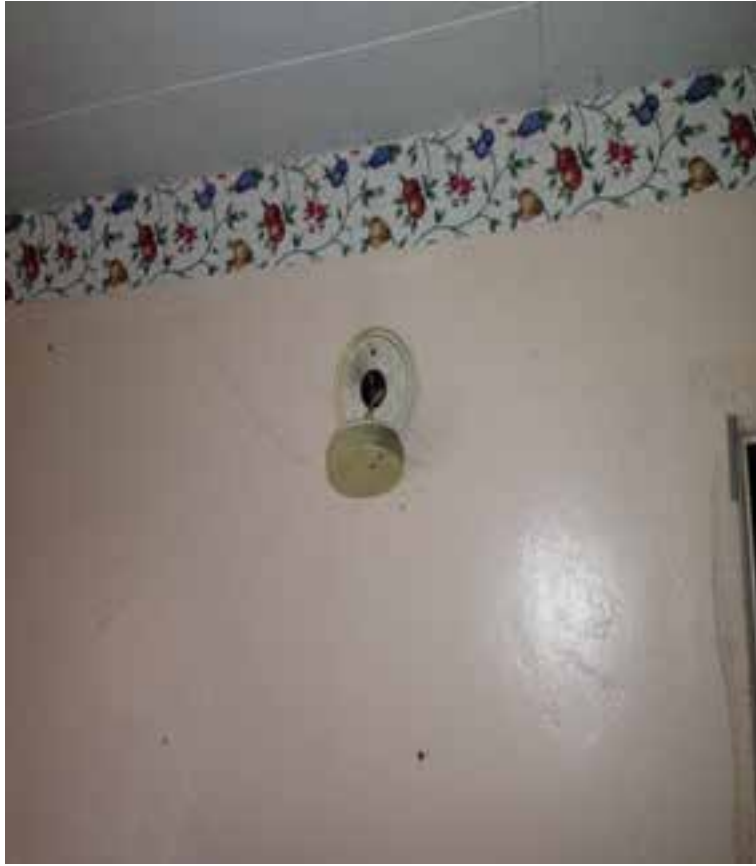
Guest Room Fire Alarm Smoke Detector

- 1.4 Fire Alarm System: Located Smoke Detectors, Fire Alarm panel system for the building could not be Located.

- 1.5.2 Fire Alarm System: Fire Alarm system for the entire facility wiring is exposed cracked and brittle, is not routed in conduit and smoke detectors are outdated and burned. For the purpose of property and building protection it is recommended to provide an entire fire alarm system for the building, consisting of manual pull stations at required exits, horn/strobes in all spaces, and automatic fire/smoke detection, conduit and wire through-out the facility installed at a minimum of one per every 900 square feet. It is recommended to provide a new fire alarm system that meets current Life Safety Codes.

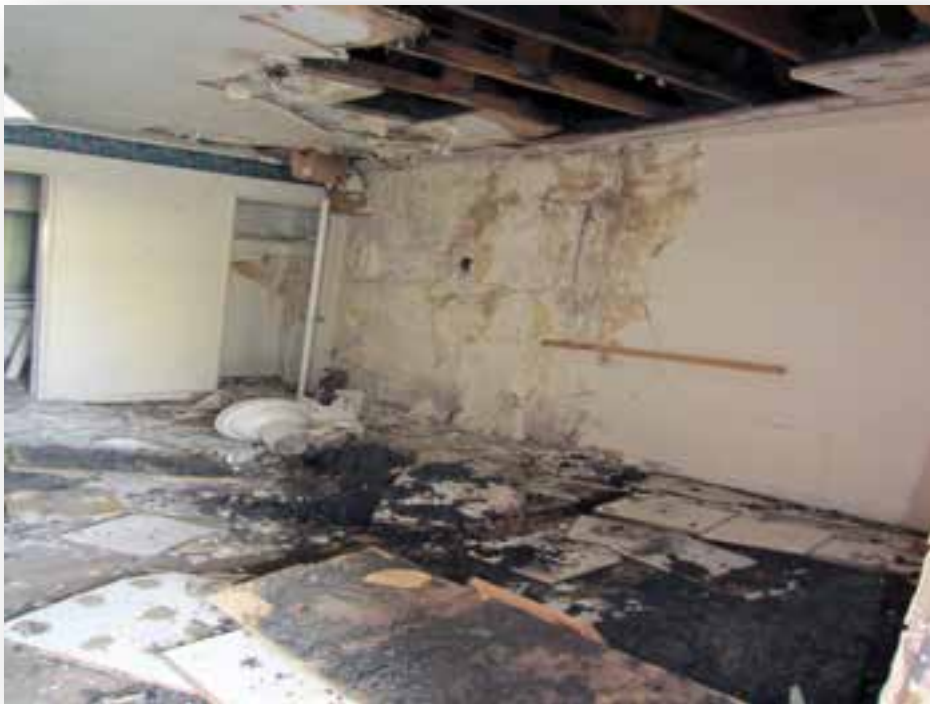
Figure 2- Building A Room 102 Ceiling Collapse

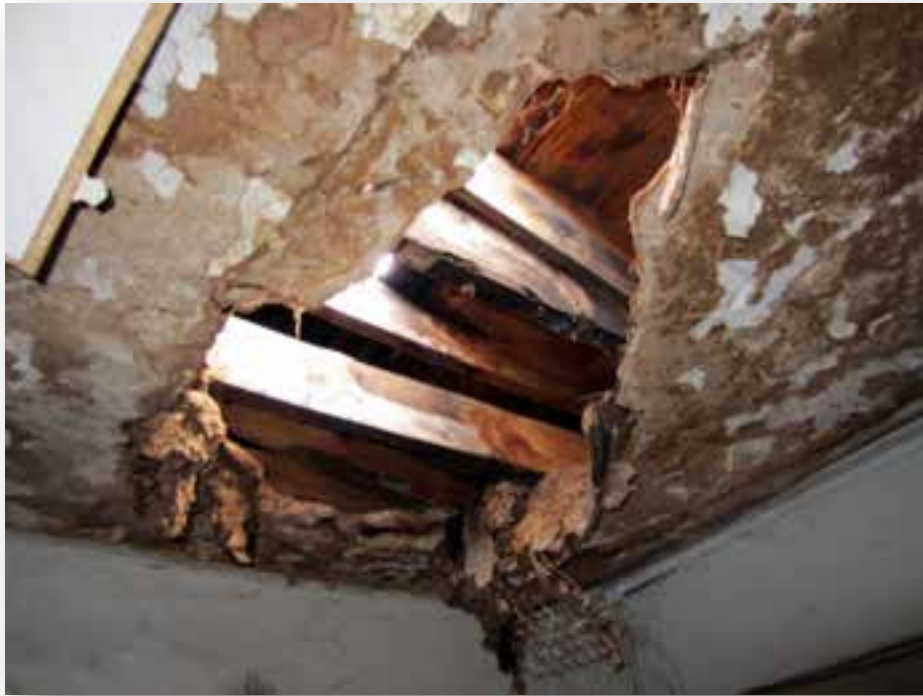
Figure 7- Building A Room 106 – Ceiling Collapse – Exposed Structure

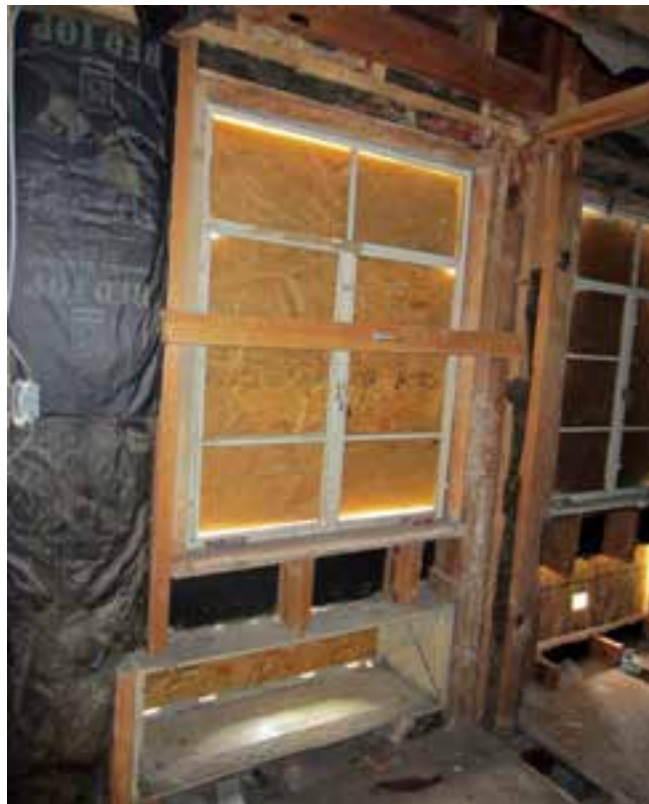
Figure 15- Building B Room 110 - Cut Exterior Studs

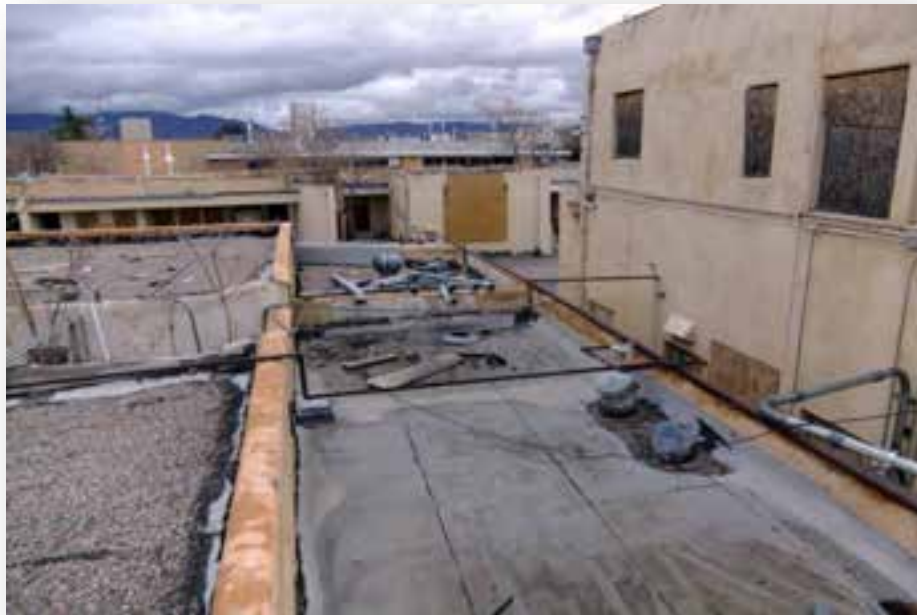
Figure 28- Building D Utility Area Roof

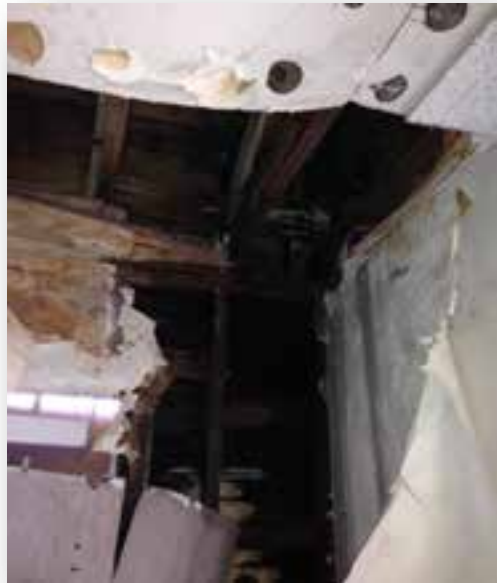
Figure 36- Building E 2<sup>nd</sup> Floor Water Infiltration

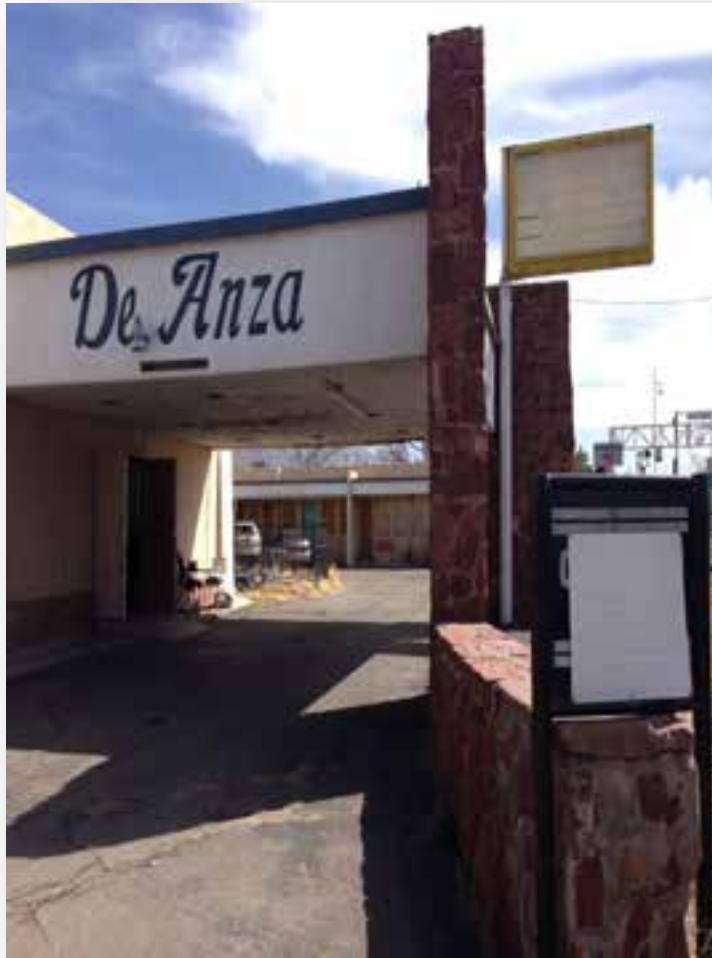
Figure 37- Building E Porte Cochere
