SRM RUNWAY 12-30 FINAL REPORT

Sustainable Airport Master Plan

ALBUQUERQUE INTERNATIONAL SUNPORT (ABQ)

HOT SPOT #1 MITIGATION

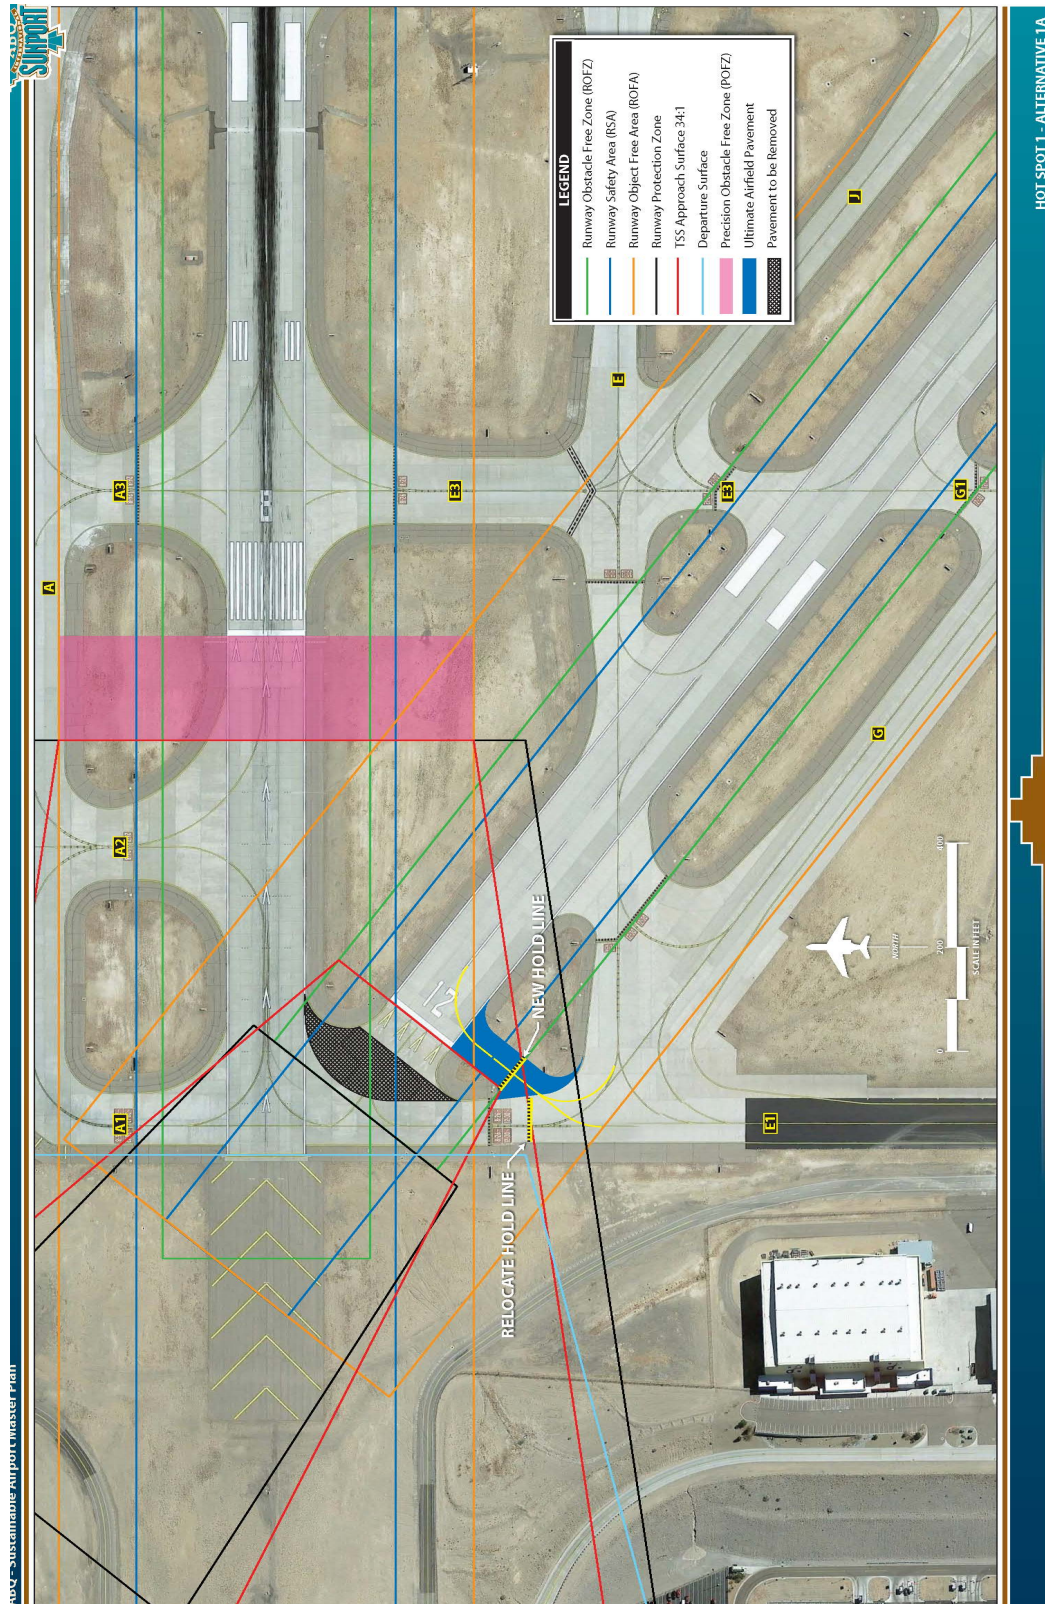
This alternative, as shown in Figure 2, leaves the Runway 12 threshold in place, thereby providing the longest runway length of all of the alternatives. A new Runway 12 threshold entrance taxiway would provide a typical 90-degree entrance and eliminate the “in-line” taxiway arrangement where pilots approaching the threshold are unable to clearly determine the runway designation. This alternative would also move the Runway 08 hold bar further south to provide proper clearance for the threshold siting surface. As shown by Figure 2, the result creates problems with the new threshold taxiway to Runway 12 where two hold bars that would effectively only handle a single aircraft.

Figure 2- Alternative 1A.

Alternative **1A** (Figure 2) essentially removes a section of pavement beyond the threshold and replaces it with a short 90 degree entrance taxiway leading to the threshold. Although this option would successfully decouple the runways, the new taxiway would intersect with and complicate the existing intersection with Taxiways E1, E, and G. One of the objectives of the FAA RIM program is to eliminate confusing airfield geometry such as taxiway intersections with more than 3 nodes. This alternative would result in a taxiway with 4 nodes. The panel believes that any risk reduction associated with pavement removal beyond the runway threshold would be more than offset by the confusing taxiway intersection.

Assessment: The panel noted that this hazard cause exists today as shown by Figure 2. Although the potential outcome is an aircraft moving onto the wrong taxiway, the panel noted that there is no history of this kind of incident at the airport. Therefore, the likelihood is judged to be **Extremely Remote** and the risk as **Low**. The hazard mitigation measure are the same as hazard-cause (a) above.

This hazard cause recognizes the compounding issues that accrue with complex, non-standard taxiway intersections. The unusual arrangement of taxiways at the E1-E-G intersection (Figure 2) can result in a wide expanse of pavement, which in turn creates difficulties in finding an effective locations of the guidance signs. The result is the increased possibility of loss of situational awareness by the pilot and an increased risk of a runway incursion or movement in the wrong direction on a taxiway. Note that the standard (left side) placement of a guidance sign for aircraft heading west on Taxiway E would be over 200 ft from the cockpit.

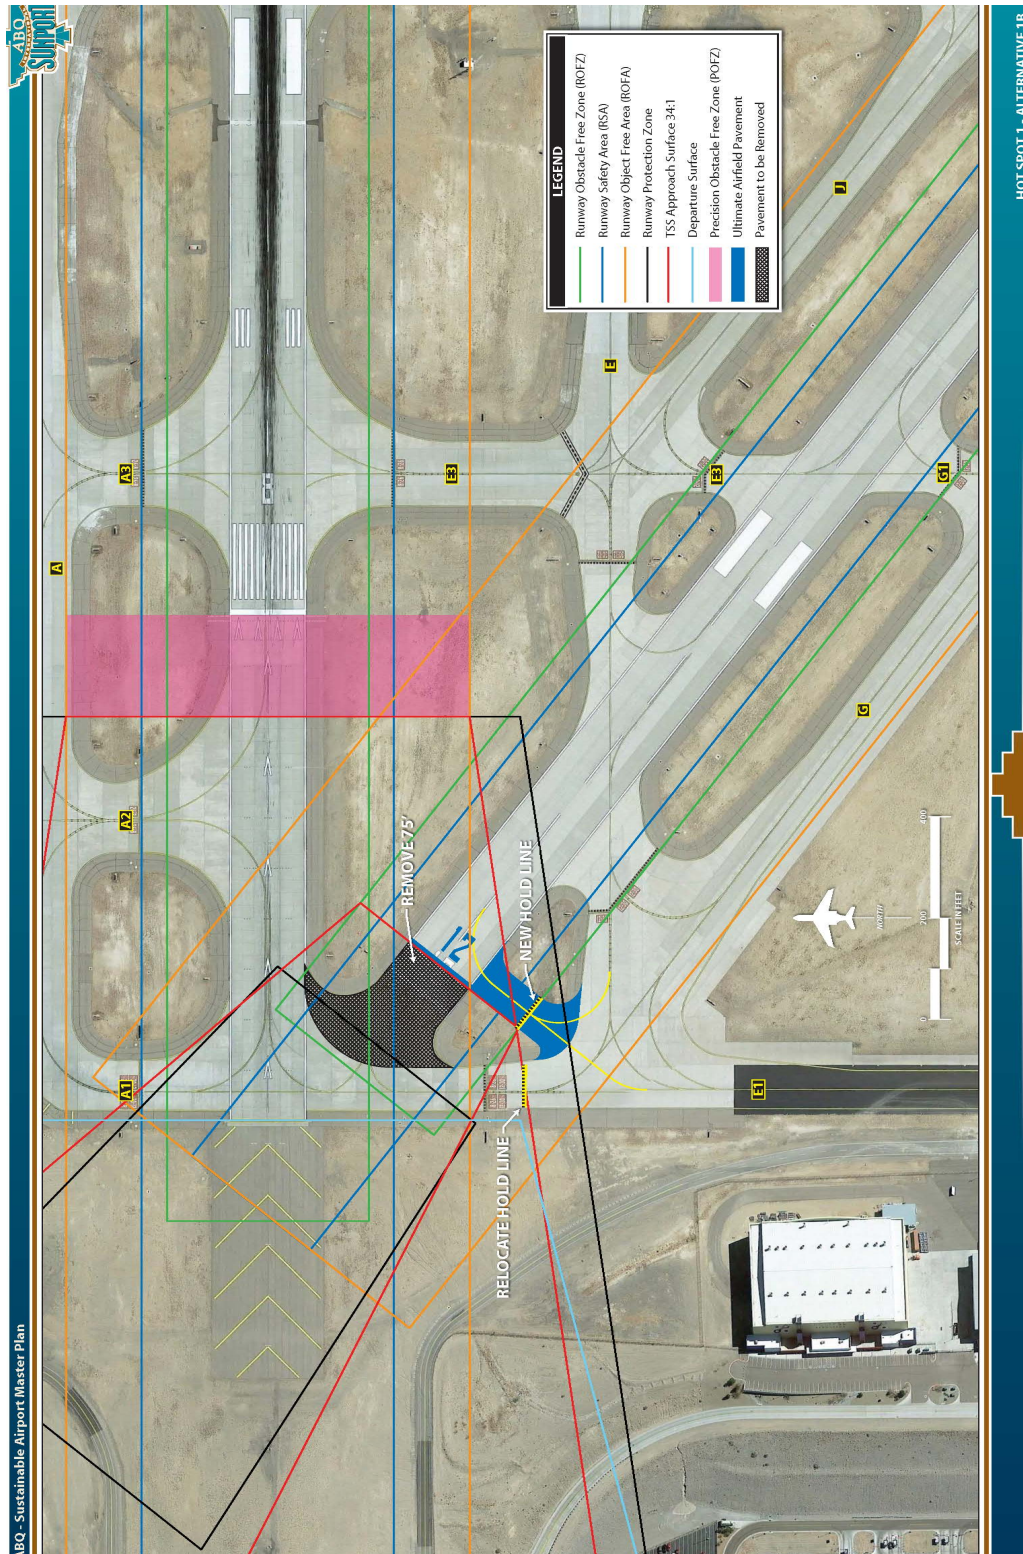
This alternative, as presented in Figure3, removes 75 feet of length from Runway 12. This allows for two separate taxiways (E1 and the new Runway 12 threshold entrance) with separate hold bars. While there is enough room to accommodate two aircraft simultaneously at the hold positions for Runway 08 and Runway 12, there are still some clearance issues for large aircraft. This solution introduces a new taxiway to an already wide expanse of pavement created by the intersection of Taxiways E, E1, and G.

Figure 3- Alternative 1B.

This hazard only applies to Alternative 1B (Figure 3). The panel identified three causes for this hazard related to the new intersection created by four separate taxiways: E1, E, G, and the new entrance taxiway: (1) Introduction of an additional taxiway node; (2) Wide pavement in the taxiway intersection, and (3) Non-standard placement of signs caused by the wide intersection

This hazard only applies to Alternative 1B as shown in Figure 3. There does not appear to be enough wingtip clearance for aircraft that are holding at the relocated hold line for Runway 08 and the new hold line for the Runway 12 threshold taxiway. For example, an aircraft holding for a Runway 12 departure might create a hazard for aircraft using the new threshold taxiway for a runway 12 departure. The same might be true if an aircraft is holding for a Runway 8 departure while another is approaching the Runway 08 hold line.

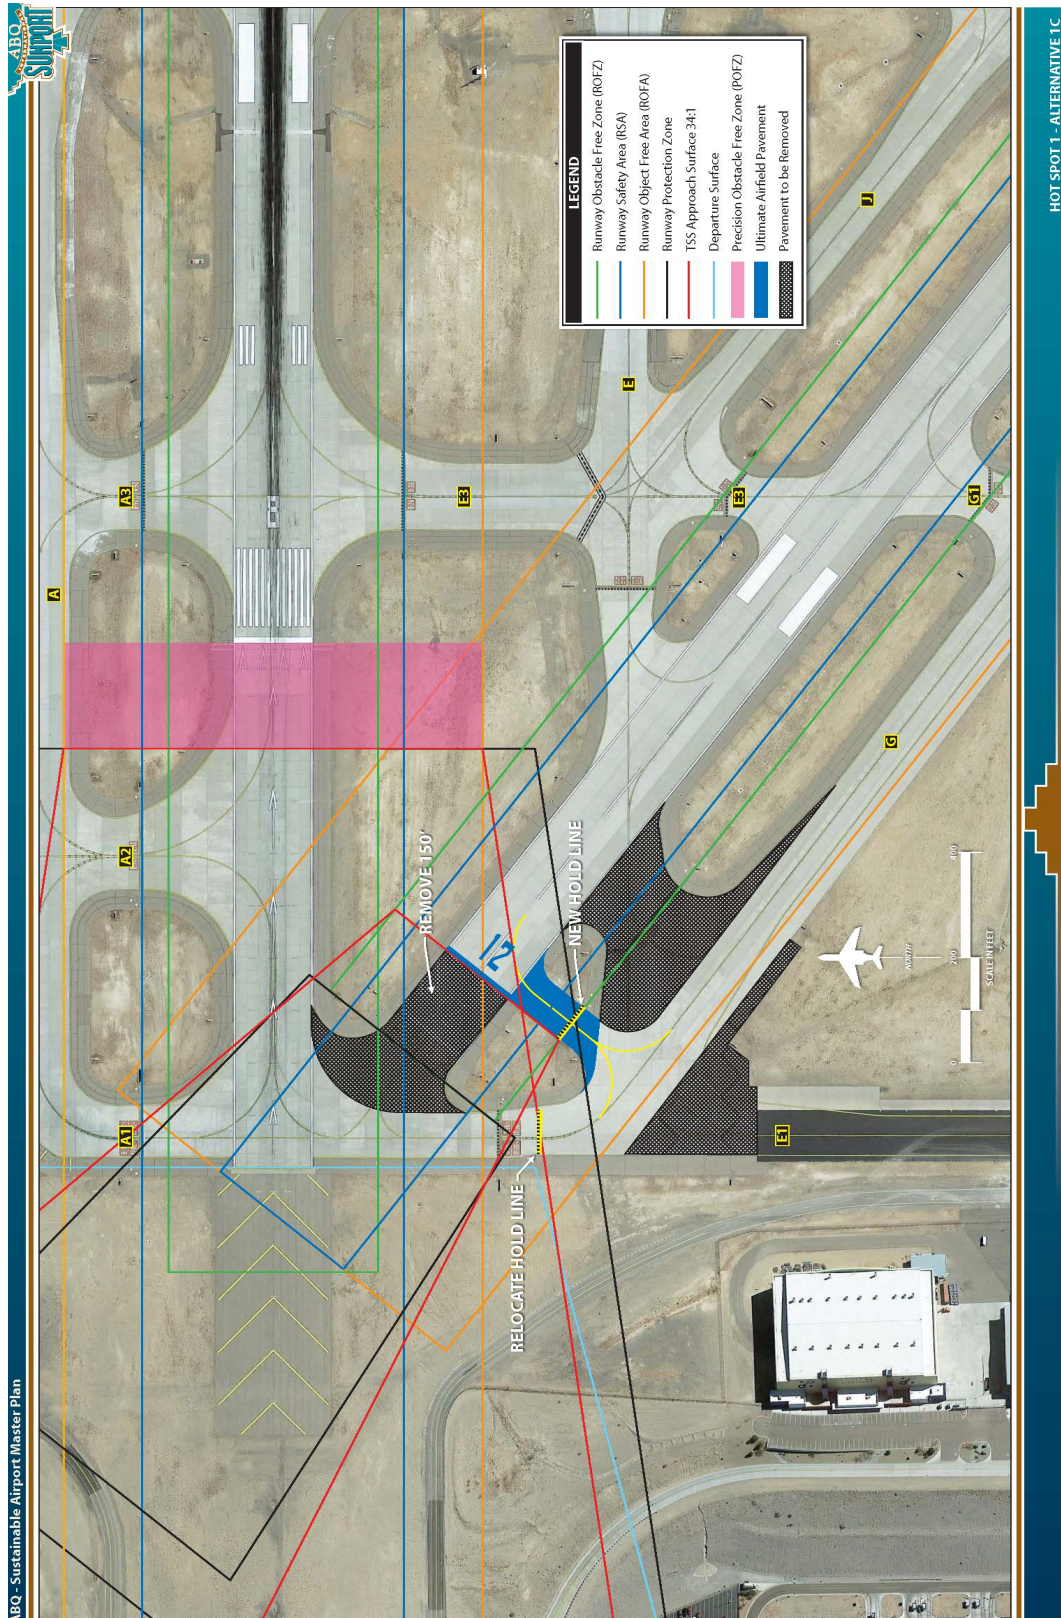
This alternative, as presented in Figure 4, considers removing 150 feet of Runway 12 length and then adds a new threshold entrance taxiway to Runway 12. This alternative provides the necessary spacing to holding aircraft and for signage. This alternative also considers closing that portion of Taxiway E between Runway 12-30 and Taxiway E1 to simplify the complex and wide taxiway intersection.

Figure 4- Alternative 1C.

Alternatives 1C and 2 (Figures 4 and 5) eliminate the western most portion of Taxiway E. Taxiway E is a full parallel taxiway for Runway 08-24. It provides a standard taxiway configuration that facilitates the east-west movement of aircraft. This hazard applies to both Alternative 1C and Alternative 2.

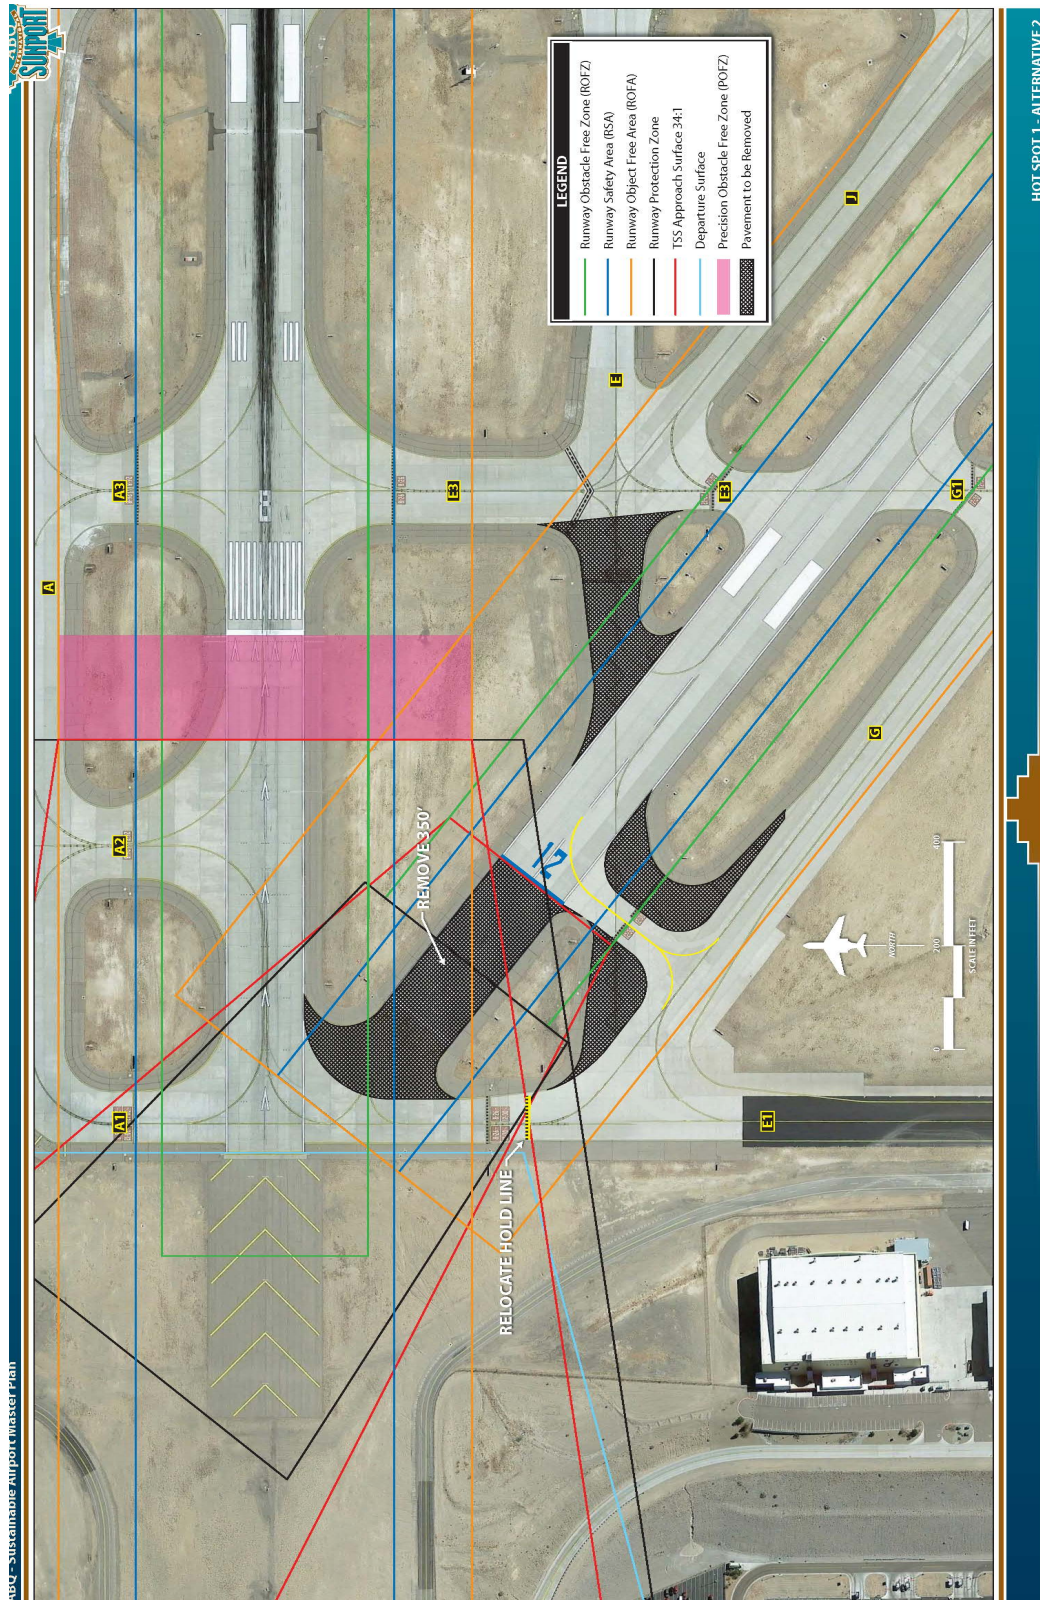
This alternative, as shown in Figure 5, shortens Runway 12 by 350 feet. It also simplifies taxiway intersections by removing parallel Taxiway E to the west of Taxiway E3 and replacing it with a Runway 12 threshold entrance taxiway. This alternative greatly simplifies the intersection of taxiways E1 and G.

Figure 5- Alternative 2.

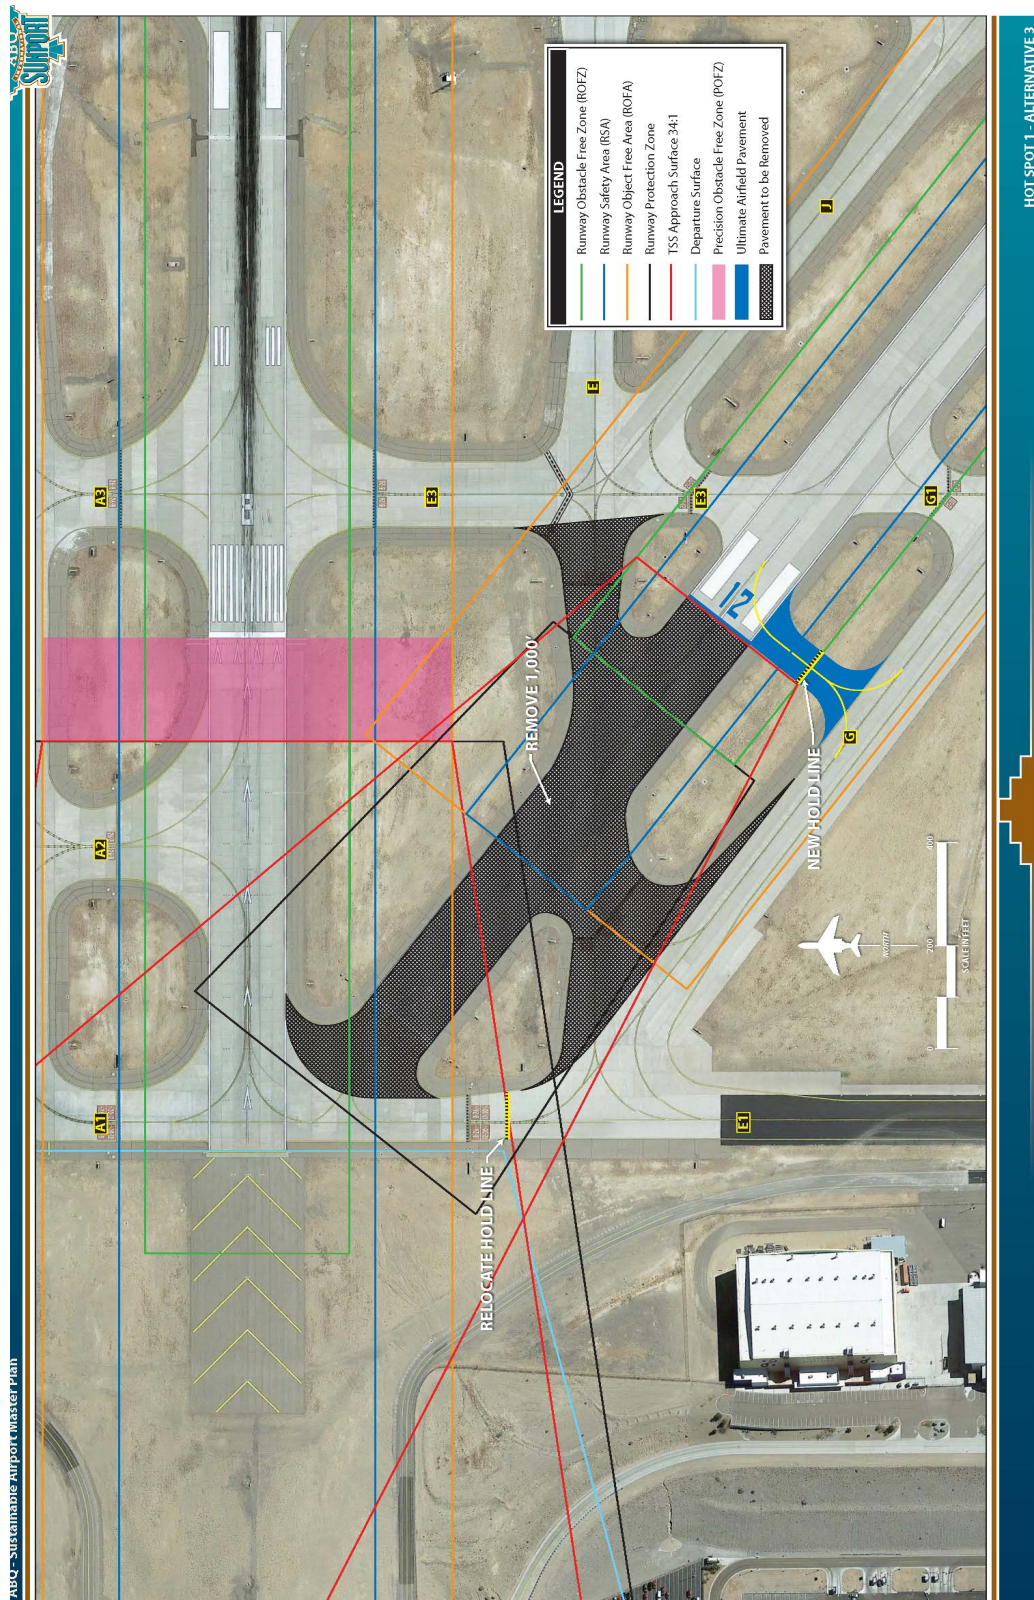
This alternative, presented in Figure 6, is similar to Alternative 2, except that it shortens Runway 12-30 by 1,000 feet in order to provide a “cleaner” Runway 12 threshold entrance taxiway. The resulting runway length (5,000 ft) is below what the planners are recommending for this runway.

Figure 6- Alternative 3.
