National Pollutant Discharge Elimination System Stormwater Program MS4 Annual Report Format

NMR04A014 City of Albuquerque

What is the reporting period for this report? (mm/dd/yyyy) From Jul 1, 2020 to Jun 30, 2021

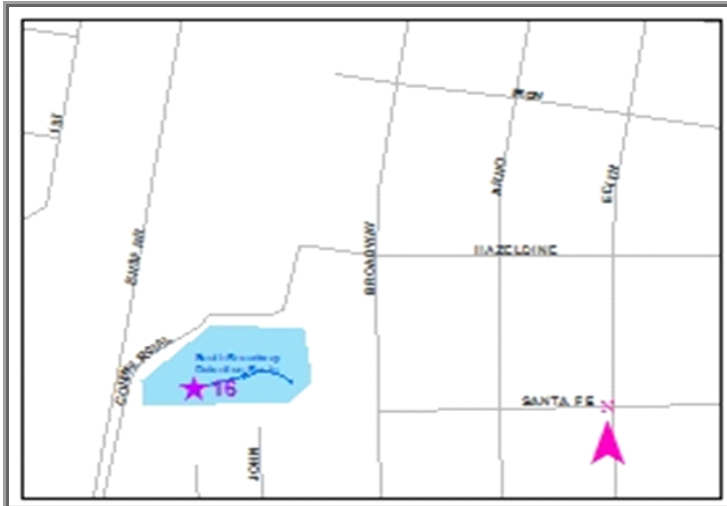
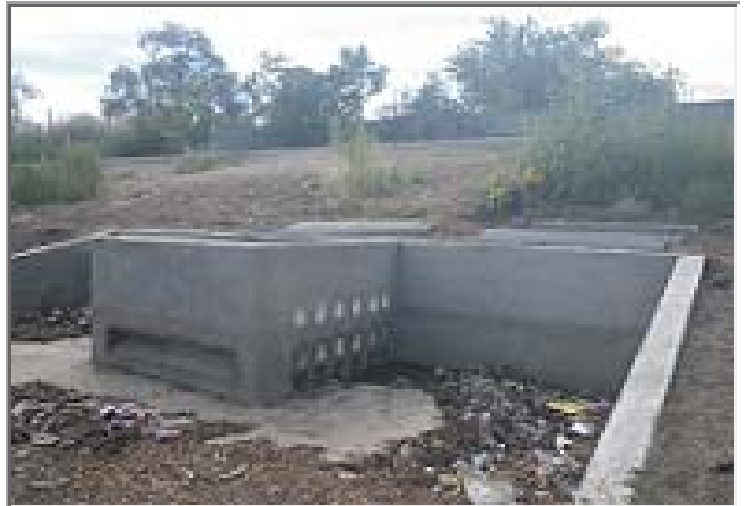
K14

CONCRETE BOX SPILLWAY

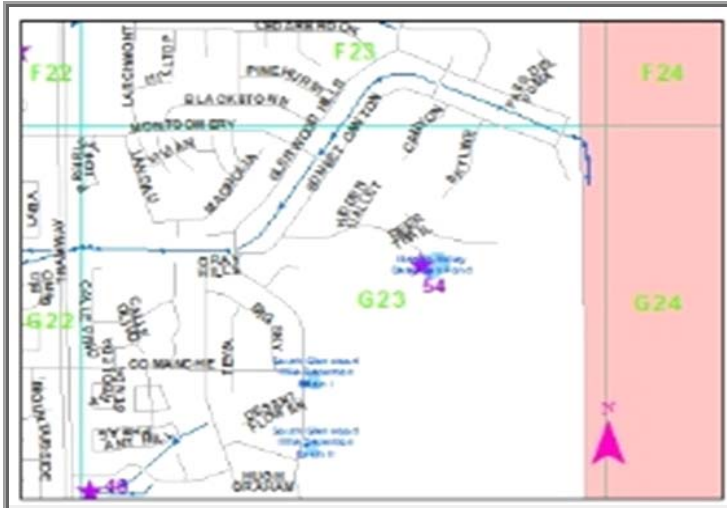
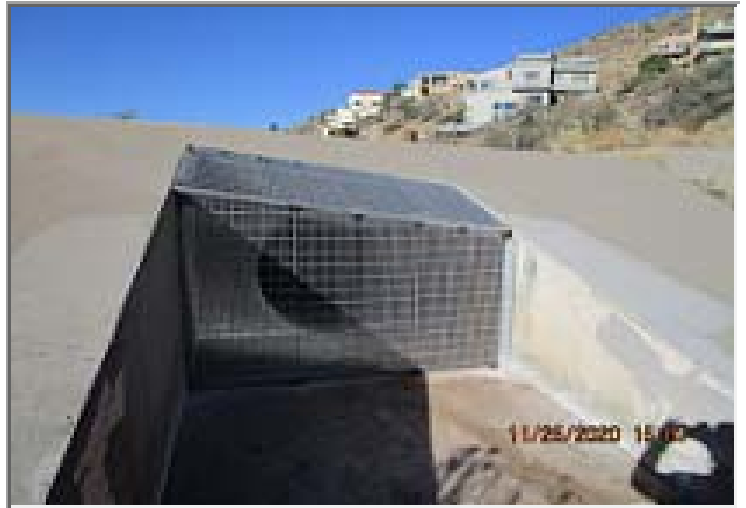
G23

TRASH RACK OUTLET

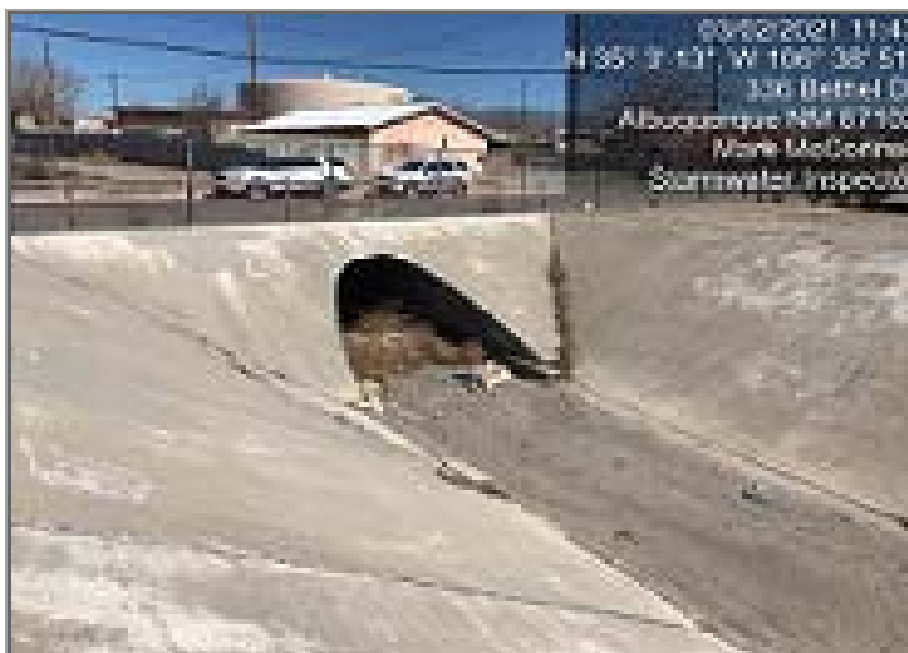
LOCATION	BROADWAY POND INFLOW CHANNEL										
OUTFALL_NO	2	QUAD	SE	GRID	K-14	SAMPLED	<input checked="" type="checkbox"/>				
DATE_INSP	2/3/2021	TIME	10:49	Inspected by		VV, MM					
WEATHER	CLOUDY	flow	Y	FLOW_GPM		1					
APPEARANCE	clear-no sheen	GROSS POLLUTANT		No odor, slight to mod particulates							
Source of Flow	cooling tower of lovelace medical center at 601 Dr MLKJ NE										
link	X:\MD\SHARE\MD-Storm\7 NPDES\311 SWQ			Lab	Hall Environmental Analysis Lab						
AIR_TEMP_F	55	Lab_Report		2102219							
WATER_TEMP_F	43										
pH	8.35	E_coli_Coliform_mpn/100ml		325.5							
CONDUCTIVITY_Umos/cm	1200	Ammonia_mg/l		<1							
BOD_mg/l	<2	Nitrite_NO2_mg/l									
COD_mg/l	<20	Nitrate_NO3_mg/l									
TSS_mg/l	<4	Nitrite+Nitrate_mg/l		1.2							
TDS_mg/l	761	TKN_Tot_Kjeld_N_mg/l		1.1							
N-Hexane Extractable-(Oil_Grease)_mg/l	<9.5	Phosphorus_total_mg/l_P		0.4

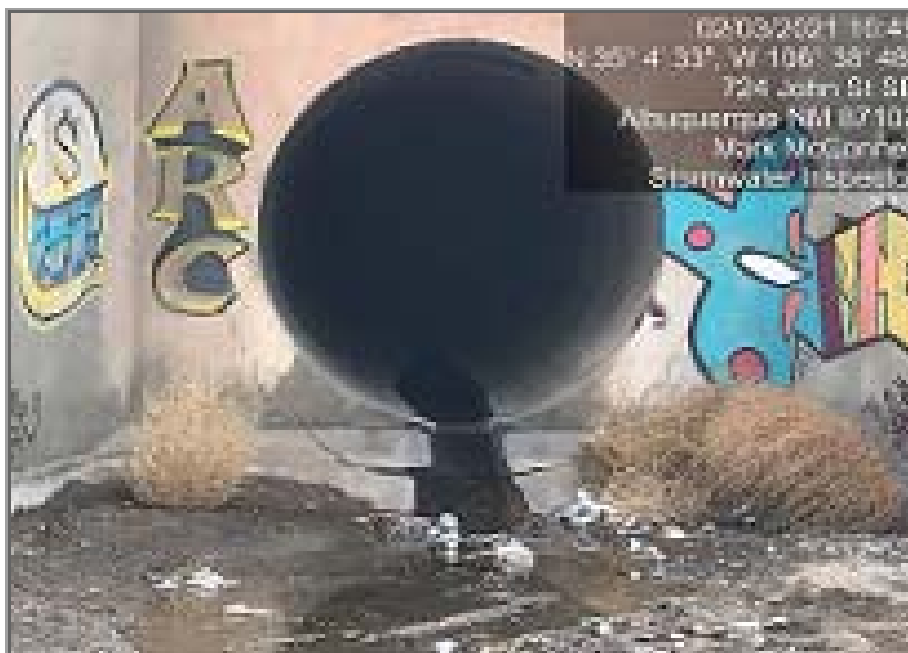
LOCATION	MENAU POND INFLOW CHANNEL									
OUTFALL_NO	3	QUAD	NE	GRID	H-15	SAMPLED	<input checked="" type="checkbox"/>			
DATE_INSP	1/12/2021	TIME	1:43 pm	Inspected by		MM,VV				
WEATHER	SUNNY	flow	YES	FLOW_GPM		20				
APPEARANCE	clear	GROSS POLLUTANT		No Odor, No Particulates						
Source of Flow	fire hydrant wash out and broken water line.									
link	X:\MD\SHARE\MD-Storm\7 NPDES\311 SWQ			Lab	Hall Environmental Analysis Lab					
AIR_TEMP_F	45	Lab_Report		2101437						
WATER_TEMP_F	42									
pH	8.22	E_coli_Coliform_mpn/100ml		1.0						
CONDUCTIVITY_Umos/cm	400	Ammonia_mg/l		<1.0						
BOD_mg/l	4.7	Nitrite_NO2_mg/l		<0.5						
COD_mg/l	<20.	Nitrate_NO3_mg/l		<0.5						
TSS_mg/l	<4.0	Nitrite+Nitrate_mg/l								
TDS_mg/l	271	TKN_Tot_Kjeld_N_mg/l		<1.0						
N-Hexane Extractable-(Oil_Grease)_mg/l	<9.5	Phosphorus_total_mg/l_P		0.05

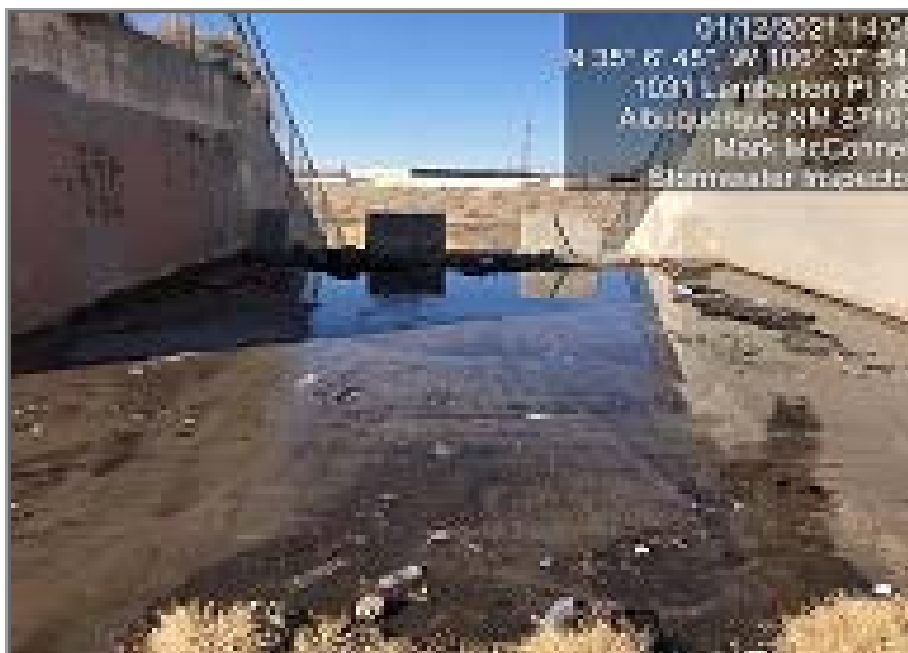
LOCATION	BARELAS PUMPING PLANT INFLOW									
OUTFALL_NO	4	QUAD	SW	GRID	L-13	SAMPLED	<input checked="" type="checkbox"/>			
DATE_INSP	2/3/2021	TIME	2:00	Inspected by		VV, MM				
WEATHER	CLOUDY	flow	YES	FLOW_GPM		10				
APPEARANCE	cloudy,slight sheen		GROSS POLLUTANT		slight musty odor, sight to mod particulates					
Source of Flow	Groundwater infiltration and irrigation water waste									
link	X:\MD\SHARE\MD-Storm\7 NPDES\311 SWQ			Lab	Hall Environmental Analysis Lab					
AIR_TEMP_F	63		Lab_Report		2102219					
WATER_TEMP_F	53									
pH	8.39		E_coli_Coliform_mpn/100ml		1732.9					
CONDUCTIVITY_Umos/cm	850		Ammonia_mg/l		<1					
BOD_mg/l	<2		Nitrite_NO2_mg/l							
COD_mg/l	<20		Nitrate_NO3_mg/l							
TSS_mg/l	<4		Nitrite+Nitrate_mg/l		<1					
TDS_mg/l	550		TKN_Tot_Kjeld_N_mg/l		<1					
N-Hexane Extractable-(Oil_Grease)_mg/l	<9.4		Phosphorus_total_mg/l_P		0.15

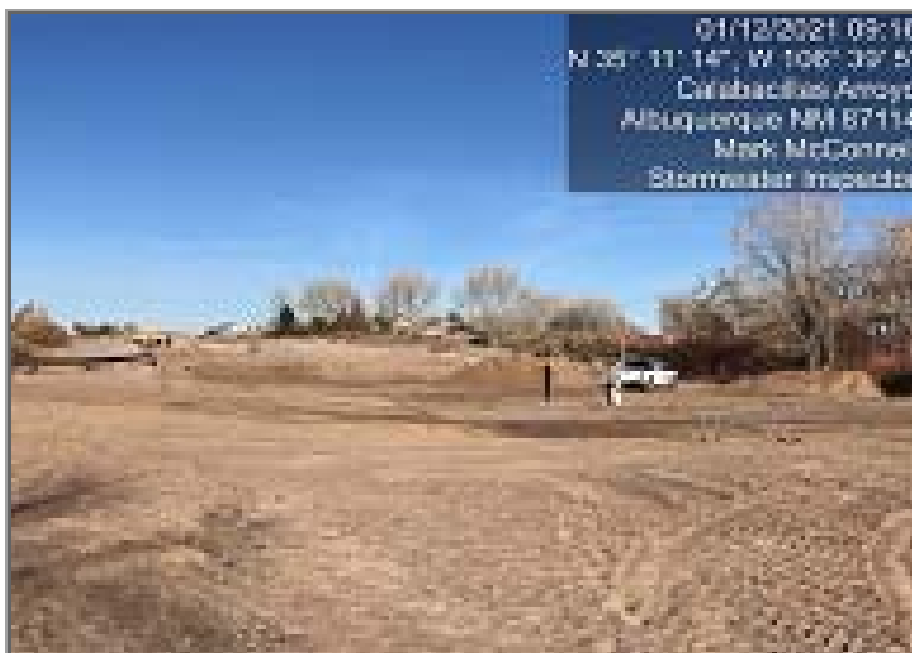
LOCATION	HAHN ARROYO AT CARLISLE NE									
OUTFALL_NO	8	QUAD	NE	GRID	G-16	SAMPLED	<input checked="" type="checkbox"/>			
DATE_INSP	3/2/2021	TIME	9:55	Inspected by		VV, MM				
WEATHER	SUNNY	flow	YES FLOW	FLOW_GPM		1				
APPEARANCE	Slight yellow, No Sheen		GROSS POLLUTANT		No Odor, Slight particulates					
Source of Flow	well wash water from Volandia2 wells									
link	X:\MD\SHARE\MD-Storm\7 NPDES\311 SWQ				Lab	Hall Environmental Analysis Lab				
AIR_TEMP_F	39		Lab_Report		2103135					
WATER_TEMP_F	51									
pH	8.40		E_coli_Coliform_mpn/100ml		3.1					
CONDUCTIVITY_Umos/cm	870		Ammonia_mg/l		<0.1					
BOD_mg/l	4.6		Nitrite_NO2_mg/l		<0.5					
COD_mg/l	35		Nitrate_NO3_mg/l		<0.5					
TSS_mg/l	15		Nitrite+Nitrate_mg/l							
TDS_mg/l	484		TKN_Tot_Kjeld_N_mg/l		4.2					
N-Hexane Extractable-(Oil_Grease)_mg/l	<9.4		Phosphorus_total_mg/l_P		0.06

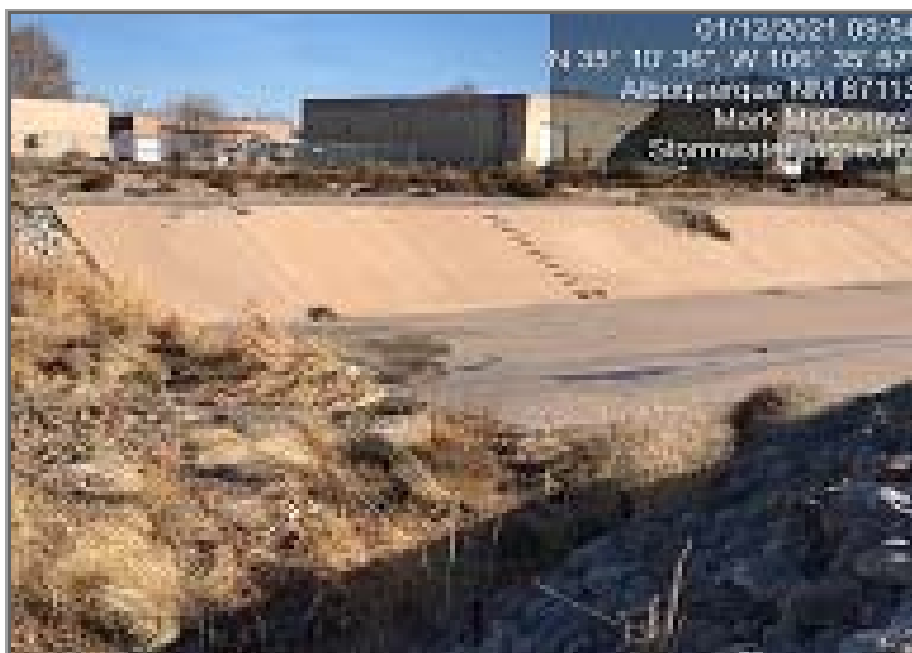
LOCATION		AMOLE DEL NORTE CHANNEL AT BLAKE SW					
OUTFALL_NO	15	QUAD	SW	GRID	N-10	SAMPLED	<input checked="" type="checkbox"/>
DATE_INSP	3/4/2021	TIME	11:30	Inspected by		VV, MM	
WEATHER	SUNNY	flow	YES	FLOW_GPM		0.5	
APPEARANCE	very cloudy, No sheen		GROSS POLLUTANT		No odor, mod particulates, Slight yellow to tan colo		
Source of Flow	irrigation water escape						
link	X:\MD\SHARE\MD-Storm\7 NPDES\311 SWQ			Lab	Hall Environmental Analysis Lab		
AIR_TEMP_F	52	Lab_Report		2103222			
WATER_TEMP_F	47						
pH	8.06	E_coli_Coliform_mpn/100ml		<1			
CONDUCTIVITY_Umos/cm	550	Ammonia_mg/l		<1			
BOD_mg/l	3.9	Nitrite_NO2_mg/l		<0.5			
COD_mg/l	<40	Nitrate_NO3_mg/l		<0.5			
TSS_mg/l	32	Nitrite+Nitrate_mg/l					
TDS_mg/l	373	TKN_Tot_Kjeld_N_mg/l		1.5			
N-Hexane Extractable-(Oil_Grease)_mg/l	<9.4	Phosphorus_total_mg/l_P		0.21

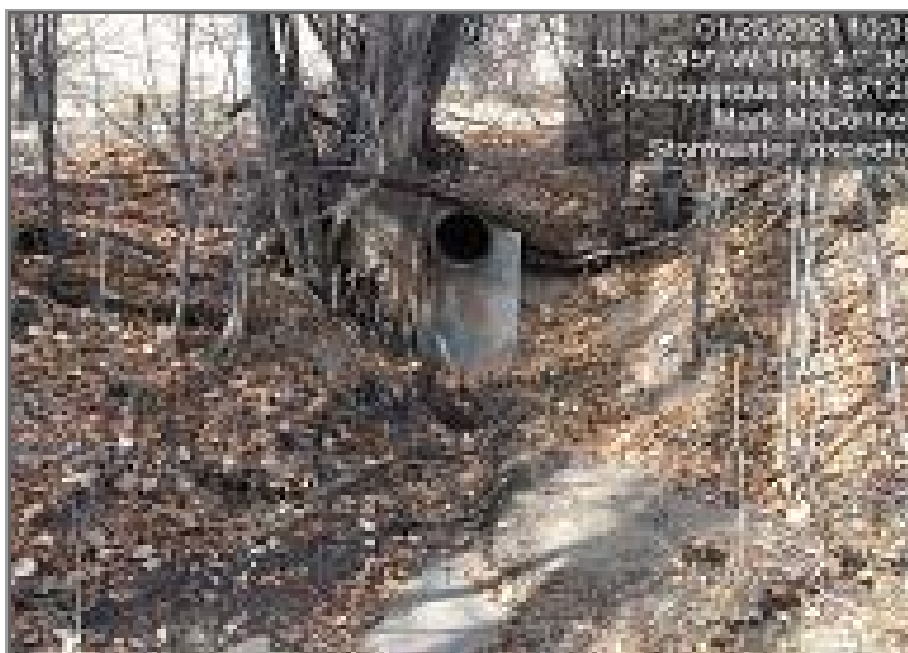
LOCATION	DURANES NW PS AT RIO GRANDE									
OUTFALL_NO	26	QUAD	NW	GRID	H-12	SAMPLED	<input checked="" type="checkbox"/>			
DATE_INSP	2/3/2021	TIME	9:20	Inspected by		MM, VV				
WEATHER	CLOUDY	flow	YES	FLOW_GPM		5				
APPEARANCE	clear, no sheen		GROSS POLLUTANT		No Odor, No Particulates					
Source of Flow	well wash out from Durance 4 & 6 wells and groundwater infiltration									
link	X:\MD\SHARE\MD-Storm\7 NPDES\311 SWQ			Lab	Hall Environmental Analysis Lab					
AIR_TEMP_F	50		Lab_Report		2102219					
WATER_TEMP_F	46									
pH	7.74		E_coli_Coliform_mpn/100ml		59.1					
CONDUCTIVITY_Umos/cm	570		Ammonia_mg/l		<1					
BOD_mg/l	<2		Nitrite_NO2_mg/l							
COD_mg/l	<20		Nitrate_NO3_mg/l							
TSS_mg/l	<4		Nitrite+Nitrate_mg/l		<1					
TDS_mg/l	349		TKN_Tot_Kjeld_N_mg/l		<1					
N-Hexane Extractable-(Oil_Grease)_mg/l	<9.3		Phosphorus_total_mg/l_P		0.07

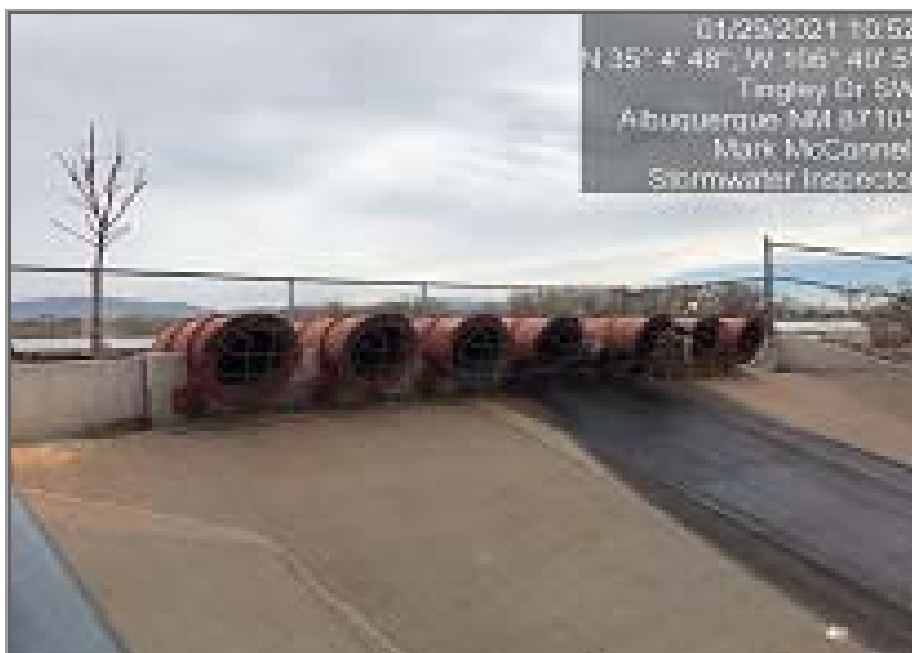
LOCATION	NDC AT ALAMEDA NE									
OUTFALL_NO	36	QUAD	NE	GRID	C-17	SAMPLED	<input checked="" type="checkbox"/>			
DATE_INSP	3/9/2021	TIME	9:17	Inspected by		VV, MM				
WEATHER	SUNNY	flow	YES	FLOW_GPM		20				
APPEARANCE	slightly cloudy		GROSS POLLUTANT		No Odor, No Sheen, Heavy Particulates					
Source of Flow	well wash out, irrigation skape water and broken pipe lines.									
link	X:\MD\SHARE\MD-Storm\7 NPDES\311 SWQ			Lab	Hall Environmental Analysis Lab					
AIR_TEMP_F	39	Lab_Report		2103222						
WATER_TEMP_F	34									
pH	8.36	E_coli_Coliform_mpn/100ml		7.5						
CONDUCTIVITY_Umos/cm	600	Ammonia_mg/l		<1						
BOD_mg/l	2.8	Nitrite_NO2_mg/l		<0.5						
COD_mg/l	24.2	Nitrate_NO3_mg/l		<0.5						
TSS_mg/l	6	Nitrite+Nitrate_mg/l								
TDS_mg/l	362	TKN_Tot_Kjeld_N_mg/l		<1						
N-Hexane Extractable-(Oil_Grease)_mg/l	<9.4	Phosphorus_total_mg/l_P		0.03

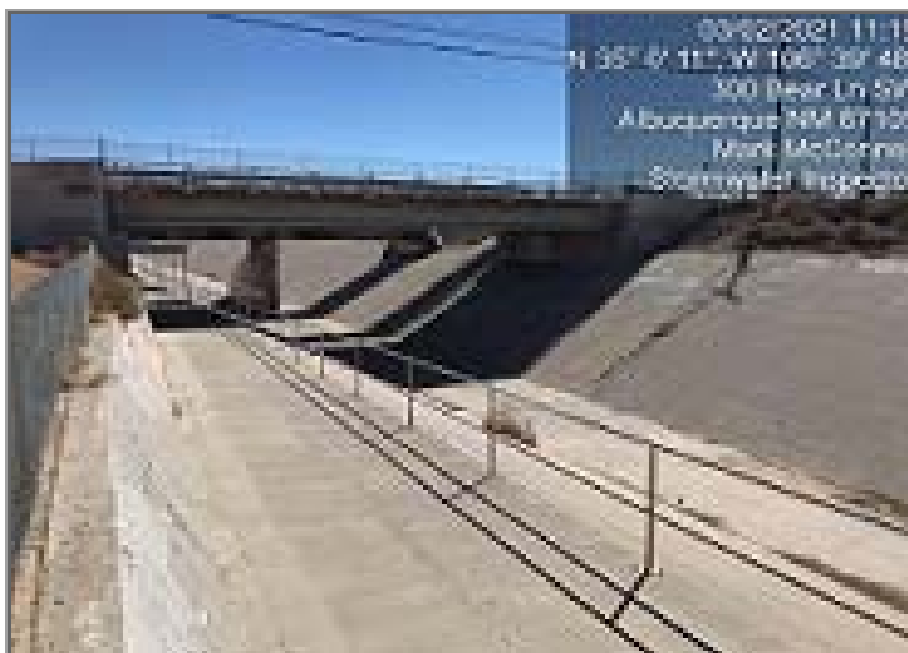
LOCATION	TIJERAS ARROYO AT 2ND ST SW									
OUTFALL_NO	37	QUAD	SW	GRID	Q-12	SAMPLED	<input type="checkbox"/>			
DATE_INSP	3/2/2021	TIME	11:20	Inspected by		MM				
WEATHER	SUNNY	flow	NO FLOW	FLOW_GPM		0				
APPEARANCE	na		GROSS POLLUTANT		na					
Source of Flow	na									
link	X:\MD\SHARE\MD-Storm\7 NPDES\311 SWQ				Lab					
AIR_TEMP_F	48		Lab_Report							
WATER_TEMP_F										
pH			E_coli_Coliform_mpn/100ml							
CONDUCTIVITY_Umos/cm			Ammonia_mg/l							
BOD_mg/l			Nitrite_NO2_mg/l							
COD_mg/l			Nitrate_NO3_mg/l							
TSS_mg/l			Nitrite+Nitrate_mg/l							
TDS_mg/l			TKN_Tot_Kjeld_N_mg/l							
N-Hexane Extractable-(Oil_Grease)_mg/l			Phosphorus_total_mg/l_P

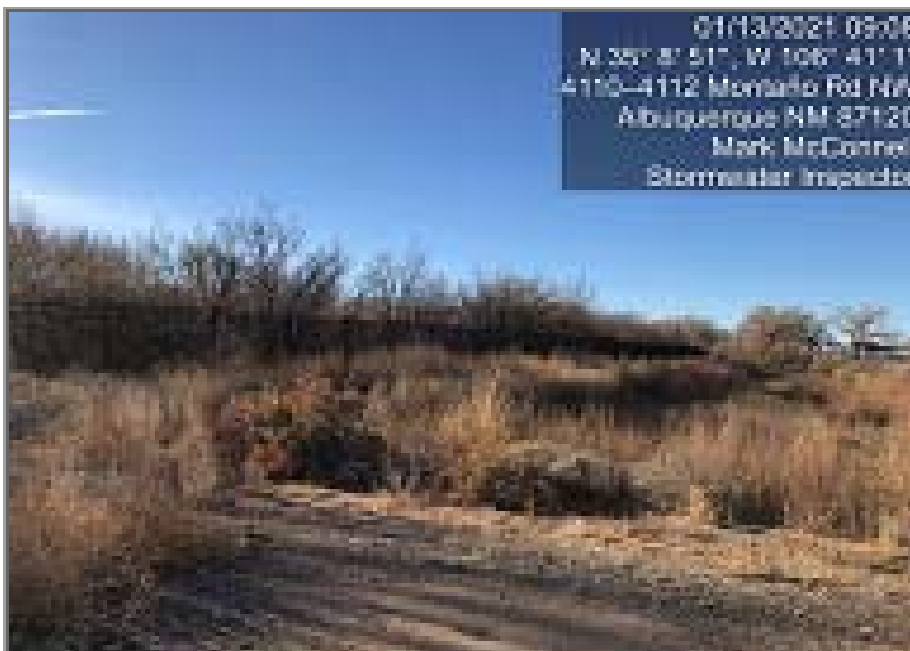
LOCATION		MIRANDELA BY PUEBLO PARK SE OF COORS AND MONTANO NW					
OUTFALL_NO	38	QUAD	NW	GRID	E12	SAMPLED	<input type="checkbox"/>
DATE_INSP	1/13/2021	TIME	9:00	Inspected by		MM, VV	
WEATHER	SUNNY	flow	NO FLOW	FLOW_GPM		0	
APPEARANCE	na	GROSS POLLUTANT		na			
Source of Flow	na						
link	X:\MD\SHARE\MD-Storm\7 NPDES\311 SWQ			Lab			
AIR_TEMP_F	34	Lab_Report					
WATER_TEMP_F							
pH		E_coli_Coliform_mpn/100ml					
CONDUCTIVITY_Umos/cm		Ammonia_mg/l					
BOD_mg/l		Nitrite_NO2_mg/l					
COD_mg/l		Nitrate_NO3_mg/l					
TSS_mg/l		Nitrite+Nitrate_mg/l					
TDS_mg/l		TKN_Tot_Kjeld_N_mg/l					
N-Hexane Extractable-(Oil_Grease)_mg/l		Phosphorus_total_mg/l_P

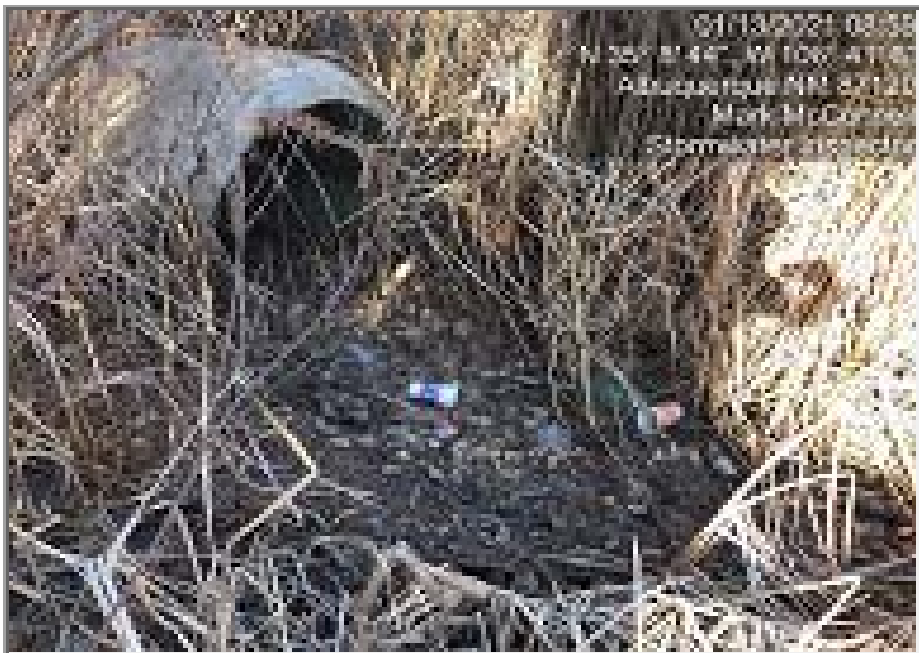
LOCATION **BOSQUE SCHOOL AND MIRANDELA SE OF COORS AND MONTANO NW**

OUTFALL_NO **39** QUAD **NW** GRID **E12** SAMPLED ☐

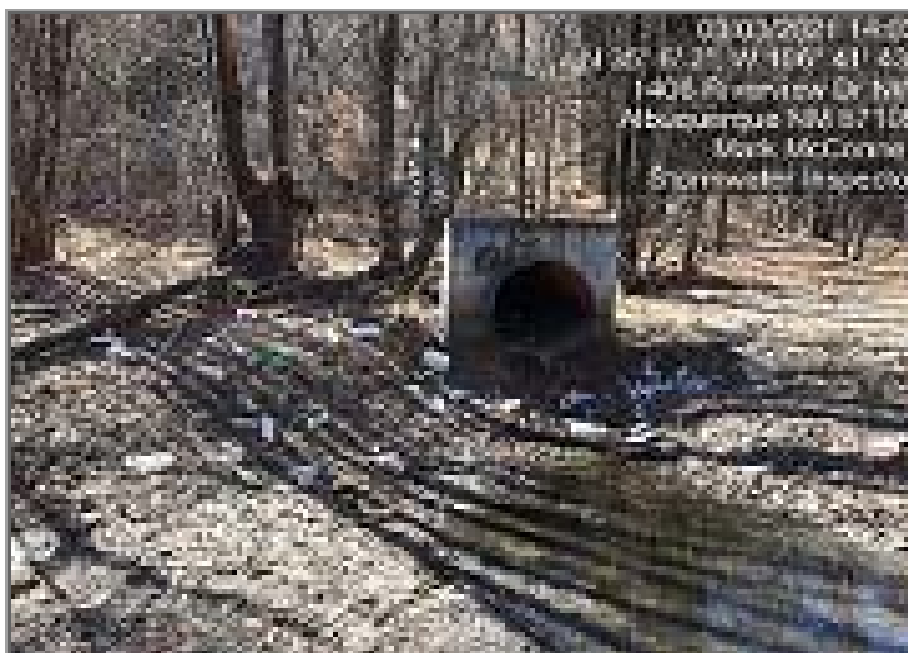
LOCATION	1406-1412 RIVERVIEW NW									
OUTFALL_NO	40	QUAD	NW	GRID	j11	SAMPLED	<input type="checkbox"/>			
DATE_INSP	3/3/2021	TIME	2:08	Inspected by		MM, VV				
WEATHER	SUNNY	flow	NO FLOW	FLOW_GPM		0				
APPEARANCE	na		GROSS POLLUTANT		na					
Source of Flow	na									
link	X:\MD\SHARE\MD-Storm\7 NPDES\311 SWQ				Lab					
AIR_TEMP_F	64		Lab_Report							
WATER_TEMP_F										
pH			E_coli_Coliform_mpn/100ml							
CONDUCTIVITY_Umos/cm			Ammonia_mg/l							
BOD_mg/l			Nitrite_NO2_mg/l							
COD_mg/l			Nitrate_NO3_mg/l							
TSS_mg/l			Nitrite+Nitrate_mg/l							
TDS_mg/l			TKN_Tot_Kjeld_N_mg/l							
N-Hexane Extractable-(Oil_Grease)_mg/l			Phosphorus_total_mg/l_P
