**RIO GRANDE VALLEY STATE PARK,
CENTRAL TO MONTAÑO PROJECT:
ENVIRONMENTAL MONITORING PLAN AND
BASELINE DATA REPORT**

**CITY OF ALBUQUERQUE
PARKS and RECREATION DEPARTMENT**
Albuquerque, New Mexico 87103
(505) 452-5200

SWCA ENVIRONMENTAL CONSULTANTS
5647 Jefferson Street NE
Albuquerque, New Mexico 87109
Telephone: (505) 254-1115; Facsimile: (505) 254-1116
www.swca.com

February 2015

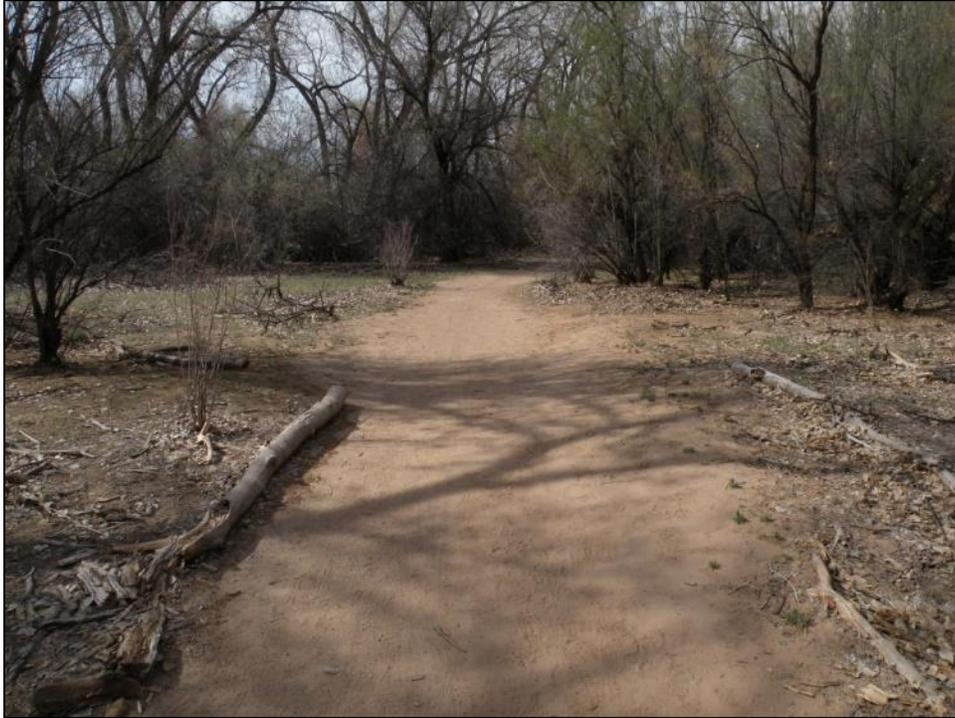
Figure 1.5. Example of an existing soil-based trail at the Rio Grande Nature Center State Park.

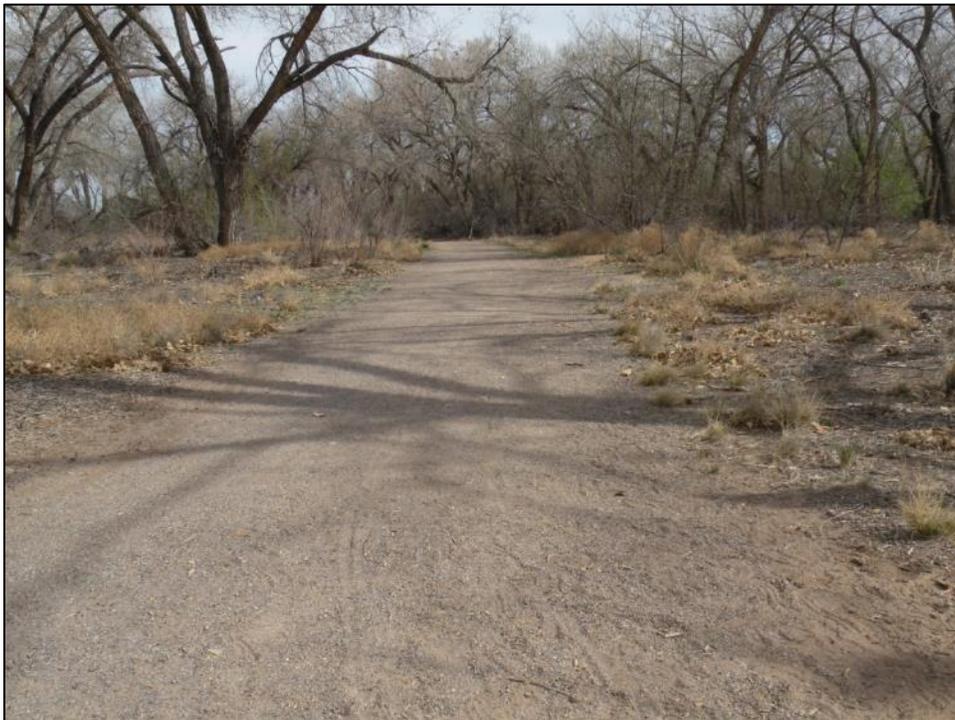
Figure 1.6. An example of the existing trail with fine-crush rock at the Rio Grande Nature Center State Park.

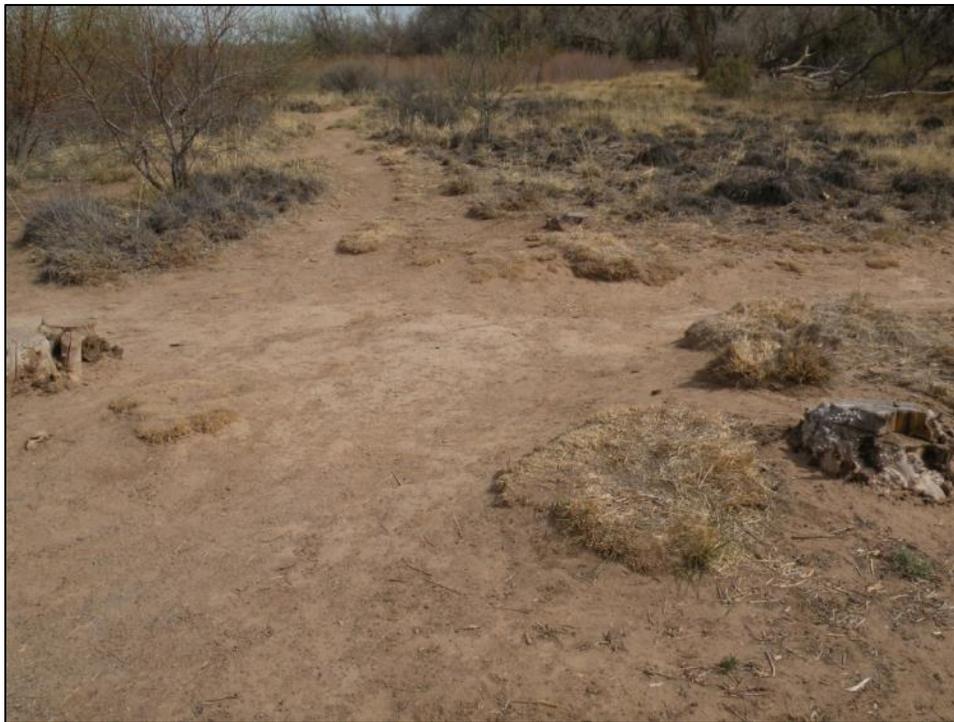
Figure 1.7. Example unofficial side trail at the Rio Grande Nature Center State Park, showing soil erosion and damage to vegetation.

Most user-made side trails are causing damage to soils and vegetation (Figure 1.7) and allow visitors to wander throughout the bosque, with an increased potential to disturb wildlife and resources. Restoration work will be done on most of the closed trails to promote soil health and for native vegetation to become re-established (see Figure 1.6). Design and construction of any amenities or of the main trail would occur no earlier than the winter months of late 2014 and early 2015, following public review.

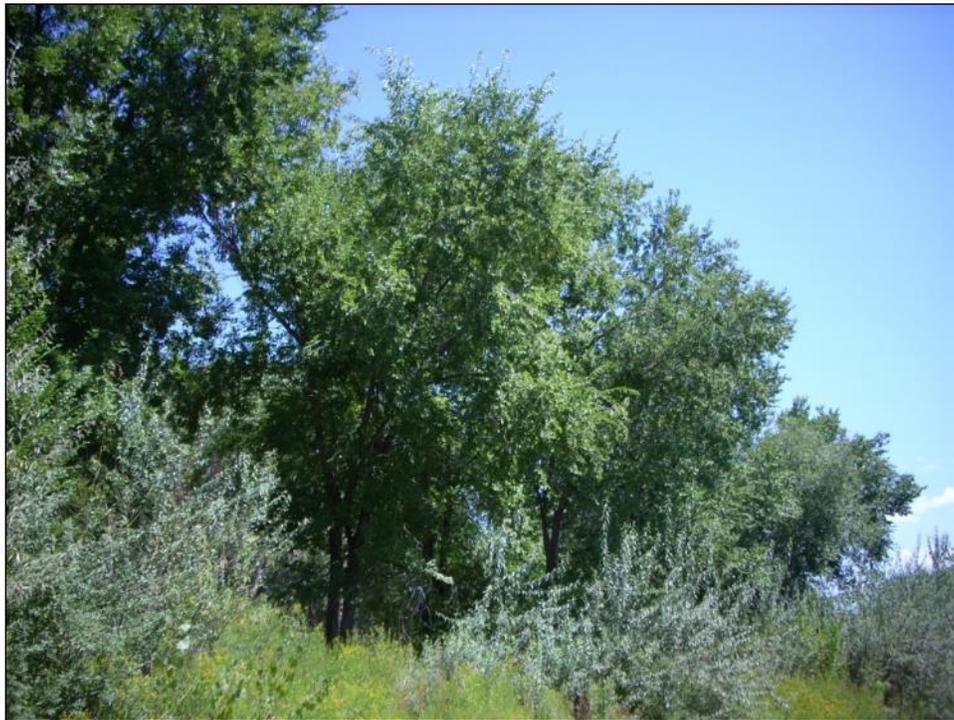
Figure 3.3. Cottonwood/Russian olive, Hink and Ohmart (1984) structural type I classification, Albuquerque Reach bosque.

Hink and Ohmart (1984) reported cottonwood forest of structure Type I to be the most abundant vegetation in their intensive study area (Figure 3.3). Russian olive was the most common understory species, often found in association with saltcedar. Much of the Albuquerque Reach bosque was characterized by thick, mixed native and non-native shrubs and trees. The midstory vegetation was dominated by Russian olive, scattered saltcedar, and fourwing saltbush (*Atriplex canescens*). Canopy vegetation, where present, was dominated by scattered Rio Grande cottonwood with occasional Siberian elm. Understory herbaceous vegetation was sparse in areas that have thick woody growth; however, in areas that were more open, alkali sacaton (*Sporobolus airoides*) and giant sacaton (*S. wrightii*) dominated. Sample images of Hink and Ohmart structural classes are in Figure 3.4 (USACE et al. 2007).

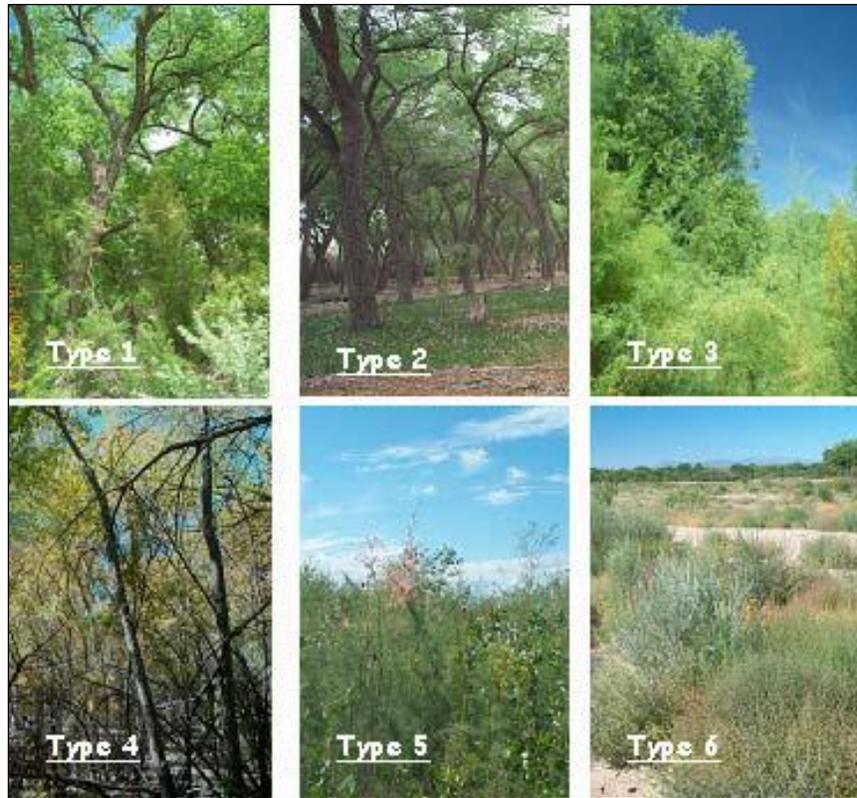
Figure 3.4. Hink and Ohmart (1984) structural classification images (USACE et al. 2007).

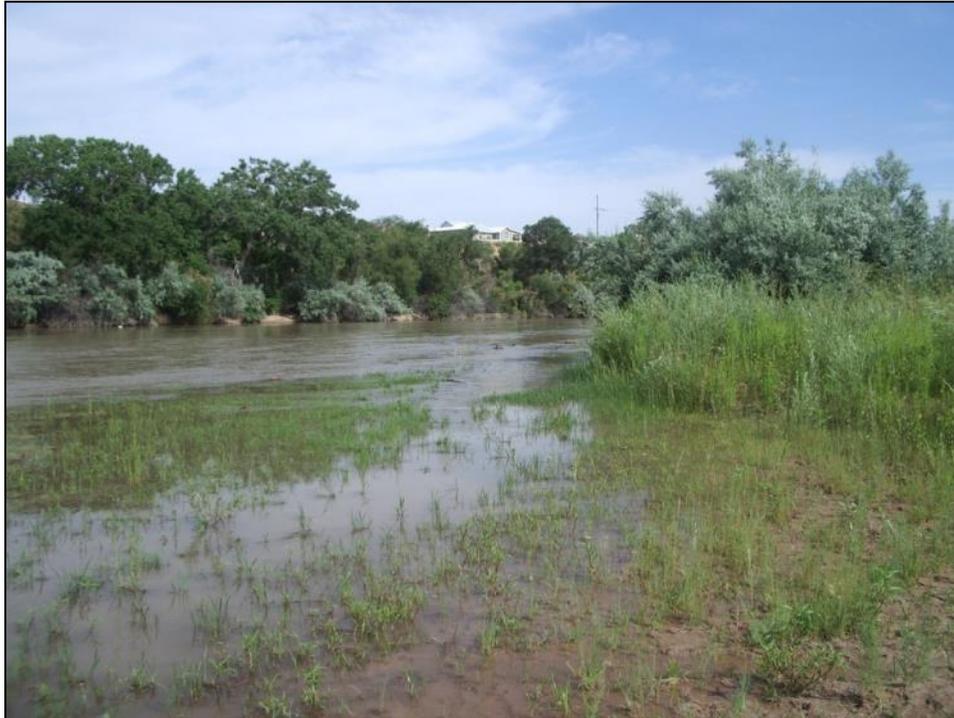
Figure 3.8. Inundated river bar and vegetation growth in the Albuquerque Reach.

Despite considerable attention devoted to the ecology and biodiversity of the riparian bosque (Hink and Ohmart 1984; Crawford et al. 1993), until recently little was known about the in-channel sandbars and islands. These dynamic environments support young wetland and riparian vegetation (Figure 3.8) and most of the natural regeneration of Rio Grande cottonwoods in the river corridor (Milford and Muldavin 2004). Perhaps due in part to the lack of flood peaks during the current drought, vegetated islands and sidebars currently support approximately 13% of the vegetated floodplain throughout the Albuquerque Reach (Milford et al. 2003).

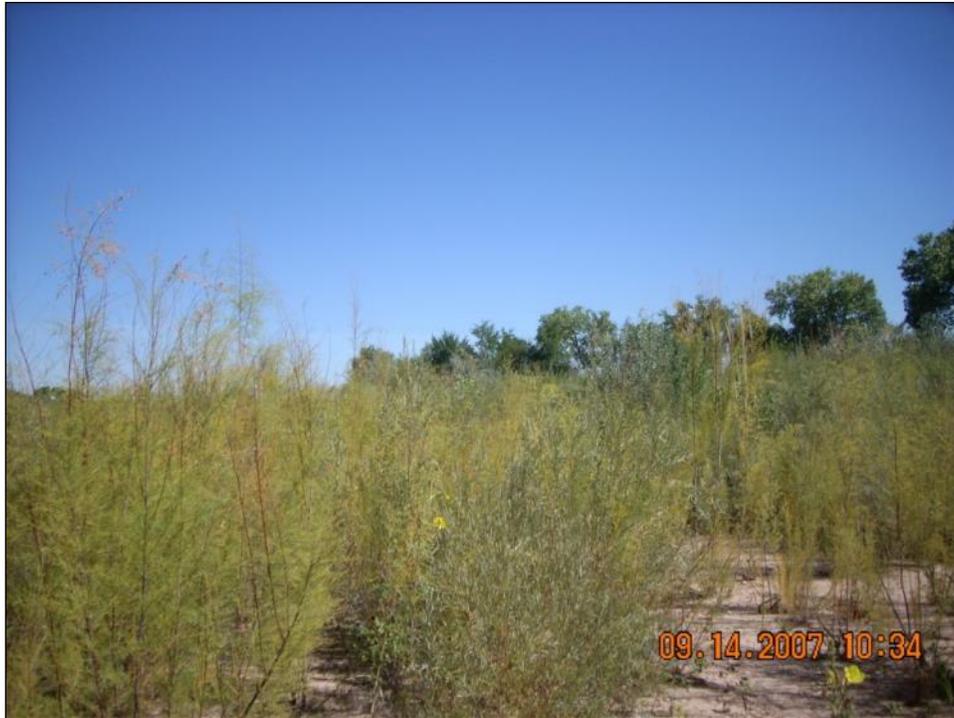
Figure 3.9. Coyote willow and saltcedar on the interior section of an Albuquerque Reach point bar.

The establishment of non-native riparian trees along the riparian zone of the MRG has become a significant environmental and natural resource management concern (Parker et al. 2005). Saltcedar (Figure 3.9) is a non-native tree introduced from central Asia that has become an ever-increasing component of the Rio Grande bosque since the mid 1930s (Crawford et al. 1993). Two species of saltcedar, *Tamarix ramosissima* and *T. chinensis*, were apparently introduced to the MRG in the early twentieth century, and both species now occur throughout the region. The two species are difficult to tell apart, and they are known to hybridize. Our references to saltcedar are inclusive for both species and for hybrids. In many areas, saltcedar has replaced native riparian understory plant communities, decreasing habitat quality for the flycatcher and many neotropical birds (Anderson et al. 1977; Smith et al. 2006). Moore and Ahlers (2008) find that productivity of flycatcher nests in the MRG is significantly greater in native willow-dominated habitats than in saltcedar habitats, and the authors conclude that flycatchers prefer native willow-dominated habitat when available over saltcedar habitats. Saltcedar seeds germinate readily in most areas that are frequently disturbed (Stromberg 1997), and the plant commonly forms impenetrable thickets, making it highly competitive. Furthermore, the ability of saltcedar to stabilize banks has supplemented human-made channelization of the river (Dahm et al. 2002), a feature of MRG morphology that has reduced habitat quality for the silvery minnow.

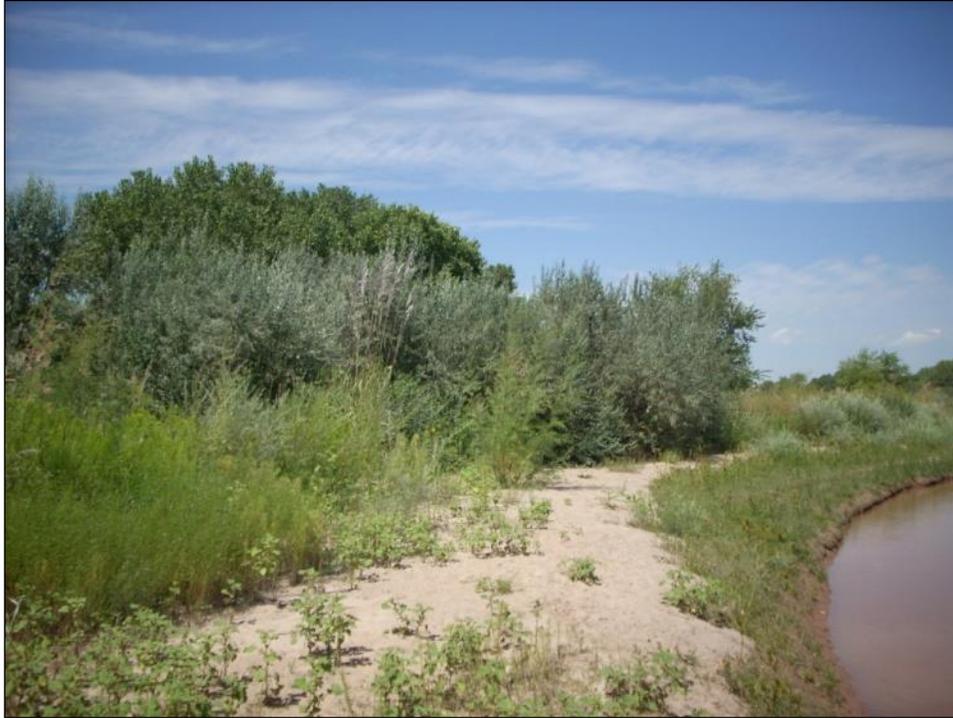
Figure 3.10. Russian olive in the Albuquerque Reach colonizing channel margin (background) with cottonwood behind.

Russian olive (Figure 3.10) was introduced to the MRG between 1900 and 1915 (Hink and Ohmart 1984) and spread throughout the MRG to become a dominant component of riparian vegetation by 1960 (Campbell and Dick-Peddie 1964). Like saltcedar, Russian olive is highly competitive due largely to its ability to survive environmental stresses such as low light and drought conditions. Russian olive also contributes to channel stabilization (Waring and Tremble 1993), reducing river sinuosity and overbank flooding. Hink and Ohmart (1984) recognize that the widespread establishment of saltcedar and Russian olive coincided with the period of significant disturbance associated with the Middle Rio Grande Project (1925–1935). Hink and Ohmart (1984) and Dick-Peddie (1993) note that Russian olive is the dominant invasive tree found along riparian reaches north of Albuquerque, while saltcedar tends to proliferate along more southern reaches.
