City of Albuquerque Facility Condition Assessment De Anza Motor Lodge

2014 REPORT

August 05, 2014

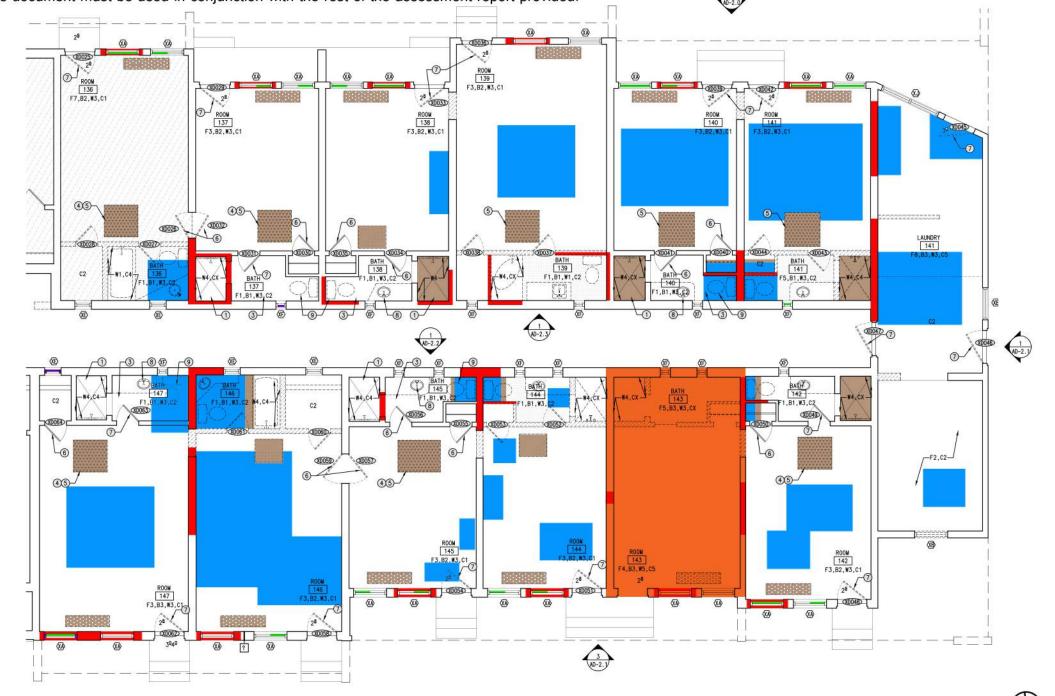
EXISTING / DEMOLITION FLOOR PLAN - BUILDING D - SOUTH

Fire Damage

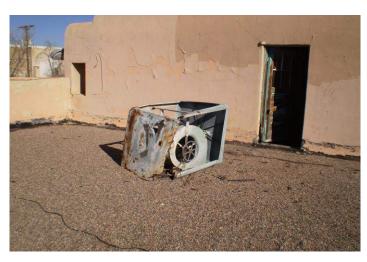
Abandoned Evaporative Cooler for Lobby

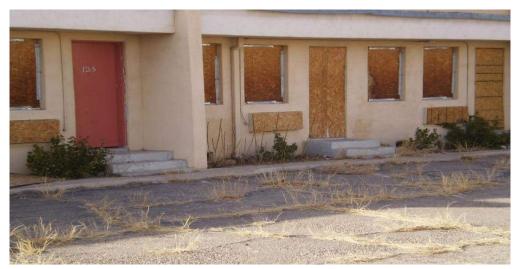
PTAC units with Plywood Cover

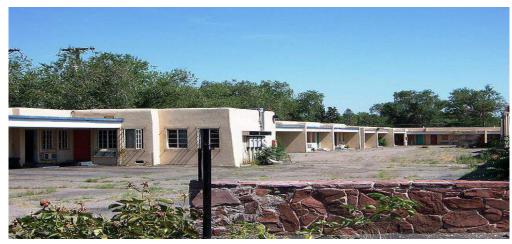
Undated Photo Showing PTAC units installed

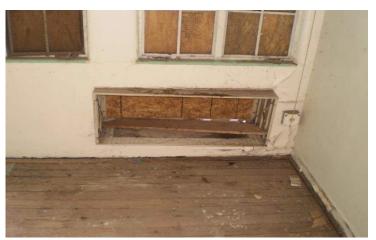
Typical Location of Removed PTAC

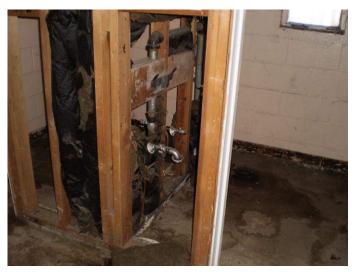
Missing Plumbing Fixtures, Water Closet and Lavatory

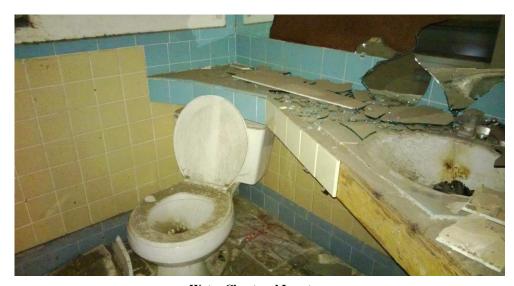
Water Closet and Lavatory

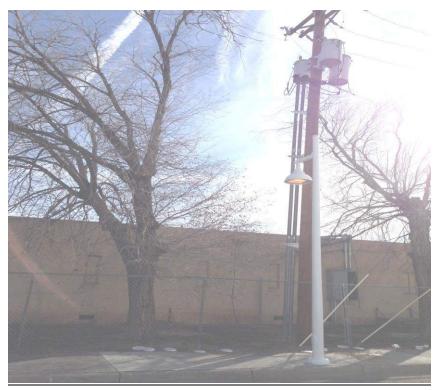
1.1.1 Power Distribution: The building electrical service is rated 120/208 volt, three phase, four wire, 800 ampere, with metering/ct service entrance equipment located on the west side of the building "G" exterior wall. The electrical service is fed from (3) PNM 50 KVA pole mounted transformers located approximately 24 feet to the West of Building "G" with (2) 3" conduits underground to the meter/ct can. All feeders are disconnected/cut and removed from pole mounted transformers to the meter/ct cabinet. The meter/ct cabinet is gutted and the aluminum feeders are cut and abandoned in place from the meter/ct can in (2) 3" C. are routed up the west wall above roof to East side of Building "G".

PNM Service Riser to Meter/Can Equipment - Exterior West Building "G"

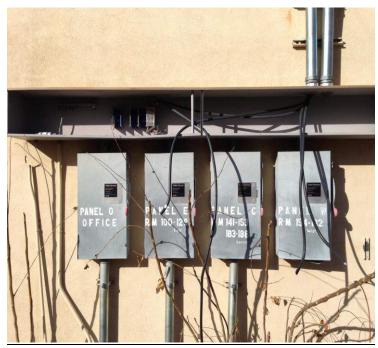
Four Fused Disconnects at East Exterior Wall Of Building "G"

- 1.1.2 There is a 10" x 10" weather proof gutter/wireway connected to a total of four fused disconnect switches rated at 240V, 200A-3 Phase, 4 wire located at the East exterior wall of Building "G" and 2.5" conduit is routed underground to Sub-Panels with-out feeders as follows:
 - A. Left side first disconnect switch is routed to Sub-Panel "O" in the back office hallway (Bldg. E), shown below.

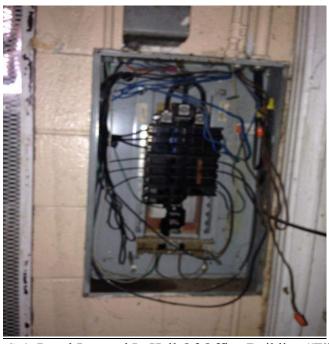
Sub-Panel Located In Hall Of Office Building "E"

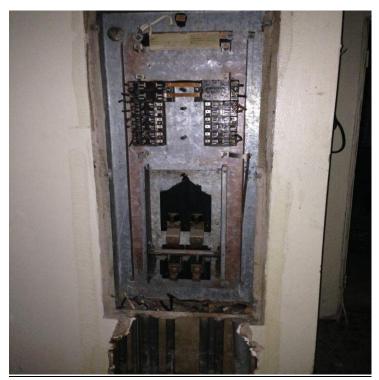
B. Sub-Panel below is vintage 1938, abandoned in place in the back office North hallway wall, shown below.

Sub-Panel Located In Hall Of Office Building "E"

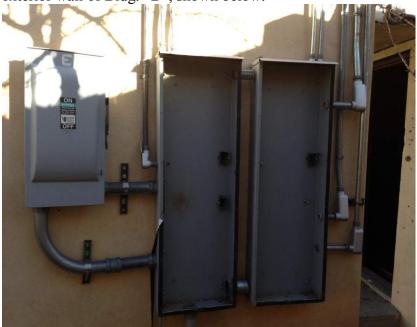
C. Second disconnect switch is routed to a 240V, 200A disconnect switch to (2) Sub-Panels "E" (EAST) for Rms. 100-129 (Building's A & B) and the other routed to Panel in Building "C" mounted at south exterior wall of Bldg. "B", shown below.

Two Sub-Panels Located At South Exterior Wall Building "B"

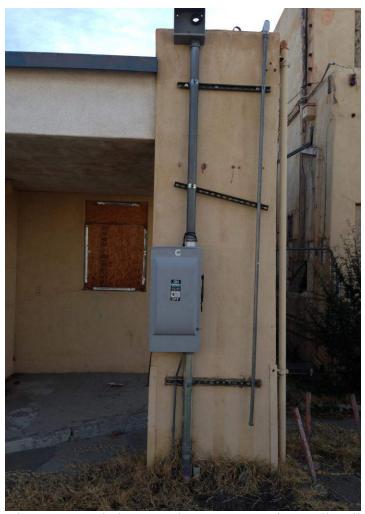
D. Third disconnect switch is routed to 240V, 200A disconnect switch mounted on West exterior wall of Building "D" routed to Sub-Panel "C" (CENTER) for Rms. 141-153/183-188 (Building's D).

Disconnect Switch Located At West Exterior Wall Building "D"

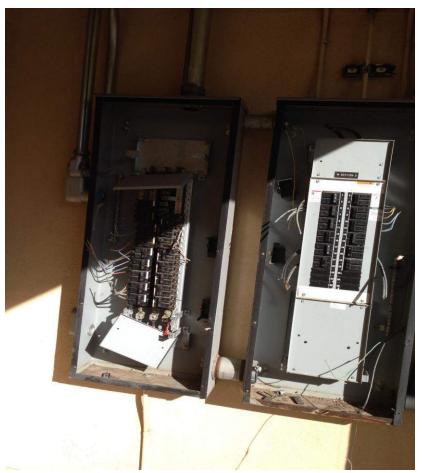
Two Section Sub-Panels Located At South Exterior Wall Building "G"

- E. Panel "W" (WEST) for Rms. 154-182 (Building's F & G) each with 2.5" Conduit abandoned in place (Feeders are all removed from disconnects to Panels).

- F. There is not any branch circuit conductors from all panels feeding the respective areas in any of the branch circuit conduits from all the panels. The majority of the power distribution system equipment in the De Anza Motor Hotel is in extremely not in usable condition. Grouped Disconnect's are located on the East side of the building "G" and are vintage 1983's. All Dead front panel covers, bus, breakers, complete interiors, including wiring of panel boards have been removed or vandalized and are vintage 1983's. Panels located in the office are load center type, vintage 1939's, and there are numerous electrical code violations relative to grounding and clearance throughout all of the Buildings. All feeders from the disconnect switches to all the subpanels and branch circuits to all guest rooms have been vandalized at some point.

- 1.5.3 Power System: The electrical service entrance equipment is not in good working condition. All the feeders from the Service Entrance Distribution to the Sub-Panels and branch circuits have been removed or vandalized. There will be new receptacle circuits routed in conduit as required in all of the new guest rooms, offices and through-out the entire facility. Our recommendation, would be to install New Service Entrance Distribution for the calculated load and individual panels for each building "A", "B", "C", "D", "E", "F" & "G" and extend branch circuits to the respective panels.

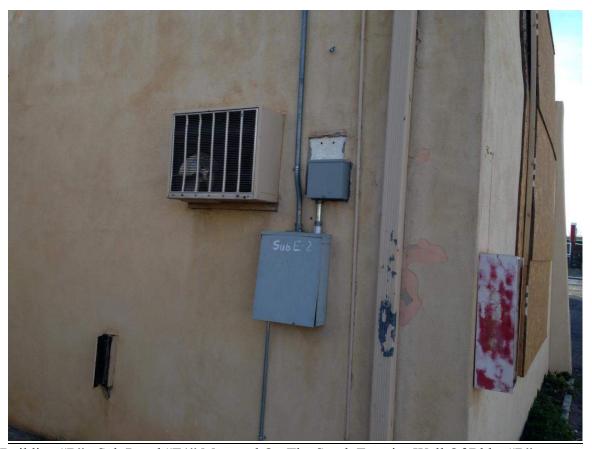
1.1.4 Sub-Panels: Vintage 1939 Sub-Panels "E2" have been used as a pull box when new Service was installed.

Building "B" – Sub Panel "E1" Mounted On The South Exterior Wall Of Bldg. "B"

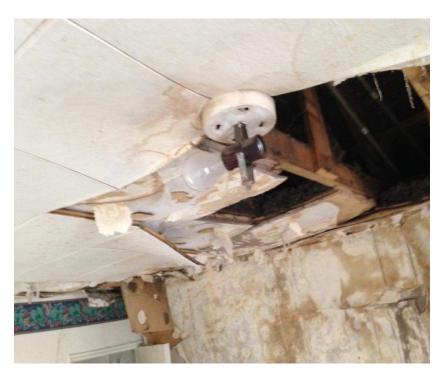
Motel Guest Room Incandescent Surface Mount Fixture

1.3 Lighting: The majority of the Hotel Guest Room interior lighting consists of two lamp incandescent ceiling surface mounted fixtures, and the bathrooms with incandescent surface wall mount fixtures with asbestos type wire to all branch circuits.

- 1.5.1 Lighting System: There are numerous NEC violations regarding illegal use of wiring for the all, including exposed junction boxes, lighting with broken lenses, branch circuits wiring running exposed along open walls and ceilings without physical protection. There are no exit lights and/or emergency egress lighting through-out facility. The exterior lighting under the canopy consists of inexpensive period type light fixtures surface mounted to the bottom of the canopy with incandescent lamps. Lantern period type fixtures are bracket mounted to the exterior on the west & east side of the canopy and Guest room are old period. Large, Bulky Incandescent PAR lamp flood lights are located on the east and west side of the building "D" & "E" parapets, as well as east of Bldg. "F" & "G" and west on Building "A", "B" are not in working conditions. There are several lights located in and through-out the facility, of which all has been vandalized and the glass cover's are broken. Several pedestrian type fixtures with period type lantern luminaires are located at the office entry wires are exposed. All lighting in the entire premises is not in working condition. There is no green wire equipment grounding conductor in any of the branch circuits. It is recommended to provide an entire lighting system through-out the facility, including new lighting fixtures, occupancy sensor switches, toggle switches, dimmer switches, conduit, equipment grounding conductors and branch circuit wiring to comply with the latest addition of the National Electrical Code.

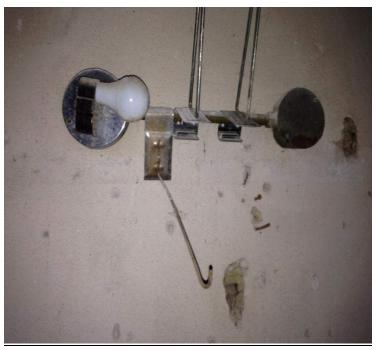
Guest Room Bathroom Incandescent Lighting Fixture and Exposed Conduit

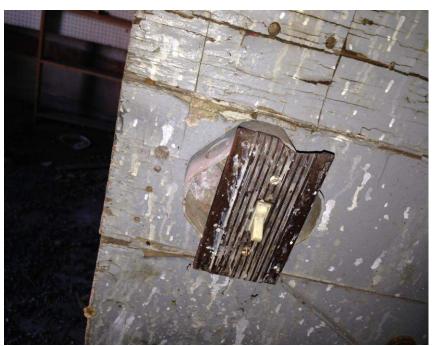
All Hotel Guest Rooms Lighting Controlled With Toggle Switch located at door entrance

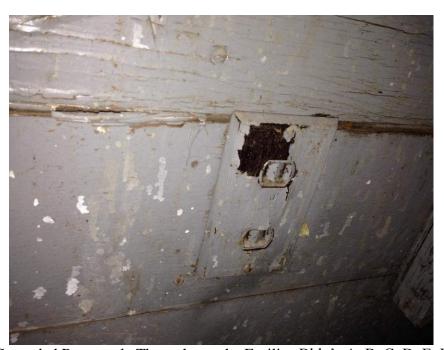
Non-Grounded Receptacle Through-out the Facility-Bldg's A, B, C, D, E, F & G

- 1.5.4 Branch Circuit Wiring: Even though it is not a code violation to have green wire equipment grounding conductors in the lighting and power branch circuits, it is recommended to replace all lighting and receptacle branch circuits and to provide green wire equipment grounds in all the conduits. It also recommended to replace all non-grounding type receptacles with grounding type receptacle through-out the entire Facility.

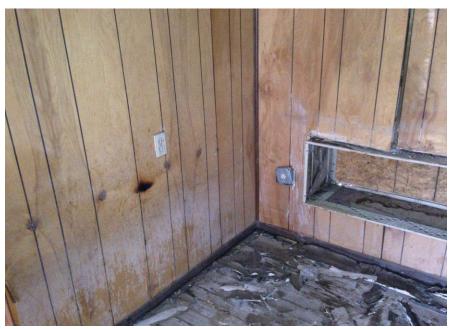
Guest Room Side Wall Heating/Cooling Unit Receptacle With Surface Mount J-Box

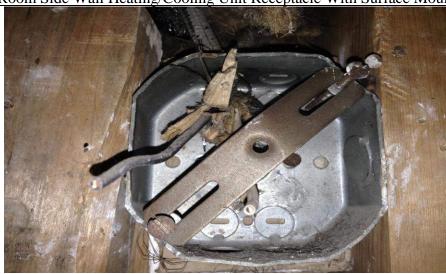
Guest Room Exposed Octagon Junction Box For Lighting At Majority Of Guest Rooms

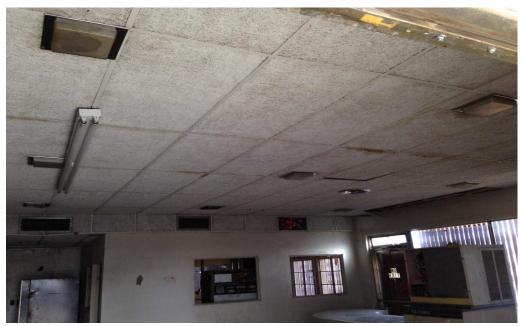
Office Entrance Lobby Area

1.3.2 The fixtures in Building "E", consist of industrial fluorescent, wraparound fluorescent type, square recessed incandescent type and pendant type light fixtures that have been vandalized at some point in the office. There are multiple code violations including no exit lights and emergency lights for path of Egress. All the lighting, switches and conductors in all areas of the site are not energy efficient, in code violations and life safety code concerns.

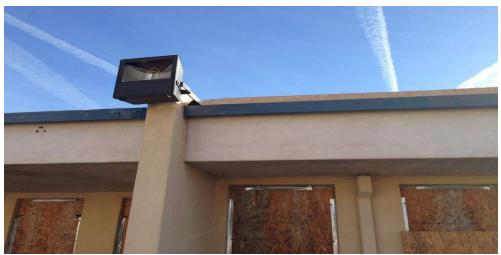
1.3.3 The fixtures at exterior of Building "E", consist of HID type fixtures, wraparound fluorescent type, square recessed incandescent type and wall mount HPS with broken lenses that have been vandalized at some point.

Exterior HID Surface Mount At Various Places On Site

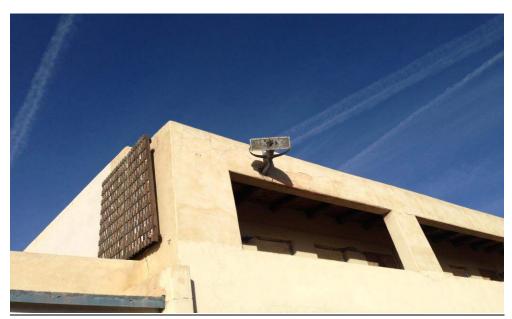
Exterior HID Wall Surface At Various Places On Site

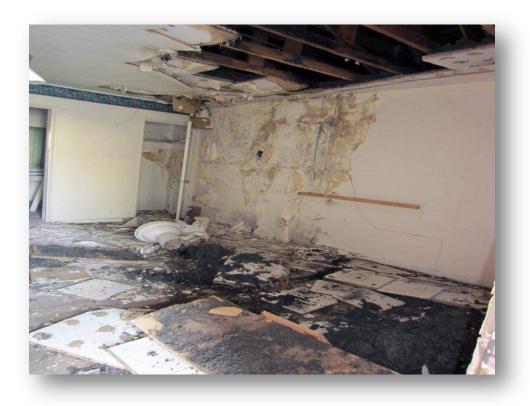
Figure 2- Building A Room 102 Ceiling Collapse

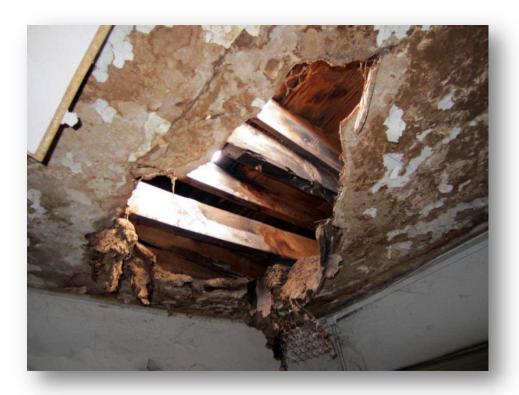
Figure 7- Building A Room 106 - Ceiling Collapse - Exposed Structure

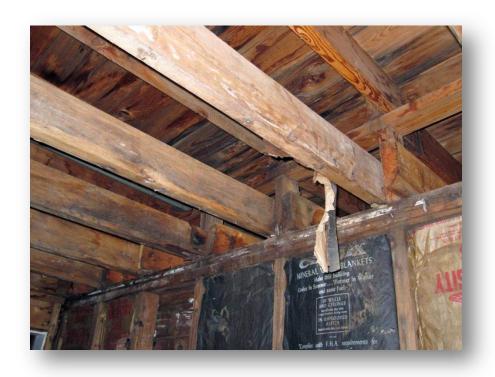
Figure 14-Building B Room 111 Exposed Roof Structure

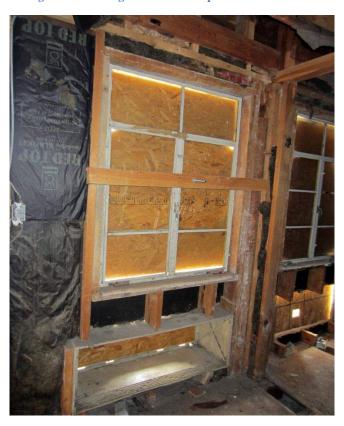
Figure 15- Building B Room 110 - Cut Exterior Studs

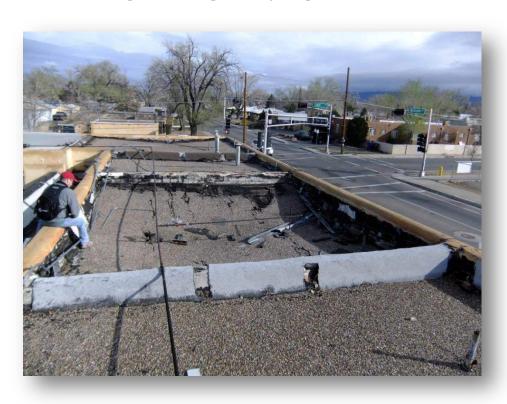
Figure 18- Building C Partially Collapsed Roof Structure
