City of Albuquerque  
Facility Condition Assessment  
De Anza Motor Lodge

2014 REPORT

## 1.0 Executive Summary

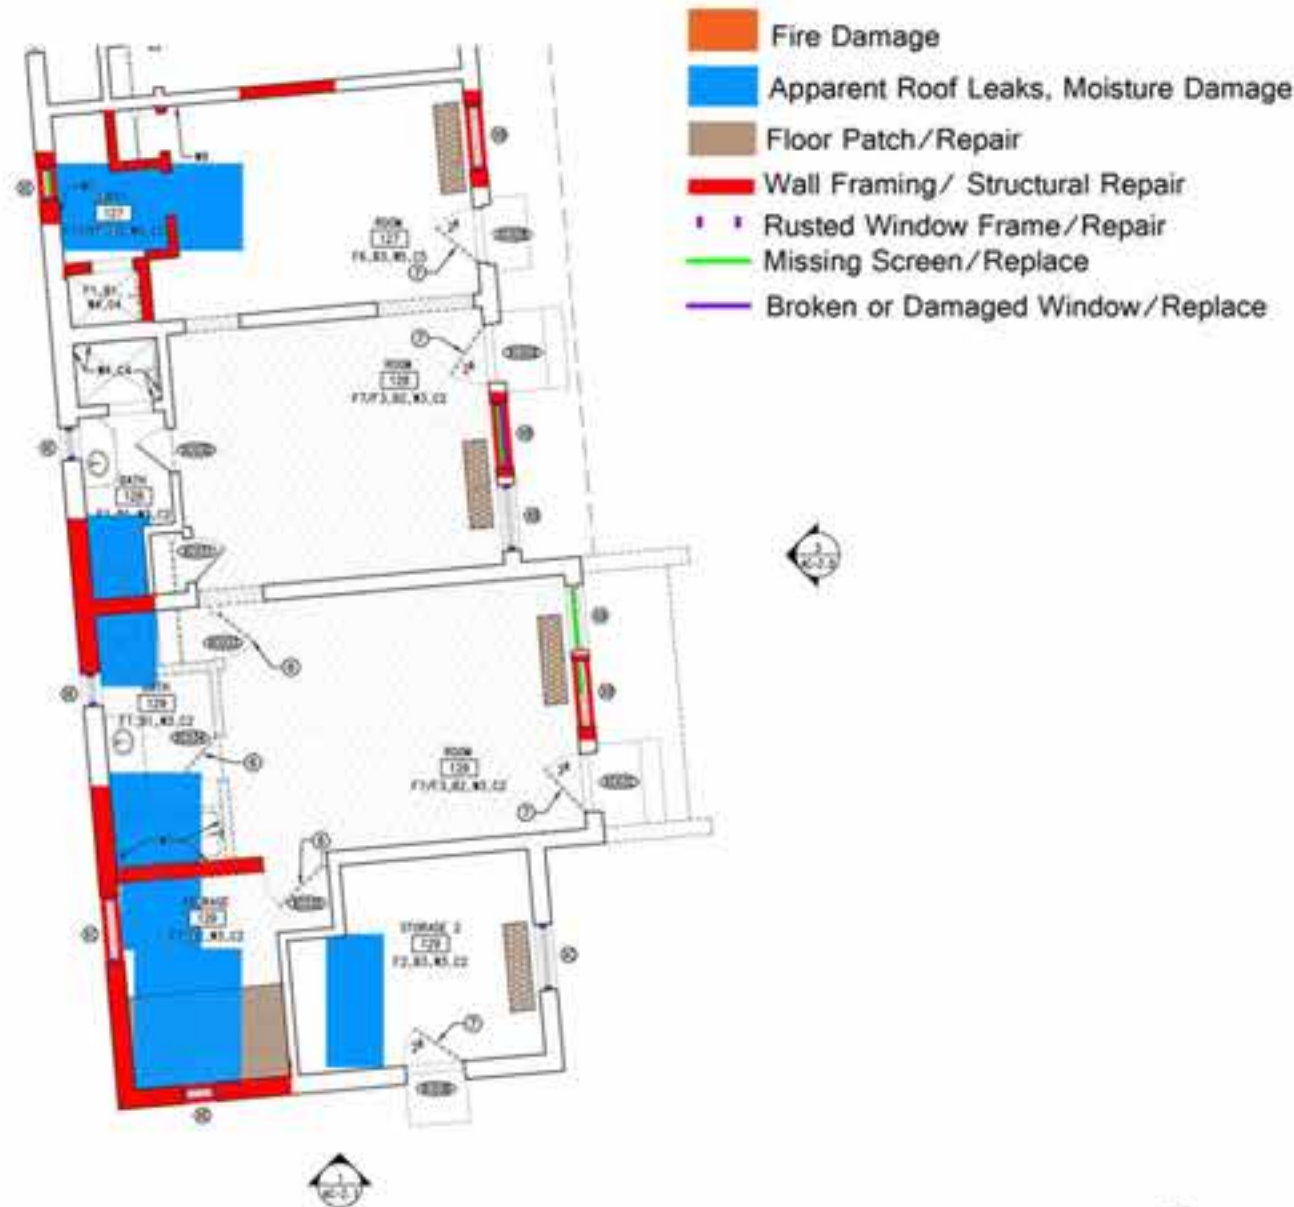
EXISTING / DEMOLITION FLOOR PLAN - BUILDING C - WEST

1. This document should be used with the Structural Inspection Report generated by Unity Engineering - April 29, 2014. This represents an observation summary of visual damage apparent at the time of review. Other damage may exist.
2. Structural members exposed to fire damage should be replaced in their entirety. Members in question should be reviewed by a licensed Professional Engineer.
3. Structural members and connections exposed to water damage should be reviewed after removal of finish materials to ensure they still have sufficient structural capacity.
4. Contractor is required to provide all shoring or bracing to maintain structural stability during selective demolition or repairs.

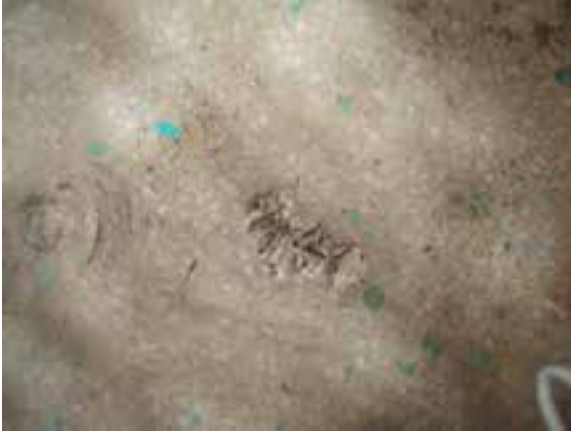
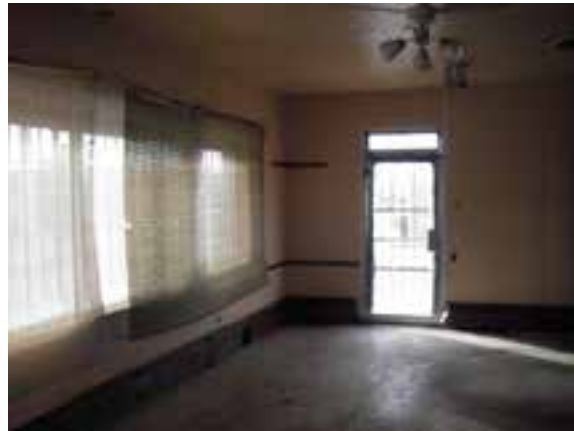
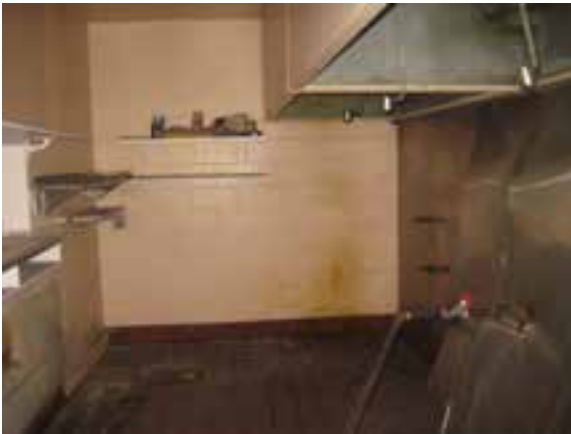
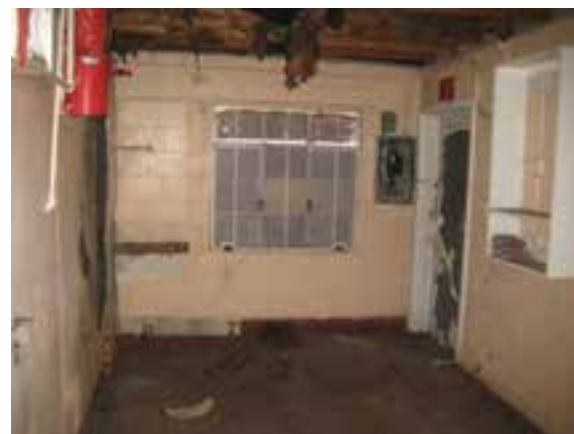
**Room 182**

This single room has a roof leak in the bathroom damaging the ceiling and walls. One bathroom window is rusted. Windows are missing screens. There are signs of a roof leak. Water stains in the ceiling tile in the bedroom/living room.

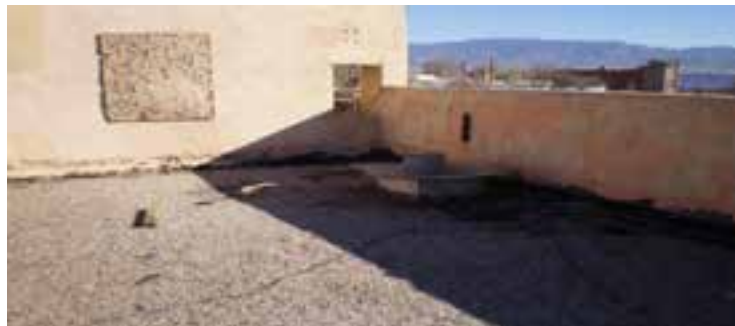
Abandoned Roof Opening for Evaporative Cooler Serving Lobby

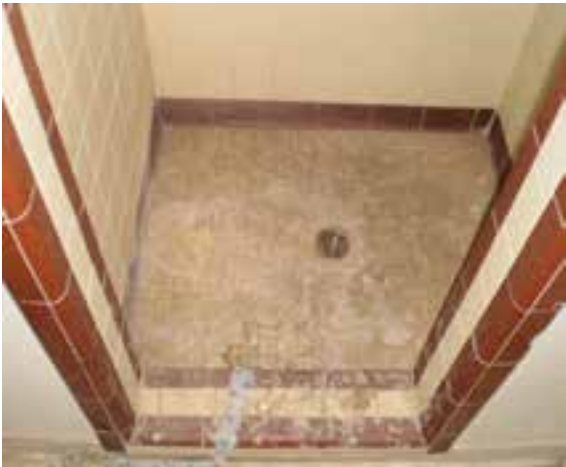
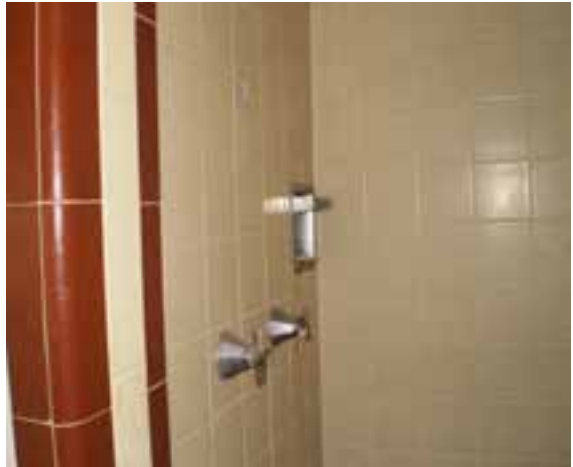
Stand Alone Shower – Not Typical Condition

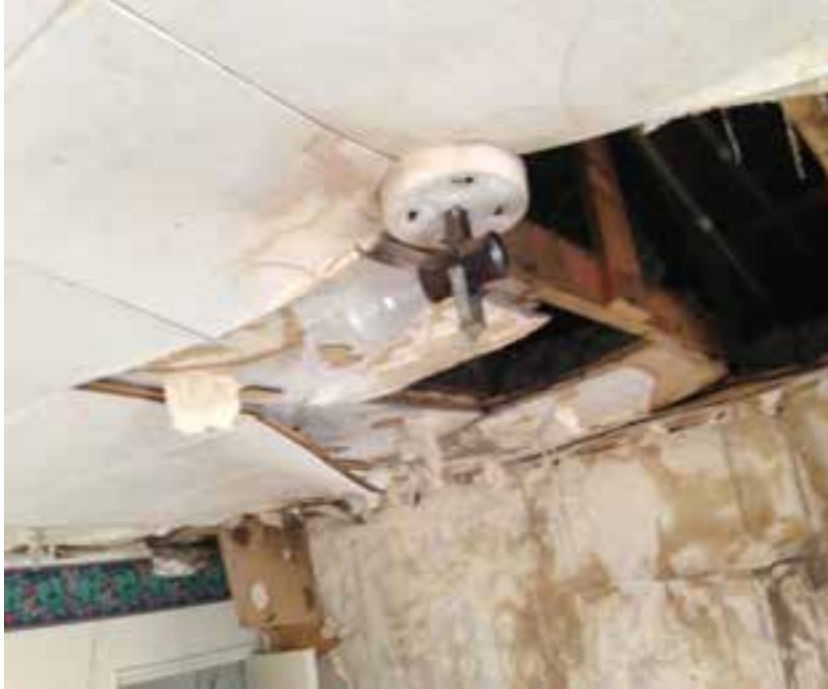
Motel Guest Room Incandescent Surface Mount Fixture

- 1.3 Lighting: The majority of the Hotel Guest Room interior lighting consists of two lamp incandescent ceiling surface mounted fixtures, and the bathrooms with incandescent surface wall mount fixtures with asbestos type wire to all branch circuits.

- 1.5.1 Lighting System: There are numerous NEC violations regarding illegal use of wiring for the all, including exposed junction boxes, lighting with broken lenses, branch circuits wiring running exposed along open walls and ceilings without physical protection. There are no exit lights and/or emergency egress lighting through-out facility. The exterior lighting under the canopy consists of inexpensive period type light fixtures surface mounted to the bottom of the canopy with incandescent lamps. Lantern period type fixtures are bracket mounted to the exterior on the west & east side of the canopy and Guest room are old period. Large, Bulky Incandescent PAR lamp flood lights are located on the east and west side of the building “D” & “E” parapets, as well as east of Bldg. “F” & “G” and west on Building “A”, “B” are not in working conditions. There are several lights located in and through-out the facility, of which all has been vandalized and the glass cover’s are broken. Several pedestrian type fixtures with period type lantern luminaires are located at the office entry wires are exposed. All lighting in the entire premises is not in working condition. There is no green wire equipment grounding conductor in any of the branch circuits. It is recommended to provide an entire lighting system through-out the facility, including new lighting fixtures, occupancy sensor switches, toggle switches, dimmer switches, conduit, equipment grounding conductors and branch circuit wiring to comply with the latest addition of the National Electrical Code.

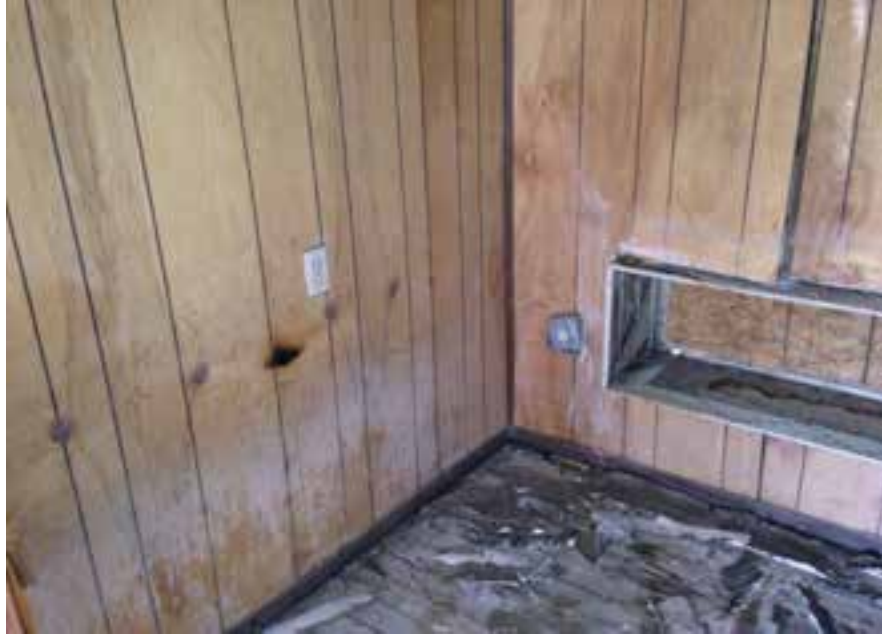
Guest Room Side Wall Heating/Cooling Unit Receptacle With Surface Mount J-Box

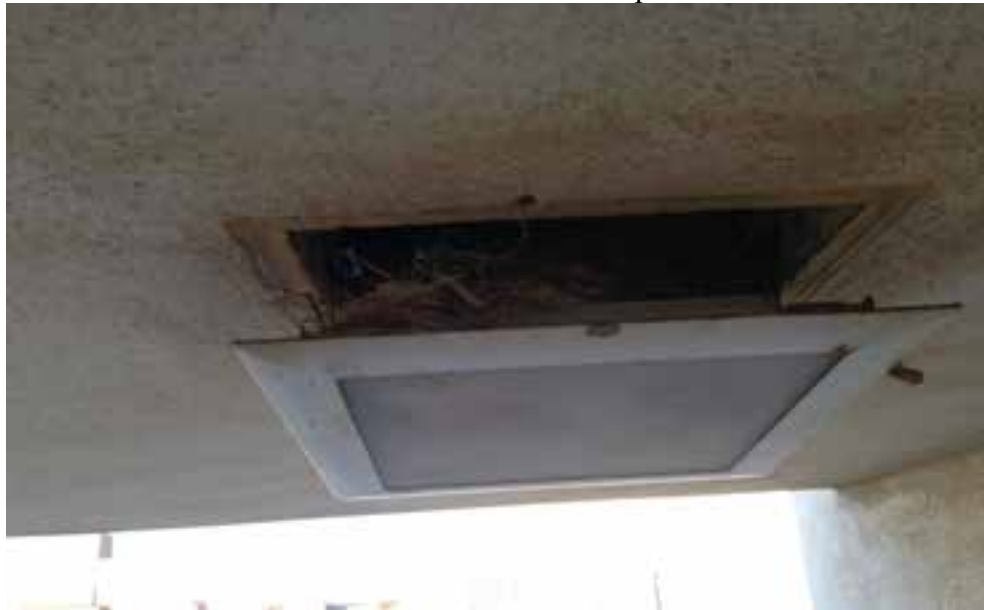
- 1.3.3 The fixtures at exterior of Building “E”, consist of HID type fixtures, wraparound fluorescent type, square recessed incandescent type and wall mount HPS with broken lenses that have been vandalized at some point.

Exterior Incandescent Light Fixtures At Canopy Entrance

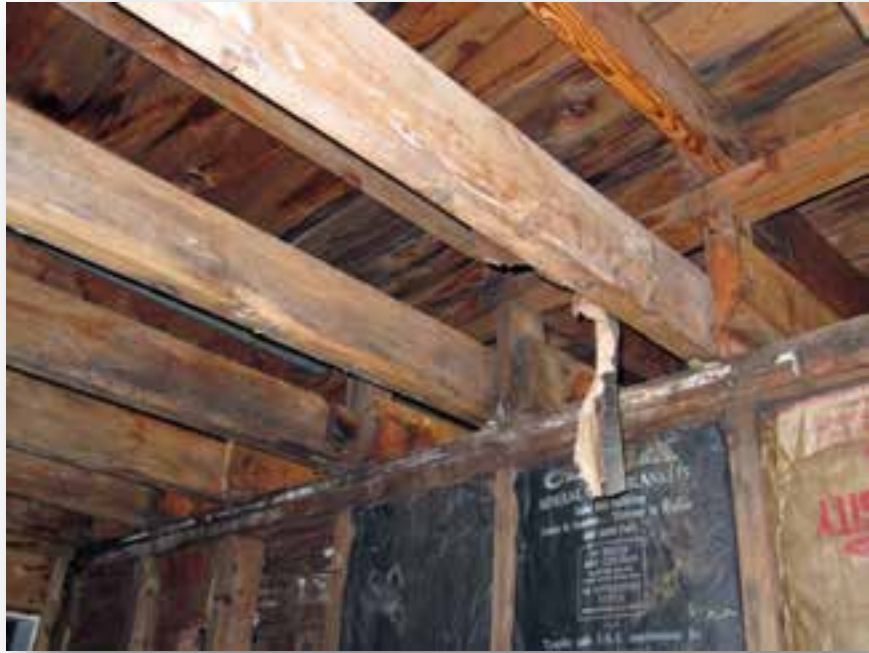
Figure 14-Building B Room 111 Exposed Roof Structure

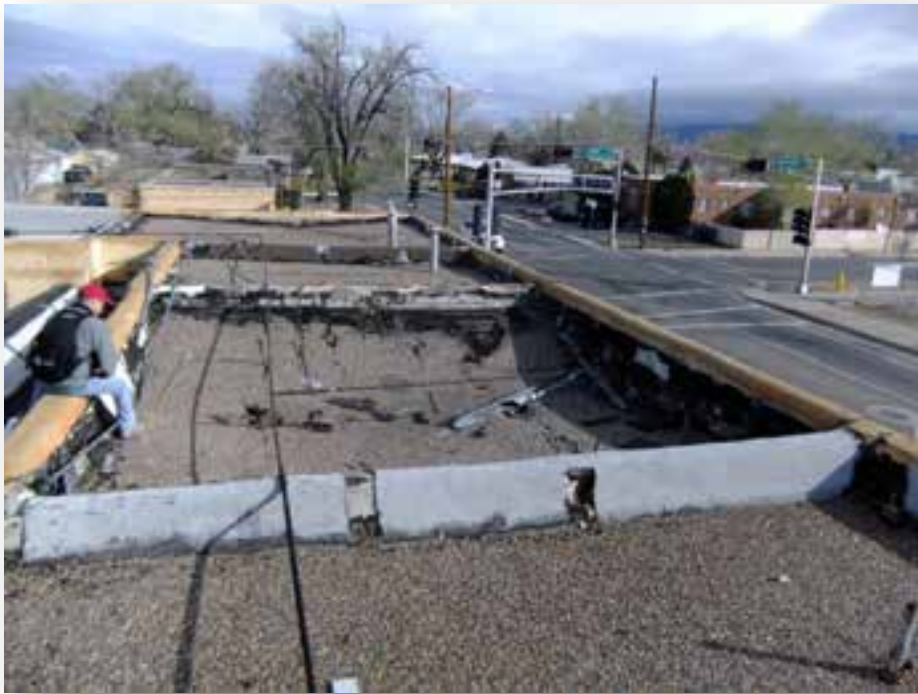
Figure 18- Building C Partially Collapsed Roof Structure

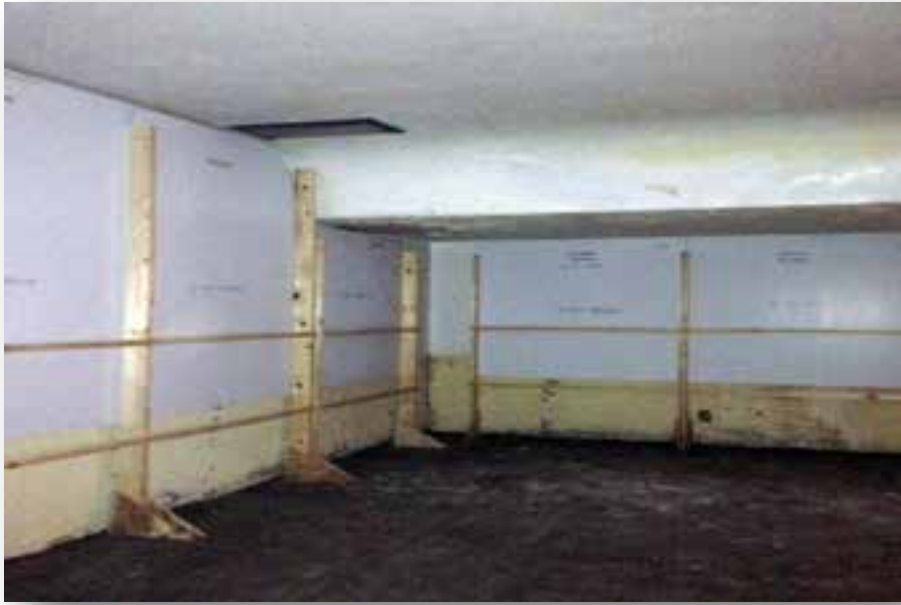
- Basement – good condition overall, minor concrete cracking. Water damage to non-structural components.
- Building Structure – Major fire damage in units 130-132. Significant water damage and corrosion of metal deck. Structural components exposed to fire would need to be replaced due to heat damage and potential embrittlement.

Figure 25- Building D Basement

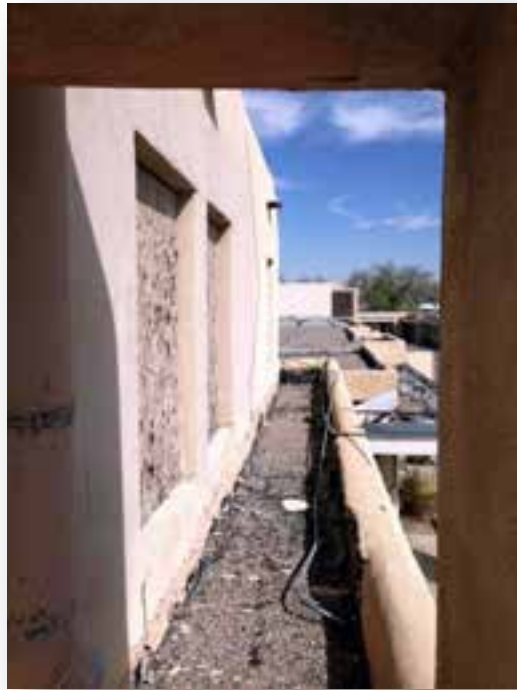
Figure 35- Building E – Roof Setback

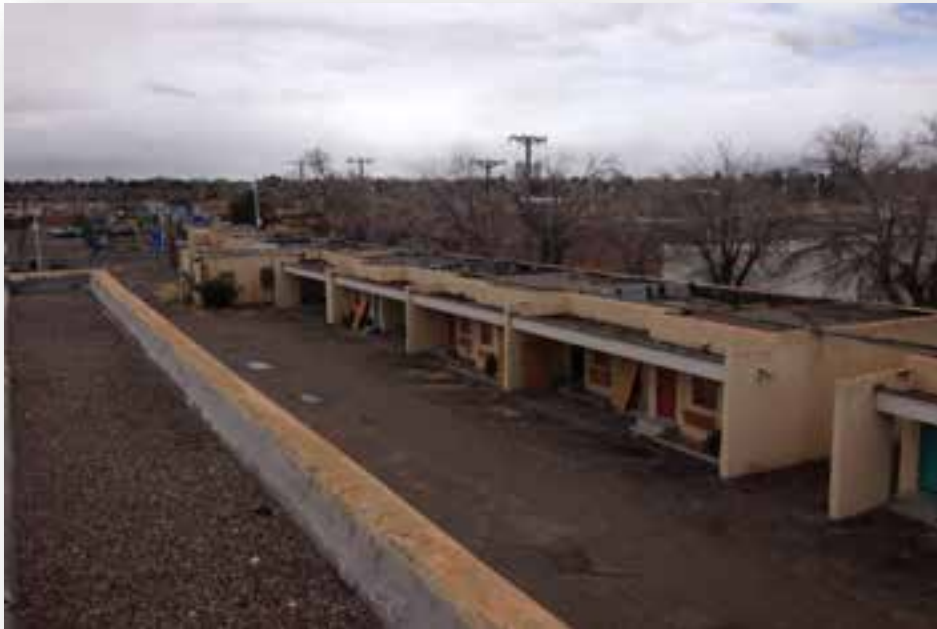
Figure 45- Building G
